**Zeitschrift:** IABSE reports = Rapports AIPC = IVBH Berichte  
**Band:** 37 (1982)

**Artikel:** Fatigue and fracture analysis of defects in a tied arch bridge  
**Autor:** Fisher, John W. / Hausammann, Hans / Pense, Alan W.  
**DOI:** <https://doi.org/10.5169/seals-28953>

## **Fatigue and Fracture Analysis of Defects in a Tied Arch Bridge**

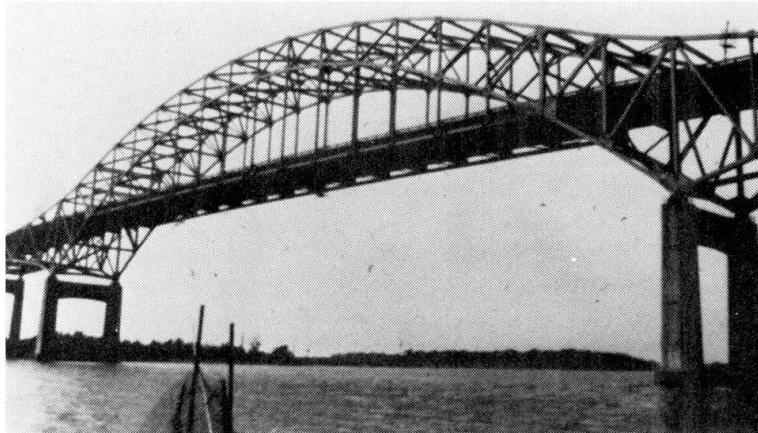
Fig. 1a Overview of Structure

The Mississippi River Gulf Outlet Bridge is located near New Orleans, Louisiana. Figure 1 shows a view of the structure and a tie girder. The tie girders were fabricated of A514 steel. The suspended span is 170.7 m long, and the trusses are spaced 22.86 m apart.

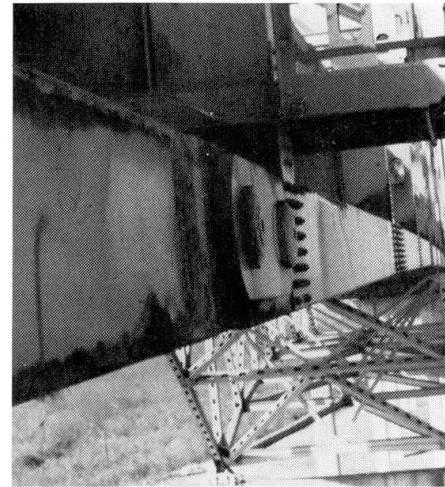
Fig. 1b View of Tie Girder

The tie girders in the Gulf Outlet Bridge are box sections. The web plates are 711 mm high and 19 mm thick, the flanges are 635 mm wide and 16 mm thick. The plates are fillet welded at the four box corners. At floor beam connections and at the pinned connection of the tie (see Fig. 1b), additional interior corner welds are used to transfer the forces. The dimensions of the box are shown in Fig. 2.

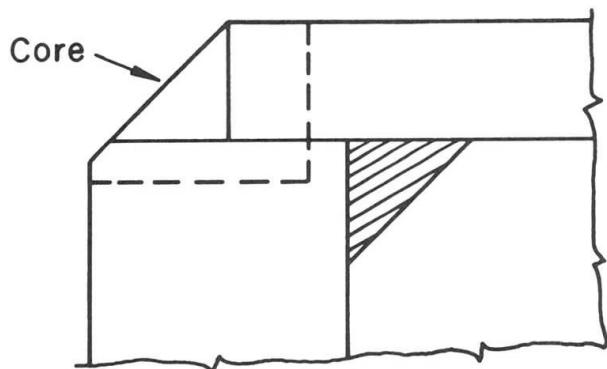
Fig. 4a Schematic Showing Core Sample at Web-Flange Corner Weld

Several of the defects were removed from the box corners by coring (see Fig. 4a), so that detailed metallographic and fractographic studies could be carried out to ascertain the cause of cracking. Figure 4b shows the polished face of the box

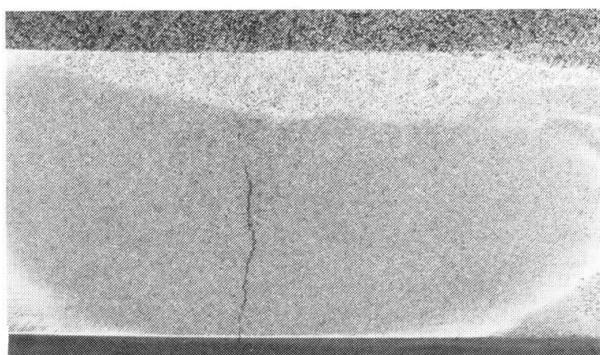
Fig. 4b Ground Surface of Weld Segment Showing Crack

corner weld and the transverse weld crack that was observed. The small segment was broken open to expose the crack surface which is shown in Fig. 4c. A section just behind the crack surface was polished and etched and can be seen in Fig. 4d. This illustrates that multiple weld passes were added to the original submerged arc weld and that the crack extends throughout the corner weld into the heat-affected zone. On the whole, the fractographic examination of the crack surface suggested that the crack was produced during or shortly after welding. Some fatigue crack growth striations were also suggested in a few areas at very low  $\Delta K$  levels. Similar transverse weld cracking has been reported in groove welds and attributed to hydrogen and residual stresses<sup>1</sup>.

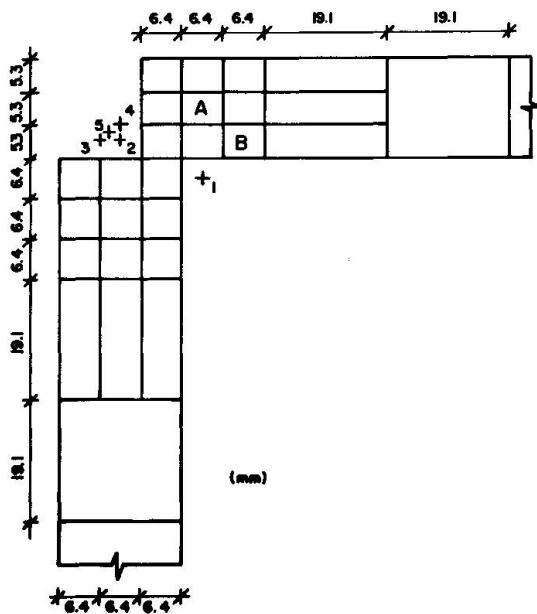
Fig. 5 Weld Sequence and Discretization near Box Corner Weld

Different weld passes are made during the fabrication of the box girder. First, the plates are temporarily assembled with small tack welds. Then the automatic submerged arc welds at the outside corners are made. Next, longitudinal welds

inside the box are made manually, and finally several manual passes are made over the outside submerged arc weld. It is assumed that the total welding at one corner can be simulated with five weld passes.

The residual stresses due to welding were calculated using a computer program developed at the University of Missouri<sup>4</sup>. To calculate the stress distribution, the cross-section was divided into finite elements; part of the discretization is shown in Fig. 5, with the weld passes shown as crosses.

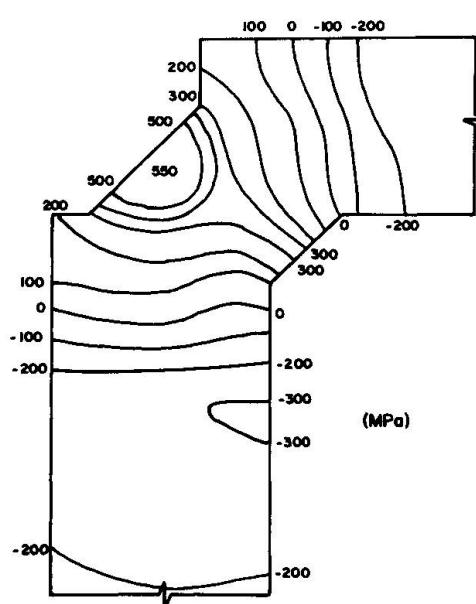
Fig. 6 Residual Stress Distribution near Box Corner Weld, Box Girder

The residual stress distribution was calculated at the end of each weld pass. This distribution was used as the initial condition for the next weld pass. Based on the residual stress at the center of each element, the total distribution was derived using linear interpolation. The final stress distribution is shown in Figs. 6 and 7.

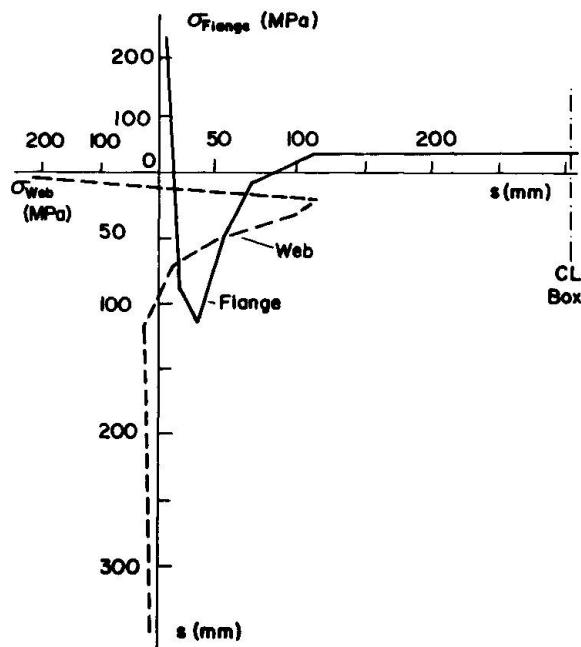
Fig. 7 Residual Stress Distribution due to Corner Welds in Middle Plan of Web and Flange Box Girder

The total stress intensity factor is calculated using the principle of superposition. The K-value due to the uniformly applied dead and live load stress is calculated using the solution to an imbedded elliptical plan<sup>7</sup>. The K-value due to the residual stress shown in Fig. 7 was estimated using a procedure described in Ref. 8. The varying stress field is discretized by discrete point loads, and the corresponding K-value is calculated. The total K-value is obtained by an integration over the entire crack surface.

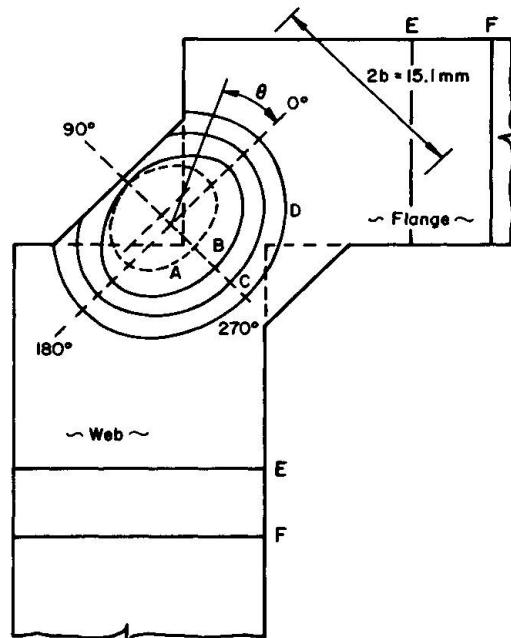
Fig. 8 Investigated Crack Shapes in Corner Weld, Box Girder

The cracks in the corner welds are of different shapes and sizes. Several shapes that were evaluated are shown in Fig. 8. It was assumed that the cracks can be analyzed as elliptical cracks circumscribing the flaw.

The crack front moves into the web and the flange plates as soon as the embedded crack becomes too large to be accommodated in the weld area of the web-flange welded connection. Typical crack stages in the web and flange are shown in Fig. 8 and indicated as E and F. These crack configurations were treated as two independent edge cracks. Both crack fronts (the front in the web and the front in the flange) propagate at the same rate, because the cyclic applied stress is uniform. The total crack opening is almost the same, because the residual stress distribution in the web is almost identical to the stress distribution in the flange. Hence, the crack in the web can be analyzed independent of the crack in the flange.

It was found that the stress intensity range is larger than  $\Delta K_{TH}$  for all the crack shapes shown in Fig. 8. Crack shapes B, C and D exceed the crack growth threshold when the stress range is  $14 \text{ MPa}$ . The increase in the total stress intensity factor (due to traffic, dead load and residual stress) is rapid, as the crack approaches the back free surface. Figure 9 shows the stress intensity along the crack front for crack shapes C and D. A material with poor fracture toughness (i.e.  $50$  to  $60 \text{ MPa}\sqrt{\text{m}}$ ) will likely fracture with crack propagation between crack shapes C and D. If the material has better fracture toughness, larger crack sizes can develop before crack instability. Fortunately all cracks were detected and retrofitted before this occurred.

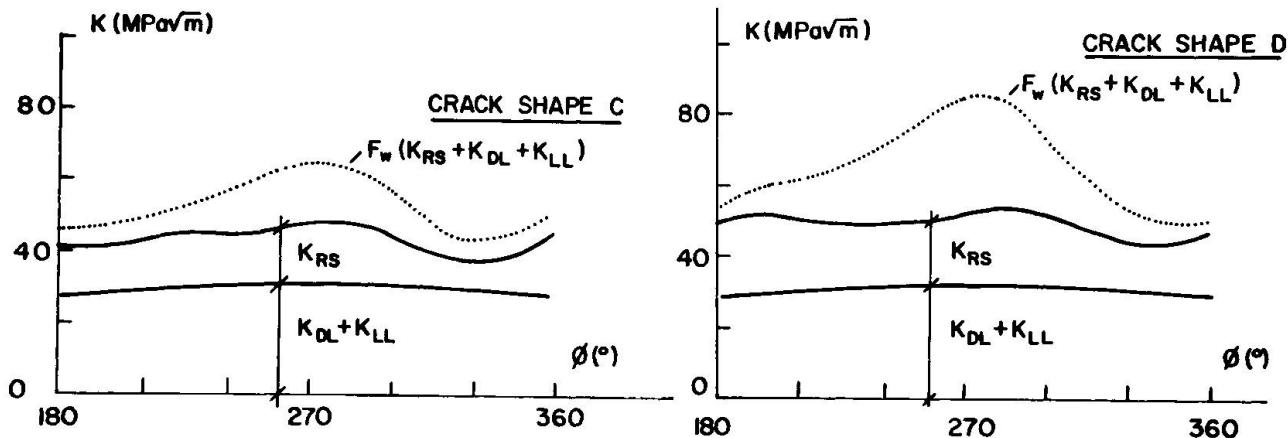
Fig. 9 Stress Intensity Factor for Cracks in Corner Weld

The crack shapes indicated in Fig. 8 were numerically evaluated, and two typical results are summarized in Fig. 9. The stress intensity factor is shown as a function of the phase angle  $\theta$  (see Fig. 8). The stress intensity factor is shown for the dead and live load stress, as well as the residual stress. The dead and live load  $K$ -value is almost constant along the circumference because of the ratio  $a/c$ . Superimposed is the  $K$ -value resulting from the residual stress field. The stress intensity factors are corrected by the finite width and the free surface correction factor.
