## **Collapse of a Cantilevered Truss Supporting a Heavy Crane**

### **JOHN M. HANSON**

Wiss, Janney, Elstner & Assoc.

### **SUMMARY**

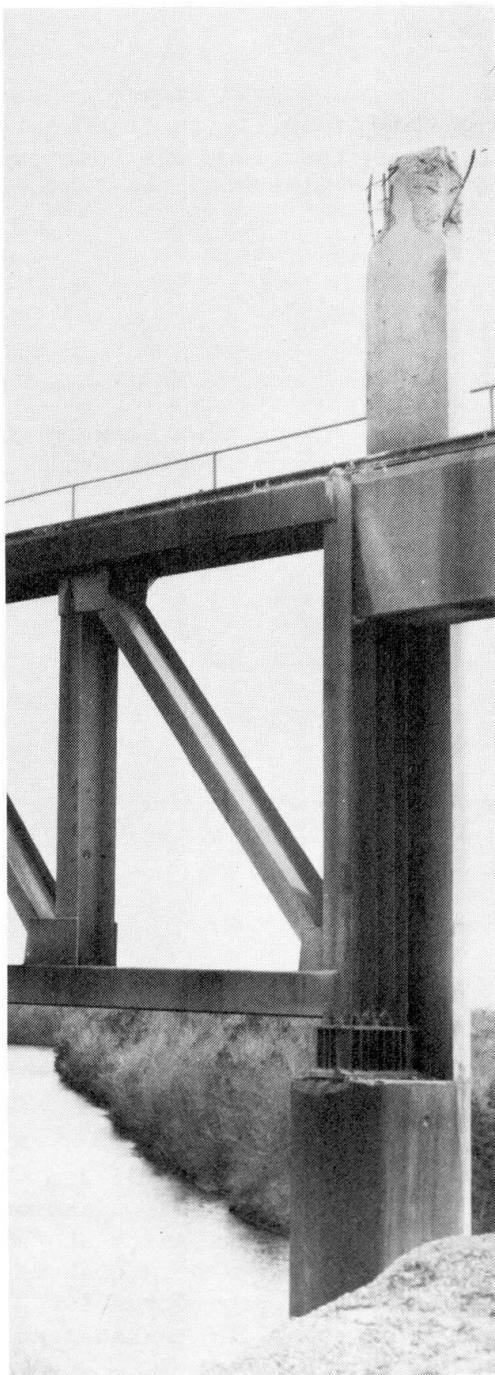
The tensile reaction was resisted by ten 51-mm diameter anchor bolts, arranged in two rows. The picture in Fig. 2 shows how the bolts protruded through a heavy weldment at the support of the truss that did not collapse. A view of the pier where the failure occurred is shown in Fig. 3. Seven bolts may be observed protruding from the pier. The bolts were bent by the impact of the truss, which occurred after the pier failed that was taking the compressive reaction, and the truss began to fall. Two bolts on the near side of the pier were broken below the top surface, apparently from the truss rolling off of the pier. One bolt, on the far side near the column extending above the top of the pier, was fractured in the region where grout had been placed between the weldment and the top of the pier. The surface of this bolt, as well as other bolts, was corroded in this region. There was no evidence of deformation or slip of any part of the anchor bolts embedded in the pier.

Fig. 2 Weldment of Tensile Reaction

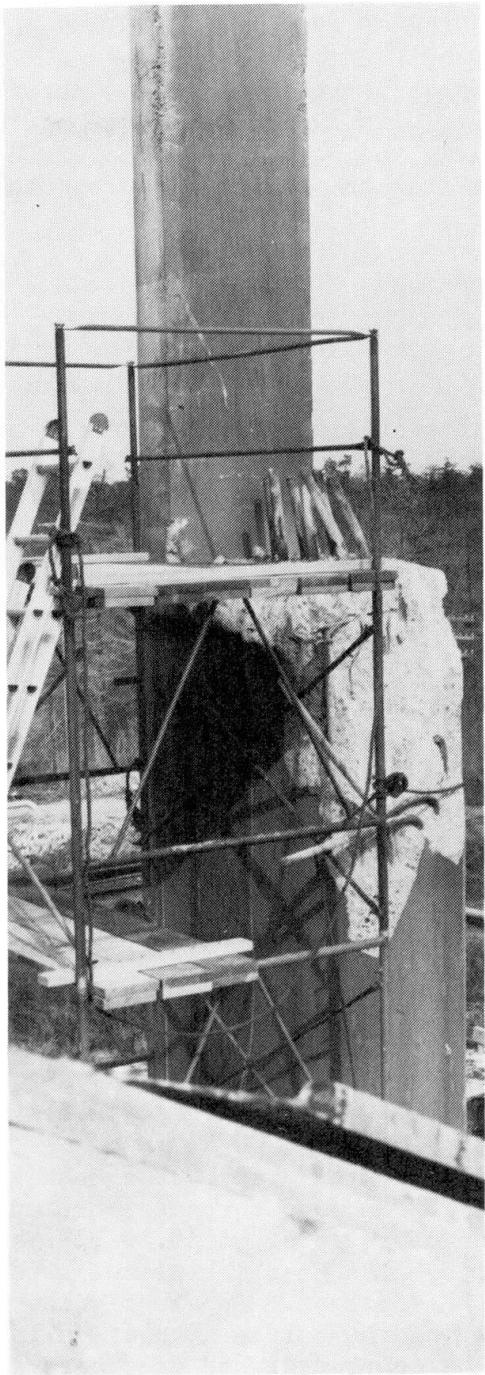
Fig. 3 Failed Anchor Bolts

The tops of five anchor bolts with nuts were eventually recovered. These bolts were fractured near the base of the nuts. It was established that fractures occurred in the threaded portions of all of the bolts.

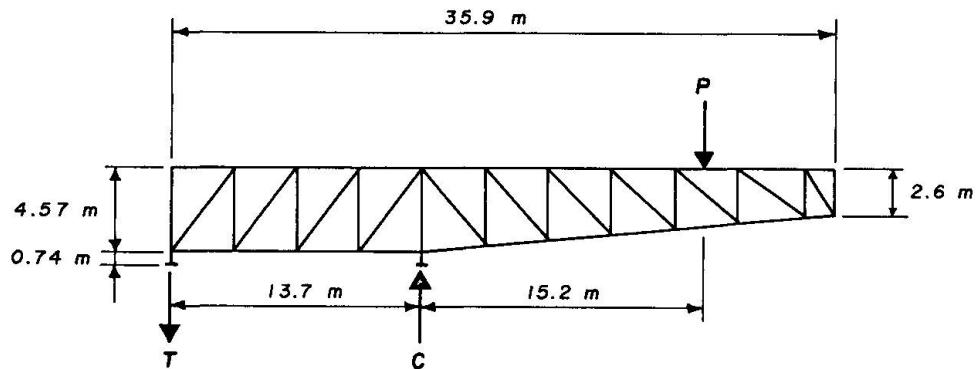
The length of the trusses, as shown in the line drawing in Fig. 4, was 35.9 m. With the crane bridge at the end of the truss, in position for unloading the barge, the load of the crane,  $P$ , on the truss was located 15.2 m from the compressive reaction. The load consisted of the following:

Crane bridge	764 kN
Trolley	262 kN
Bucket	44 kN
8m <sup>3</sup> of oysters	62 kN

Lateral stability was provided by a welded channel connection between the top chord of the trusses and the concrete columns, and a supplemental truss between the ends of the cantilevers.

Fig. 4 Elevation of Truss

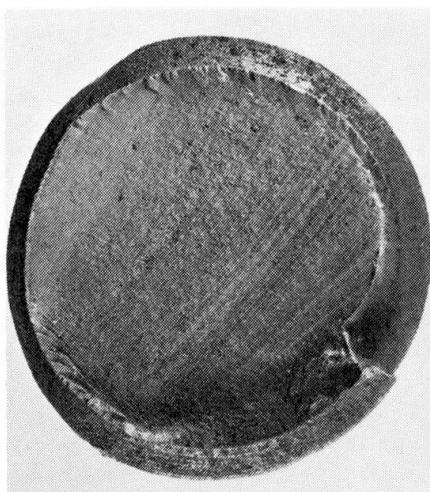
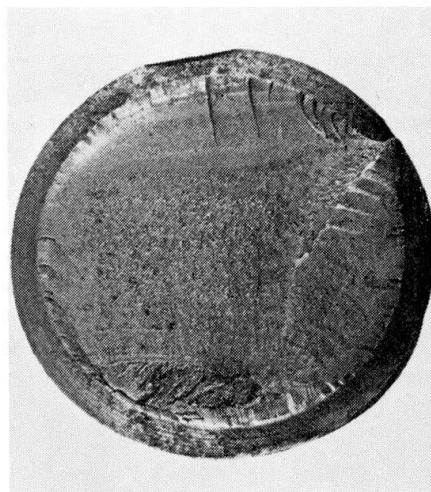
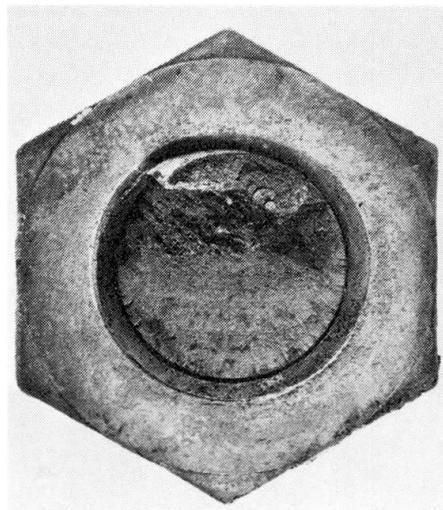
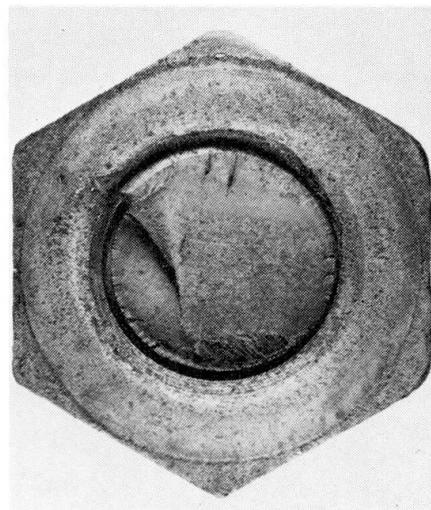
Fig. 5 Fracture Surfaces

Extensive metallurgical examinations of the bolts were carried out by several parties. There was general agreement that fatigue cracking and fracture had occurred in the threaded portion of all of the bolts. Views of the cracked and fractured surfaces in four of the bolts are shown in Fig. 5. The fatigue cracking appeared to have advanced across the bolts in an intermittent manner. Final ruptures appeared to be due to overloading.

also have had a significant influence on the stress conditions, irrespective of their adequate end anchorage. Consequently, it is likely that stress ranges as high as 150 to 200 MPa may have occurred in some of the bolts. As noted earlier, the examination of the fracture surfaces indicated that the fatigue cracks advanced across the bolts in a variable manner.

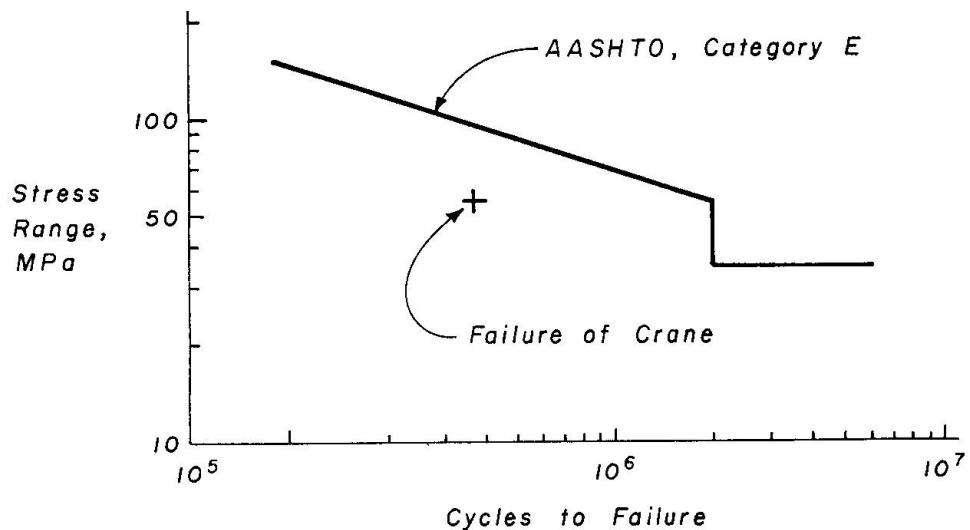
The AASHTO Category E design stress range is shown in Fig. 6. Superimposed on the plot is a point representing a nominal stress range of 55 MPa and 370,000 cycles at which the truss is estimated to have collapsed. The failure occurred well below the Category E design range.

Fig. 6 Comparison of Failure Condition to AASHTO Category E Design Criteria

It should be noted that the AASHTO Category E design stress range is established on the basis that there is a 95 percent level of confidence that 95 percent of the failures will exceed the design condition. There were also a number of uncertainties in the determination of the stress range and cycles causing the failure. However, the most plausible reason for the failure occurring below the Category E design range is lack of uniformity of stress in the anchor bolts. The method of construction apparently did not insure that the stress was uniform when the system was placed in operation. With time, there may have been considerable variation in the bond between the surface of the bolts and the concrete, which may

The collapse of the crane occurred as a result of fatigue failures of the anchor bolts. Considering the potential for unequal stresses in the bolts, it was not surprising that the number of cycles to failure was less than the fatigue life indicated by tests on single bolts. More importantly, a structural connection should have been used for the tensile reaction which would not have allowed fluctuating tension in the anchor bolts.
