Rubrik: Session 3: Rehabilitation and repair of bridges

Rehabilitation and Repair of Bridges

Experiences with Orthotropic Steel Deck and Cable Stayed Bridges

Dietrich E. LEBEK
P. Eng.
Federal Road Research Institute
Köln, Fed. Rep. of Germany

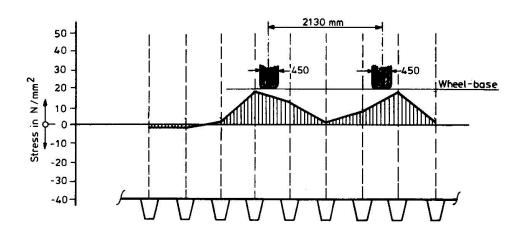
Orthotropic plates, even those with torsionally stiff stiffeners, have a poor transverse load distribution. Results of strain gauge measurements on the bottom flange of stiffeners of a "standard" orthotropic plate are shown in Fig. 1 [1]. Studies made under traffic in motion show that about seventy to eighty per cent of all wheels of commercial vehicles passed within about - 300 mm of the centre line of the "ideal" wheel track. These two facts combined indicate that orthotropic plates have heavily loaded and less heavily loaded stiffeners.

Fig. 1 Transverse Load Distribution

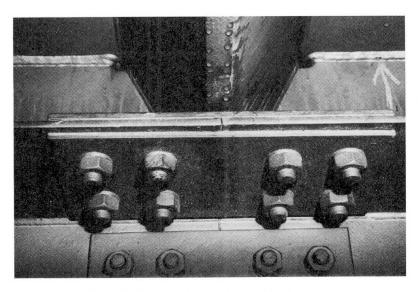
The need for a good, durable and longlasting corrosion protection of the deck plate surface is obvious. Not so obvious is, at first sight, the need for a high class corrosion protection of the underside of an orthotropic plate. The temperature gradients, inherent to orthotropic plates, cause condensation which in turn causes rusting. Dewdrops on the underside of a stiffener and condensation stains on the stiffener web are shown in Fig. 2. Experience has clearly demonstrated that only the best paint systems available are

capable to give the desired corrosion protection. Since condensation is a permanent occurrance, intervals between application of paint layers should be kept as short as possible.

Fig. 2 Dew-Drops on the Underside of Stiffeners

Temperature gradients, inherent to orthotropic plates, cause condensation which in turn causes rusting on the underside of stiffeners. It is recommended to use only the best paint systems available. Since condensation is a permanent occurance, it is recommended that intervals between application of paint layers be kept as short as possible.

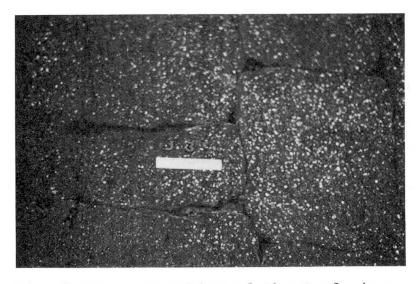
Cracking of the surfacing may loosely be grouped under the two categories of cracking over elements much stiffer than the orthotropic plate, e.g. webs of main girders, box girders, stiffening girders, etc. and cracking due to insufficient bond to the insulating layer or to the steel plate. When cracks have formed, water may penetrate and this causes corrosion of the steel which gradually spreads under the surfacing away from the cracks. This results in loss of adhesion which, in turn, leads to the formation of a series of parallel cracks as demonstrated in Fig. 3.

Fig. 3 Severe Cracking of the Surfacing

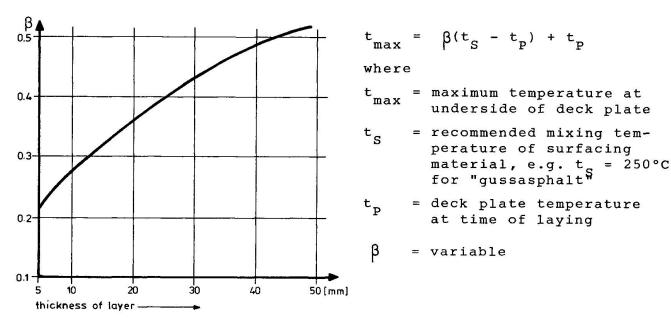
where the variable β is to be used in the case of total resurfacing as presented in Fig. 4 and the variable γ for the case of partial resurfing as presented in Fig. 5; t_{S} is the recommended mixing temperature of the surfacing material and t_{D} the existing deck plate temperature at time of laying. The β -values account for an existing layer of a few millimeter thickness. The use of Fig. 4 and Fig. 5 are best illustrated by an example:

- A typical resurfacing operation in Germany would have a first layer of "gussasphalt" with an average thickness of 35 mm laid on an insulating layer about 2 mm thick. The recommended mixing temperature t for "gussasphalt" is 250°C. The deck plate temperature t shall be 40°C, a value typical for the months May and September. From Fig. 4 a β -value = 0.46 is taken for a thickness of 35 mm. With the above values the predicted maximum plate temperature would be

$$t_{max} = 0.46 (250 - 40) + 40 = 137$$
°C

Fig. 4 Maximum Deck Plate Temperature due to Machine Laying of first Layer.

heat resistance of paint systems. The maximum plate temperature and the duration of certain temperature ranges, both values are interrelated, define the criterion for heat resistance of paint systems. The results of many temperature measurements in various bridges under various climatic conditions and with varying surfacing systems can be used to predict the maximum deck plate temperature and the duration of temperature ranges. The results are presented in Fig. 4 to 7.

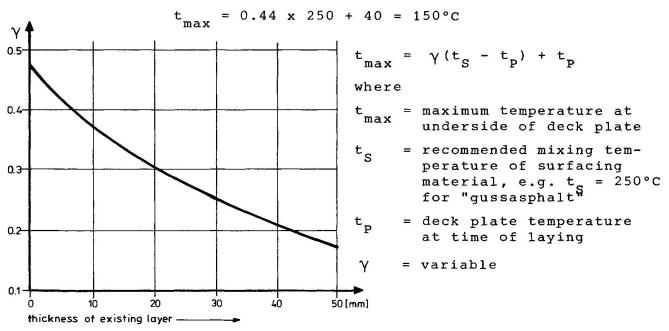
- A typical partial resurfacing operation in Germany would have a wearing course of "gussasphalt" with an average thickness of 35 mm laid on an existing layer about 35 mm thick. The deck plate temperature shall be 40°C. From Fig. 5 a γ -value = 0.23 is taken for an existing thickness of 35 mm. With the above values the predicted maximum plate temperature would be

$$t_{max} = 0.23 (250 - 40) + 40^{\circ}C = 88^{\circ}C$$

Fig. 5 Maximum Deck Plate Temperature due to Machine Laying on already Existing Layer.

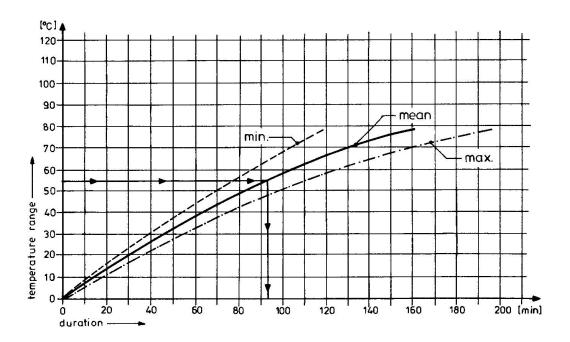
Because the critical temperature range for normally used paint systems starts from 80°C, the duration of the temperature range above 80°C shall be predicted. The following data are needed: the recommended mixing temperature t $_{\rm p}$, the thickness of the surfacing layer and the existing deck plate temperature t $_{\rm p}$.

the average duration 10 min + 95 min = 105 min

the maximum duration 10 min + 110 min = 120 min

Fig. 6 Duration of Temperature Ranges for Paint Systems

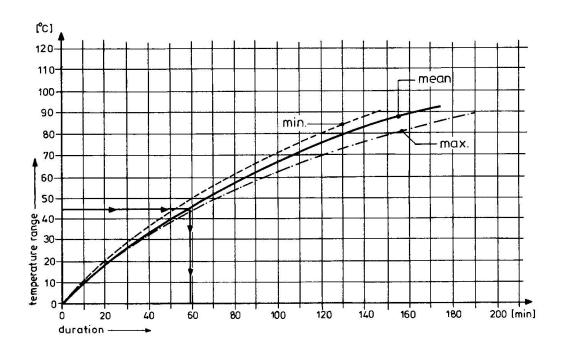
The use of Fig. 7 will be illustrated by a following example. Critical temperatures for tar-epoxy-resin start from above 100°C. The recommended mixing temperature and the existing surface temperature of the insulating layer must be known in order to predict the desired temperature range.

In the example, a layer of 35 mm thick "gussasphalt" is to be laid on an insulating layer with a surface temperature of 35°C. The duration of the temperature range above 100°C shall be predicted.

Required is again the upper and the lower temperature limit. The upper limit is $0.44 \times 250 ^{\circ}\text{C} = 110 ^{\circ}\text{C}$, the lower limit is $100 ^{\circ}\text{C} - 35 ^{\circ}\text{C} = 65 ^{\circ}\text{C}$. Consequently, the temperature range is $110 ^{\circ}\text{C} - 65 ^{\circ}\text{C} = 45 ^{\circ}\text{C}$ as indicated by arrows in Fig. 7. The predicted average duration for temperatures above $100 ^{\circ}\text{C}$ is about 60 min.

Fig. 7 Duration of temperature Ranges for Insulating Layers

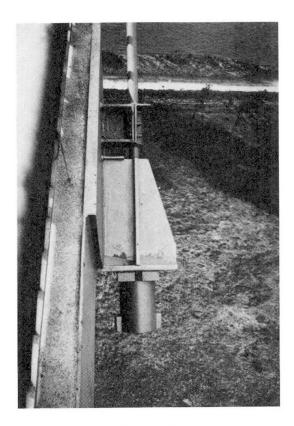
As mentioned above, the combination of dynamic effects and corrosion may present a serious problem. In addition, the aerodynamics of cables in service due to the combined actions of wind, dead load, live load and inter-related vibrations of cables, towers and super-structure is not yet fully understood. There are indications that only a certain combination of wind velocity, wind direction and mean

Fig. 8 Elastomeric Damper

stress in a cable cause vibrations where amplitudes in the order of several hundred millimeters have been observed. Normally even such amplitudes are relatively harmless from the stress point of view because of their seldom occurance. However, the psychological effect to road users should not be underestimated.

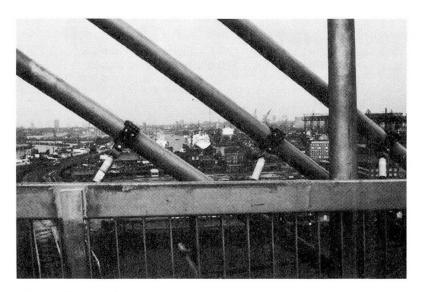
It stands to reason that damping devices should be installed wherever dynamic effects can be presumed to have adverse effects on the life expectancy of cables or where the behaviour of an existing bridge suggests that damping devices are installed as a rehabilitation measure. Fig. 8 and 9 present examples of possible solutions for the installation of damping devices as a rehabilitation measure. The springtype dampers as shown on Fig. 9 were fixed to stiffened hand rails.

Fig. 9 Spring Type Damper

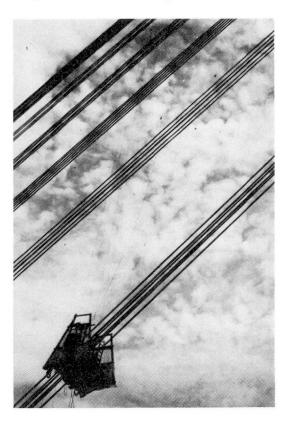
The development of an appropriate procedure and sequence for the inspection of all parts of a cable is important. In the past, the importance of a thorough and complete inspection of cables was often not acknowledged to the required extent by all designers of cable stayed bridges. Even an appropriate access to cable anchorages and cable sockets has not always been provided for in the design. Access to the free cable length between bridge deck and tower must also be possible and would normally require a special type of traveller. Fig. 10 shows a possible solution to this problem.

Fig. 10 Inspection of Cables

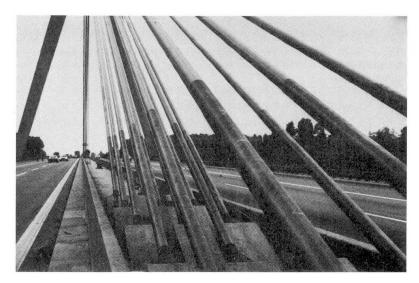
A "standard" rehabilitation measure is now wrapping single cables in the bridge deck area as shown in Fig. 11 in order to provide additional protection in the brine spray zone and against any kind of mechanical damage. Best results can be expected if the wrapping is done before the paint is hardened.

Fig. 11 Additional Wrapping in Splash-Zone
