## **SESSION 3**

**Rehabilitation and Repair of Bridges**

## Experiences with Orthotropic Steel Deck and Cable Stayed Bridges

Sanierung und Instandstellung von Brücken

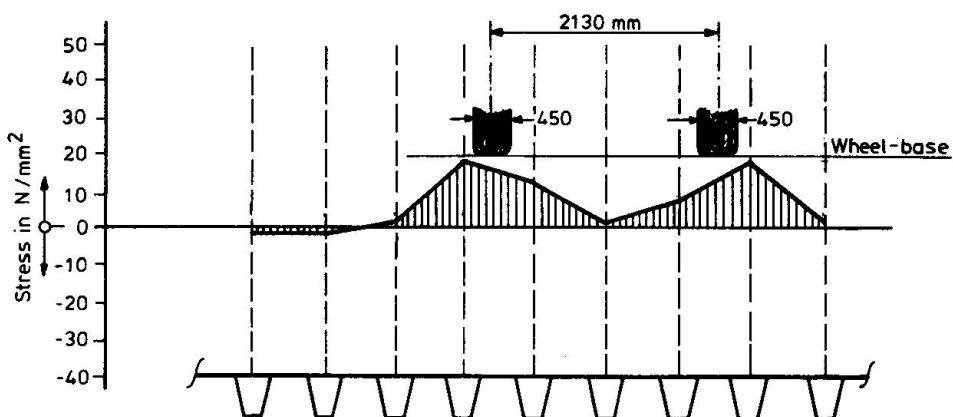
Fig. 1 Transverse Load Distribution

Orthotropic plates, even those with torsionally stiff stiffeners, have a poor transverse load distribution. Results of strain gauge measurements on the bottom flange of stiffeners of a "standard" orthotropic plate are shown in Fig. 1 [1]. Studies made under traffic in motion show that about seventy to eighty per cent of all wheels of commercial vehicles passed within about  $\pm 300$  mm of the centre line of the "ideal" wheel track. These two facts combined indicate that orthotropic plates have heavily loaded and less heavily loaded stiffeners.

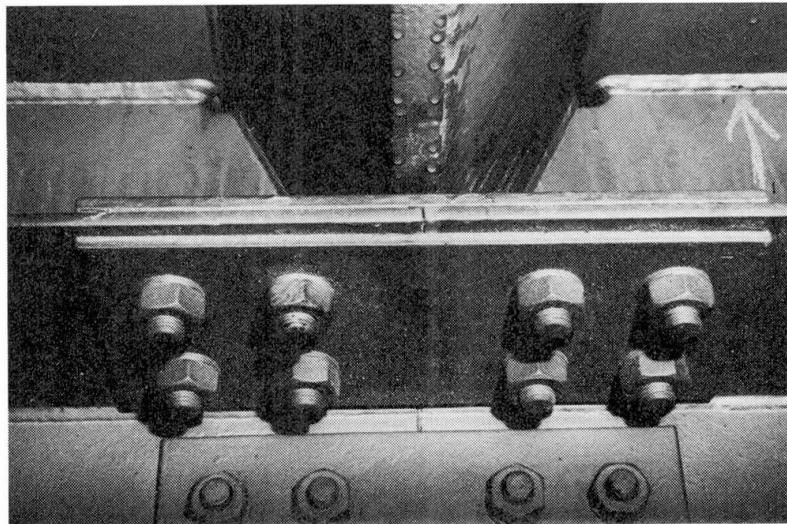
Fig. 2 Dew-Drops on the Underside of Stiffeners

The need for a good, durable and longlasting corrosion protection of the deck plate surface is obvious. Not so obvious is, at first sight, the need for a high class corrosion protection of the underside of an orthotropic plate. The temperature gradients, inherent to orthotropic plates, cause condensation which in turn causes rusting. Dewdrops on the underside of a stiffener and condensation stains on the stiffener web are shown in Fig. 2. Experience has clearly demonstrated that only the best paint systems available are

capable to give the desired corrosion protection. Since condensation is a permanent occurrence, intervals between application of paint layers should be kept as short as possible.

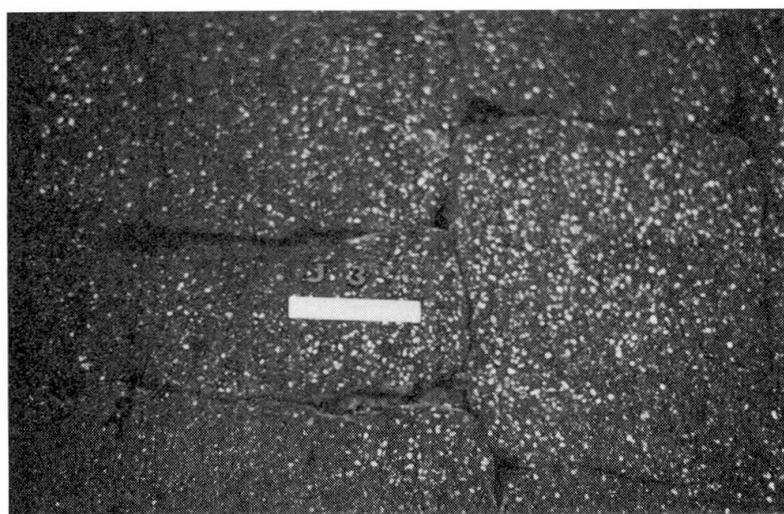
Fig. 3 Severe Cracking of the Surfacing

Cracking of the surfacing may loosely be grouped under the two categories of cracking over elements much stiffer than the orthotropic plate, e.g. webs of main girders, box girders, stiffening girders, etc. and cracking due to insufficient bond to the insulating layer or to the steel plate. When cracks have formed, water may penetrate and this causes corrosion of the steel which gradually spreads under the surfacing away from the cracks. This results in loss of adhesion which, in turn, leads to the formation of a series of parallel cracks as demonstrated in Fig. 3.

Ongoing research in Germany into the interaction of plate stiffness factors and surface cracking suggests that it may be advisable to formulate stiffness criteria for orthotropic plates in addition to the traditional strength requirements to achieve a smoother transition between unfavourable stiffness ratios.

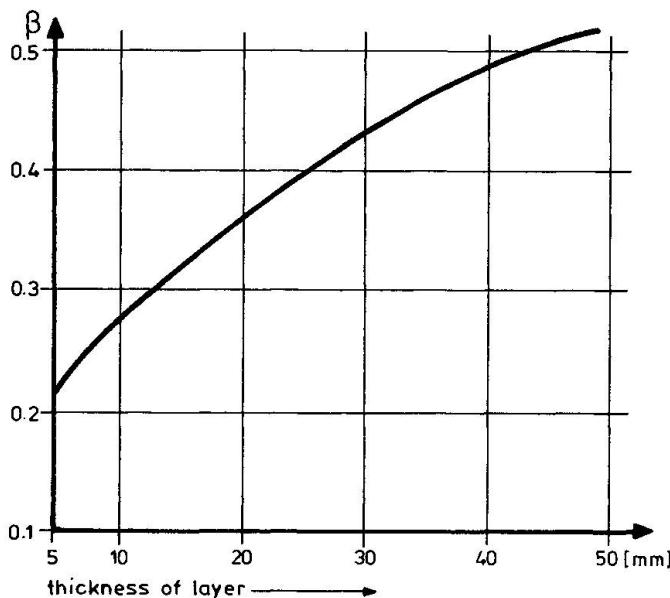
where the variable  $\beta$  is to be used in the case of total resurfacing as presented in Fig. 4 and the variable  $\gamma$  for the case of partial resurfacing as presented in Fig. 5;  $t_s$  is the recommended mixing temperature of the surfacing material and  $t_p$  the existing deck plate temperature at time of laying. The  $\beta$ -values account for an existing layer of a few millimeter thickness. The use of Fig. 4 and Fig. 5 are best illustrated by an example:

- A typical resurfacing operation in Germany would have a first layer of "gussasphalt" with an average thickness of 35 mm laid on an insulating layer about 2 mm thick. The recommended mixing temperature  $t_s$  for "gussasphalt" is 250°C. The deck plate temperature  $t_p$  shall be 40°C, a value typical for the months May and September. From Fig. 4 a  $\beta$ -value = 0.46 is taken for a thickness of 35 mm. With the above values the predicted maximum plate temperature would be

$$t_{\max} = 0.46 (250 - 40) + 40 = 137^\circ\text{C}$$

$$t_{\max} = \beta(t_s - t_p) + t_p$$

- For a typical total resurfacing operation with the condition and values mentioned in the example for Fig. 4, the predicted maximum surface temperature of the insulating layer would be

$$t_{\max} = 0.44 \times 250 + 40 = 150^\circ\text{C}$$

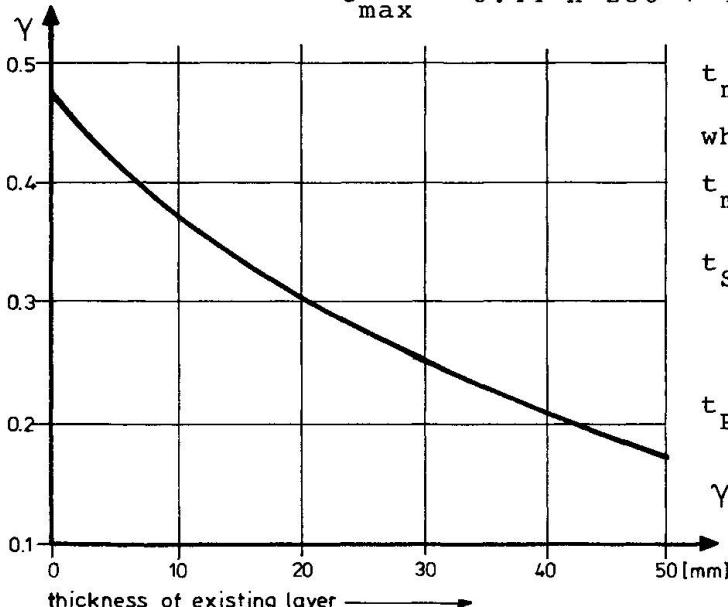
- A typical partial resurfacing operation in Germany would have a wearing course of "gussasphalt" with an average thickness of 35 mm laid on an existing layer about 35 mm thick. The deck plate temperature shall be  $40^\circ\text{C}$ . From Fig. 5 a  $\gamma$ -value = 0.23 is taken for an existing thickness of 35 mm. With the above values the predicted maximum plate temperature would be

$$t_{\max} = \gamma(t_s - t_p) + t_p$$

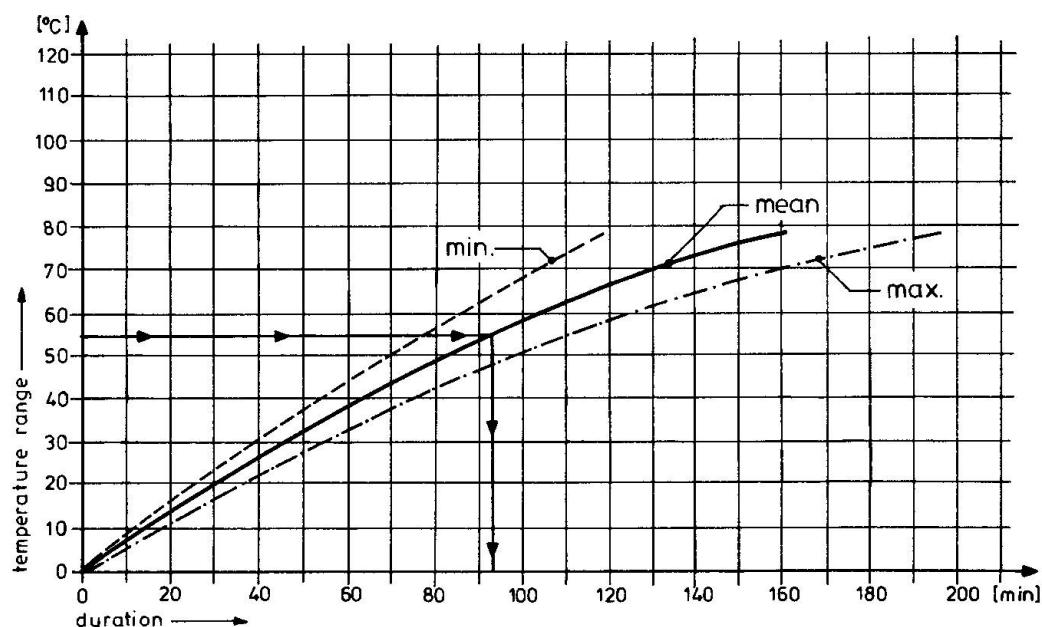
Fig. 6 Duration of Temperature Ranges for Paint Systems

Because the critical temperature range for normally used paint systems starts from 80°C, the duration of the temperature range above 80°C shall be predicted. The following data are needed: the recommended mixing temperature  $t_s$ , the thickness of the surfacing layer and the existing deck plate temperature  $t_p$ .

The predicted duration for a temperature range above 80°C is for:  
 the minimum duration  $10 \text{ min} + 75 \text{ min} = 85 \text{ min}$   
 the average duration  $10 \text{ min} + 95 \text{ min} = 105 \text{ min}$   
 the maximum duration  $10 \text{ min} + 110 \text{ min} = 120 \text{ min}$

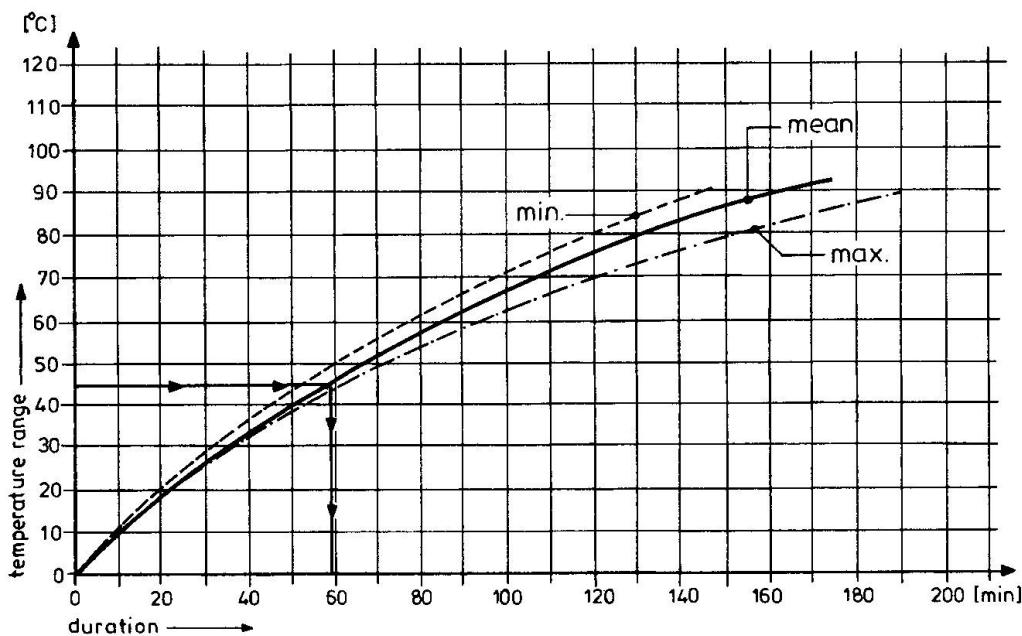
Fig. 7 Duration of temperature Ranges for Insulating Layers

The use of Fig. 7 will be illustrated by a following example. Critical temperatures for tar-epoxy-resin start from above 100°C. The recommended mixing temperature and the existing surface temperature of the insulating layer must be known in order to predict the desired temperature range.

Required is again the upper and the lower temperature limit. The upper limit is  $0.44 \times 250^\circ\text{C} = 110^\circ\text{C}$ , the lower limit is  $100^\circ\text{C} - 35^\circ\text{C} = 65^\circ\text{C}$ . Consequently, the temperature range is  $110^\circ\text{C} - 65^\circ\text{C} = 45^\circ\text{C}$  as indicated by arrows in Fig. 7. The predicted average duration for temperatures above 100°C is about 60 min.

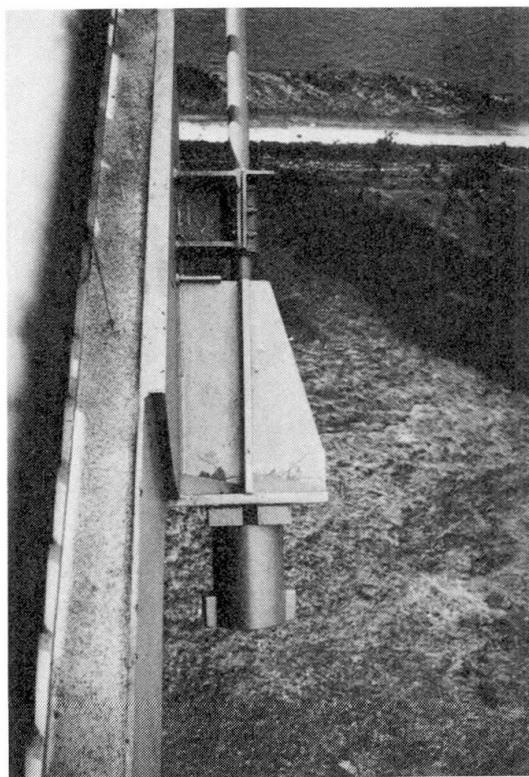
Fig. 8 Elastomeric Damper

It stands to reason that damping devices should be installed wherever dynamic effects can be presumed to have adverse effects on the life expectancy of cables or where the behaviour of an existing bridge suggests that damping devices are installed as a rehabilitation measure. Fig. 8 and 9 present examples of possible solutions for the installation of damping devices as a rehabilitation measure. The spring-type dampers as shown on Fig. 9 were fixed to stiffened hand rails.

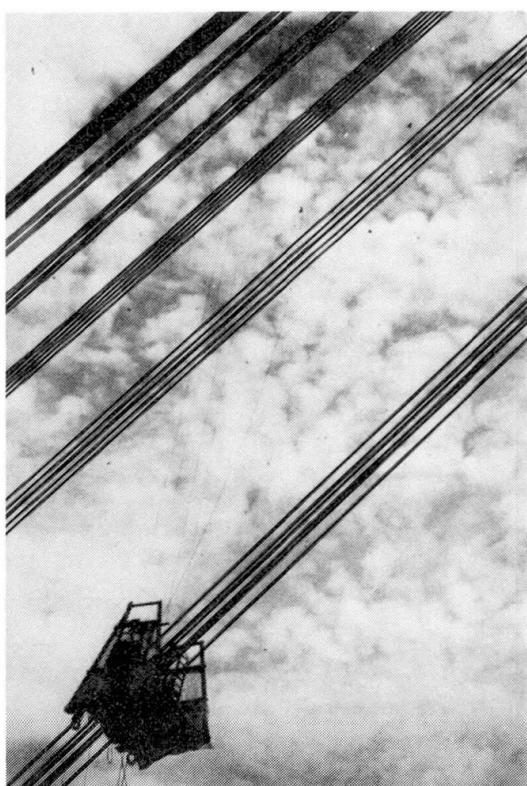
Fig. 10 Inspection of Cables

The development of an appropriate procedure and sequence for the inspection of all parts of a cable is important. In the past, the importance of a thorough and complete inspection of cables was often not acknowledged to the required extent by all designers of cable stayed bridges. Even an appropriate access to cable anchorages and cable sockets has not always been provided for in the design. Access to the free cable length between bridge deck and tower must also be possible and would normally require a special type of traveller. Fig. 10 shows a possible solution to this problem.

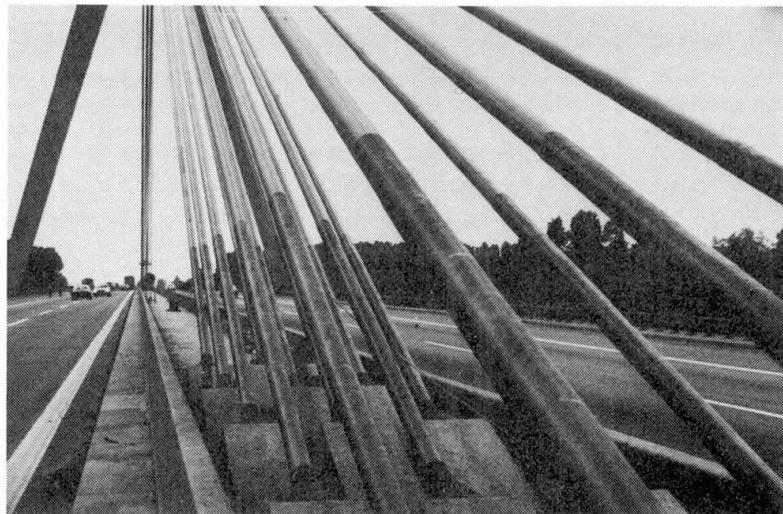
Fig. 11 Additional Wrapping in Splash-Zone

In sum, corrosion protection should only make use of the best paint systems available in order to achieve an economical, long lasting durable protection of all corrosion prone elements against an increasing number of aggressive gases and soluble substances and taking into account mechanical damage that cannot be excluded in the vicinity of the bridge deck area.

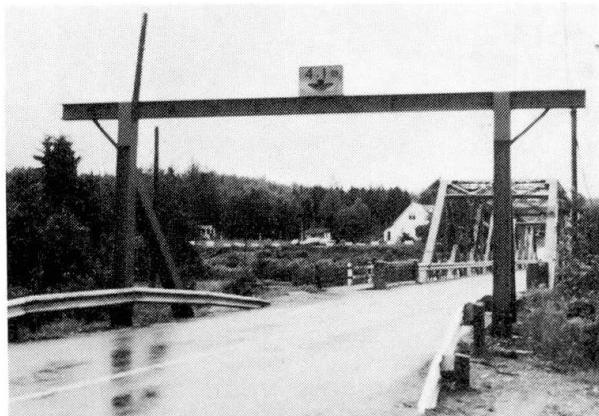
Figure 1 Height Protection

The solution shown in figure 1 is a lot more economical than building a new bridge. The construction of a new bridge can wait until the traffic warrants it, since the occasional high truck can get across by using a short detour.

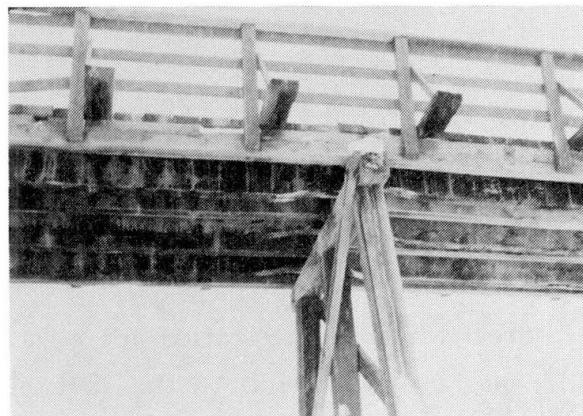
Figure 2 Crushing Timber

The structure shown in Figure 2 shows crushing of the outside stringers and floor beams which are wooden beams. Nevertheless, the center of the structure is used to get one farm tractor across daily. By blocking off the edges, repairs or replacement are avoided.

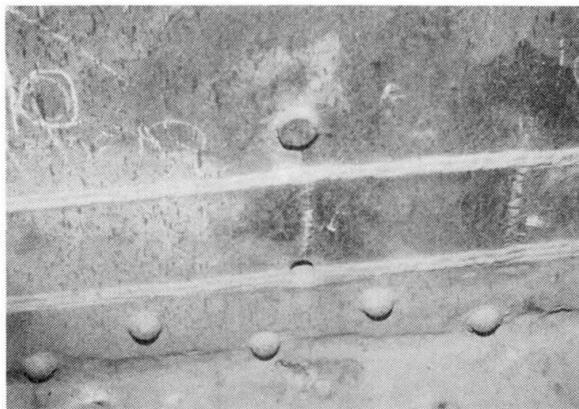
Figure 3 Crack in Girder

The structure shown in Figure 3 has been carrying mainline railway traffic for three years with the cracks shown. The cracks are monitored annually and if they remain dormant the span won't be replaced for at least another 5 years, at which time they will be replaced for other reasons.

I would recommend the repair shown in Figure 11 to replace the section lost due to corrosion of the web just above the bottom flange. This is a much better solution than the one shown in Figure 3 where the welds cracked.

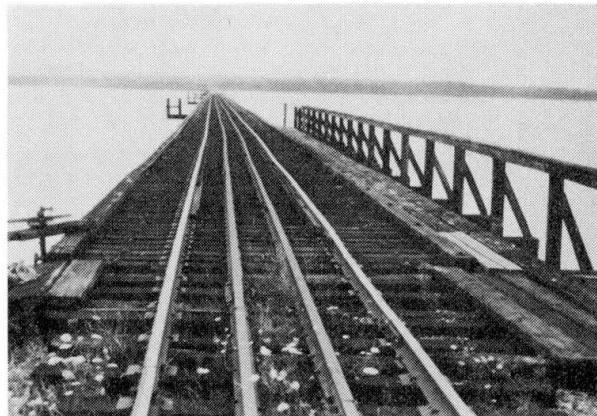
Figure 5 Moved by ice

Figure 5 shows a structure over which operations have ceased. This structure became unsafe recently. To rehabilitate it to new condition would cost \$7. million dollars, to fix it to last until the next spring ice movement would cost over \$400,000. The saving to the railway by using the bridge was of the order of \$40,000 before considering any maintenance expenses. I must say that the initial damage to the structure was caused by the action of others who changed the ice conditions. Should the structure be rehabilitated, they will probably be held liable. Nevertheless, we have found another way to adequately serve our customers and are not throwing away money which can be better spent elsewhere.

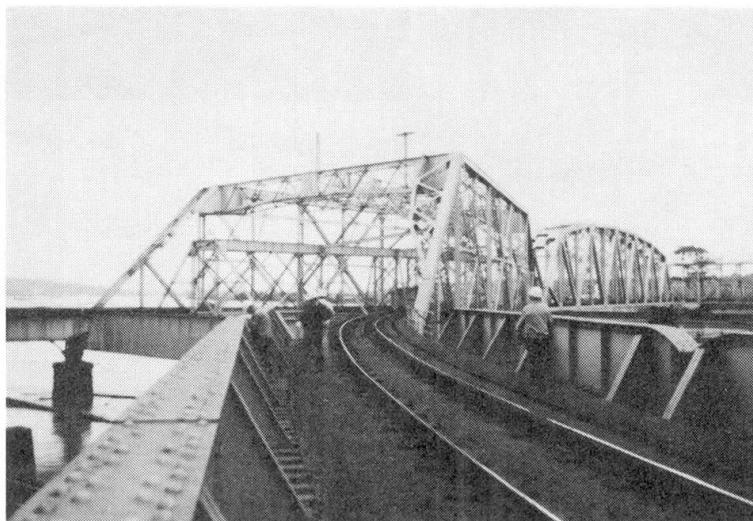
Figure 8 Well maintained

Structurally weak bridges should be maintained to a higher than normal level consistent with their use. The bridge shown in Figure 8, built in 1904 is one of the heaviest travelled and yet weakest of our main line bridges (6, 7). Because of extremely good preventative maintenance the structure serves us well.

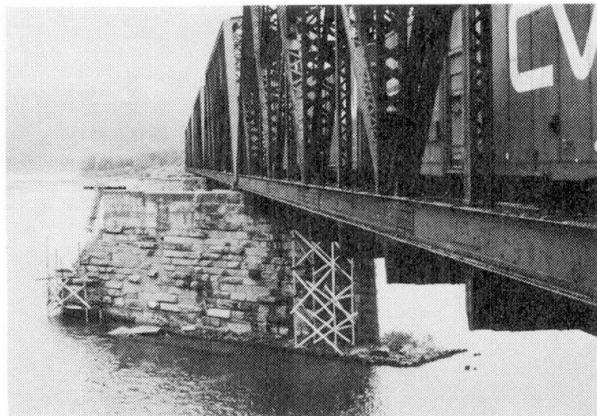
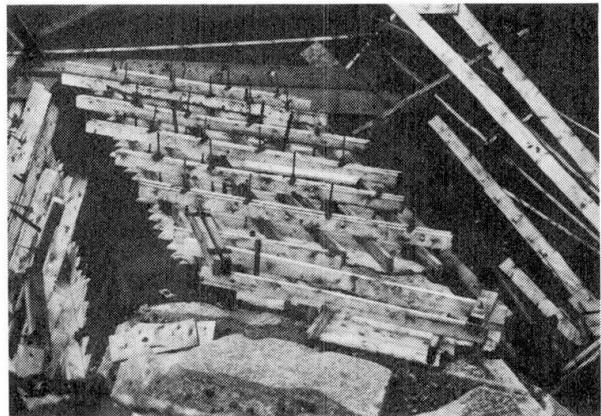
Figure 9 Repair to pier

The underpinning, straightening or strengthening of a pier can be quite an undertaking.

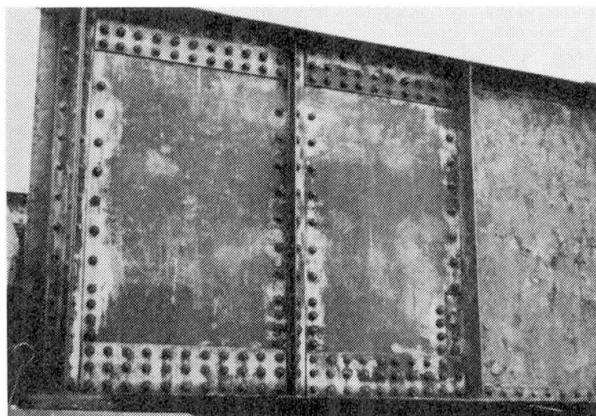
Figure 10 Replacement Web

corrosion is confined to the web near the stiffener, the stiffener can be removed and a small plate added to the web before replacing the stiffener.

I must warn against welding these replacements as weld terminations have very low fatigue strength. Cracks initiated in patch plate welds can go into the original web causing a potentially dangerous situation. Welding to a non-welded structure can destroy the inherent component redundancy in the structure (8). In a bolted or riveted girder, a crack in one plate or angle will not propagate to the rest of the member. Join these with a weld and the crack can propagate.

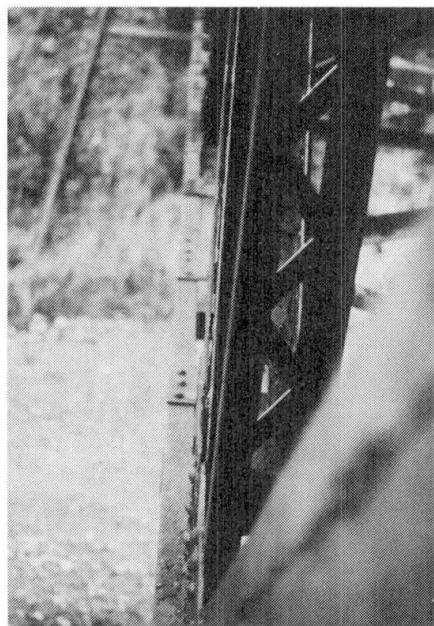
Figure 13 Broken welds

Care must be taken in the connection of all repair and rehabilitation schemes. The strengthening of a deck truss shown in Figure 13 was not very successful. The staggered welds eventually broke.

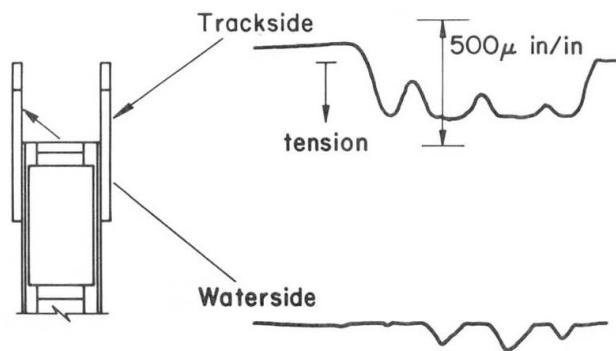
Figure 14 Unequal loading

In trusses, when the pins or pinplates wear they can be replaced by larger pins after reaming to make the hole larger. If this is not possible, then a pin joint can sometimes be replaced by gusset plates. In order to minimize future fatigue problems, it is important to be very careful about compatible deflections to ensure that the replacement gusset plates equally share all loads (Figure 14). If one plate carries no load, then the doubled stress range in the other could lead to unexpected fatigue problems (6,7).

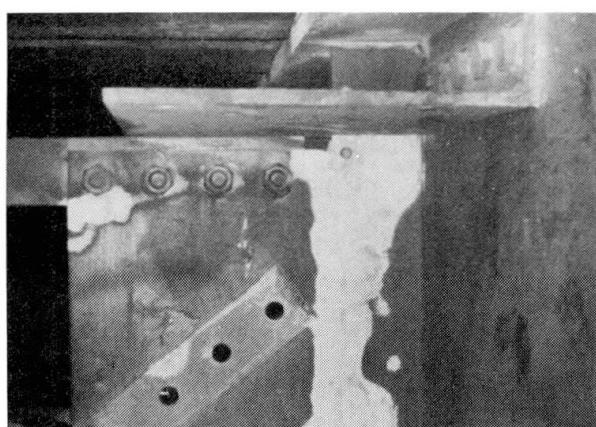
Figure 15 Crack at sharp notch

The crack shown in Figure 15 started where the gusset plate to vertical stiffener weld terminates (10). Many of these cracks were not detected until the crack front had reached the stiffener to web weld. In order to stop the crack from proceeding up or down this weld, holes were drilled. These holes, which were drilled from both sides of the interior stiffener and then from the outside, were quite difficult to do. If the crack is not stopped then a more costly retrofit would be necessary. A permanent repair is shown in Figure 16 (9).

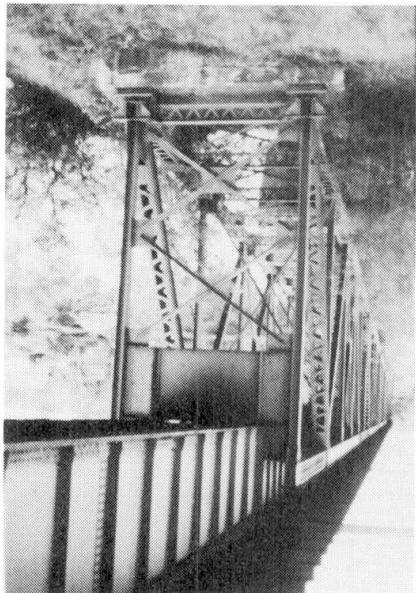
Figure 17 End of deck truss

The structure shown in Figure 17 has cracked and been repaired once every ten years when in fact the problem is that there is no where for breaking forces to be dissipated.

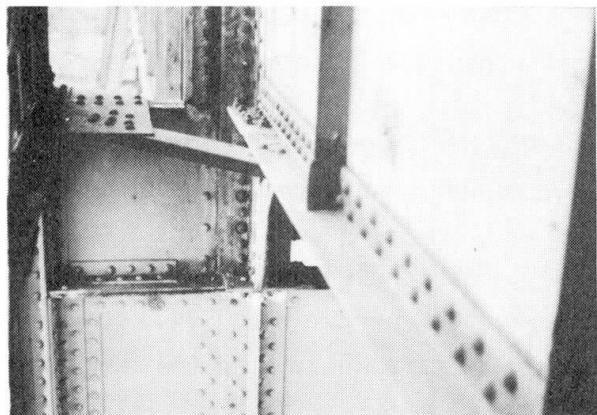
Figure 18 Bracing leads nowhere

The traction bracing ends at the top of the deck truss (Figure 18). Since the end post is relatively flexible, the load is forced to try and go through the deck plate girder. The connection is not designed for this force and movement, so it cracks. Changing the location of traction bracing in order to get it directly to the bearings of the truss would permanently solve the problem.

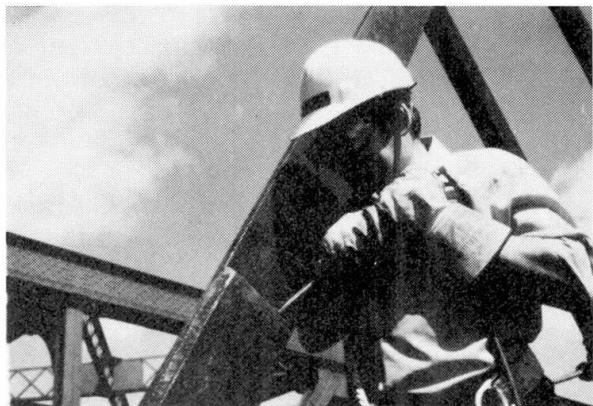
Figure 19 Peening welds

One technique, we have used, is to peen the ends of shallow cracked welds (Figure 19) to prolong their life. In other cases, replacing poorly installed rivets with high-strength bolts can prolong the life of a connection.

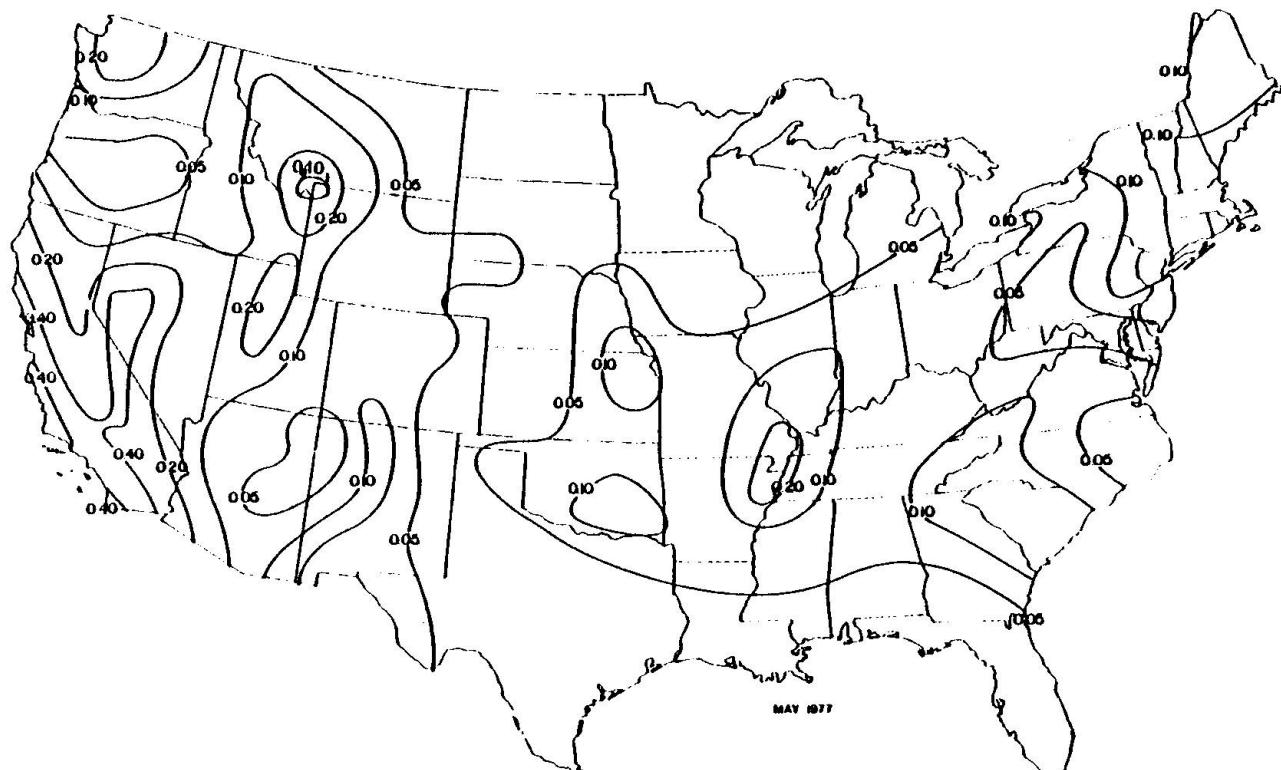
Fig. 1 Acceleration coefficient - Continental United States

The seismic design guidelines utilize one of two elastic response spectrum analysis procedures to determine the seismic displacements and elastic member forces due to the design earthquake in each of two perpendicular horizontal directions. Provisions are given for combining forces resulting from earthquakes in the two horizontal directions to account for directional uncertainty of the earthquake. The response spectra to be used vary based on acceleration coefficient and the soil profile at the bridge site.

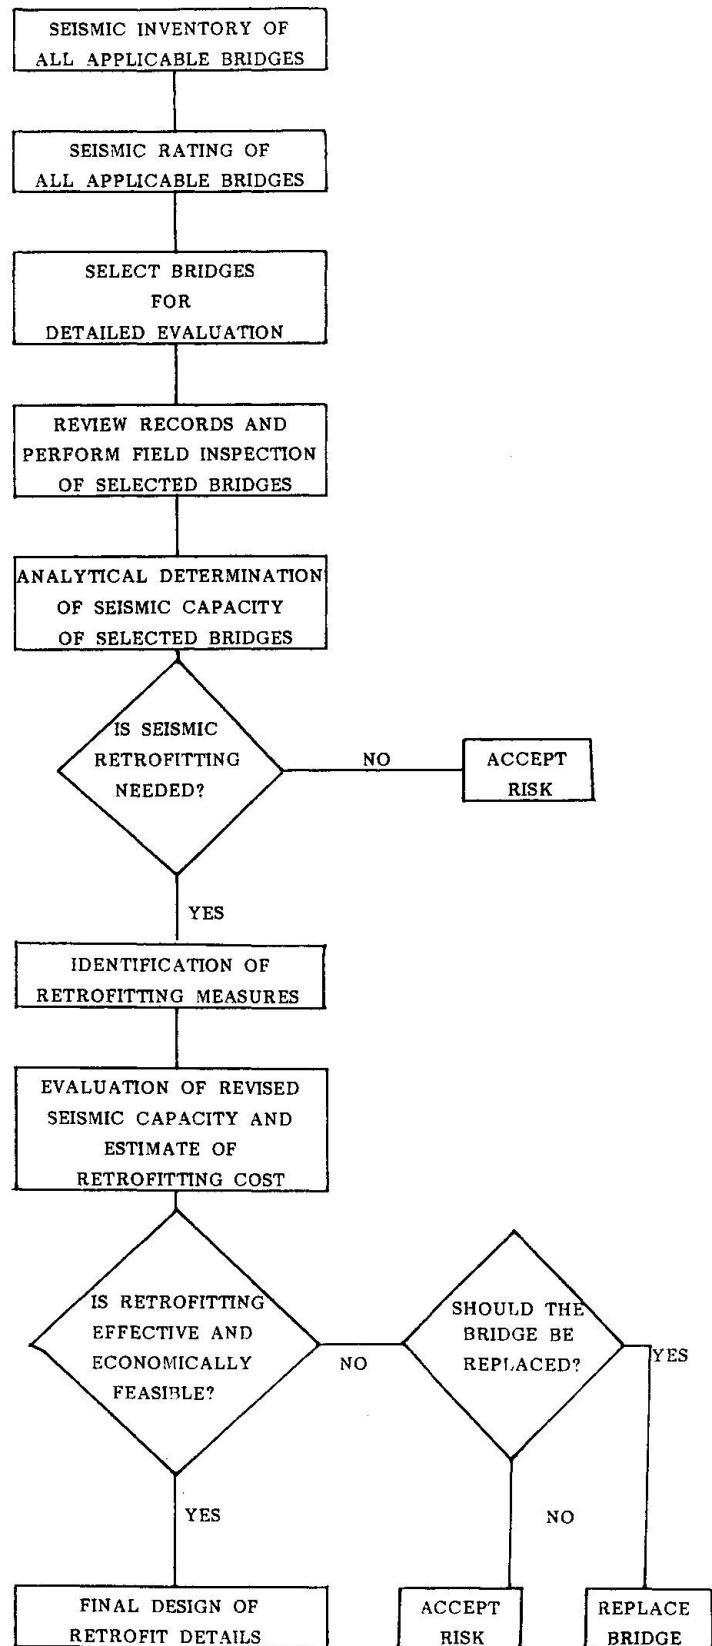
Fig. 2 Seismic retrofitting process for bridges

- A preliminary screening process for determining which bridges present the greatest hazard due to earthquakes
- A methodology for quantitatively evaluating the seismic capacity of an existing bridge
- Retrofit measures that can be used to increase the seismic resistance of bridges

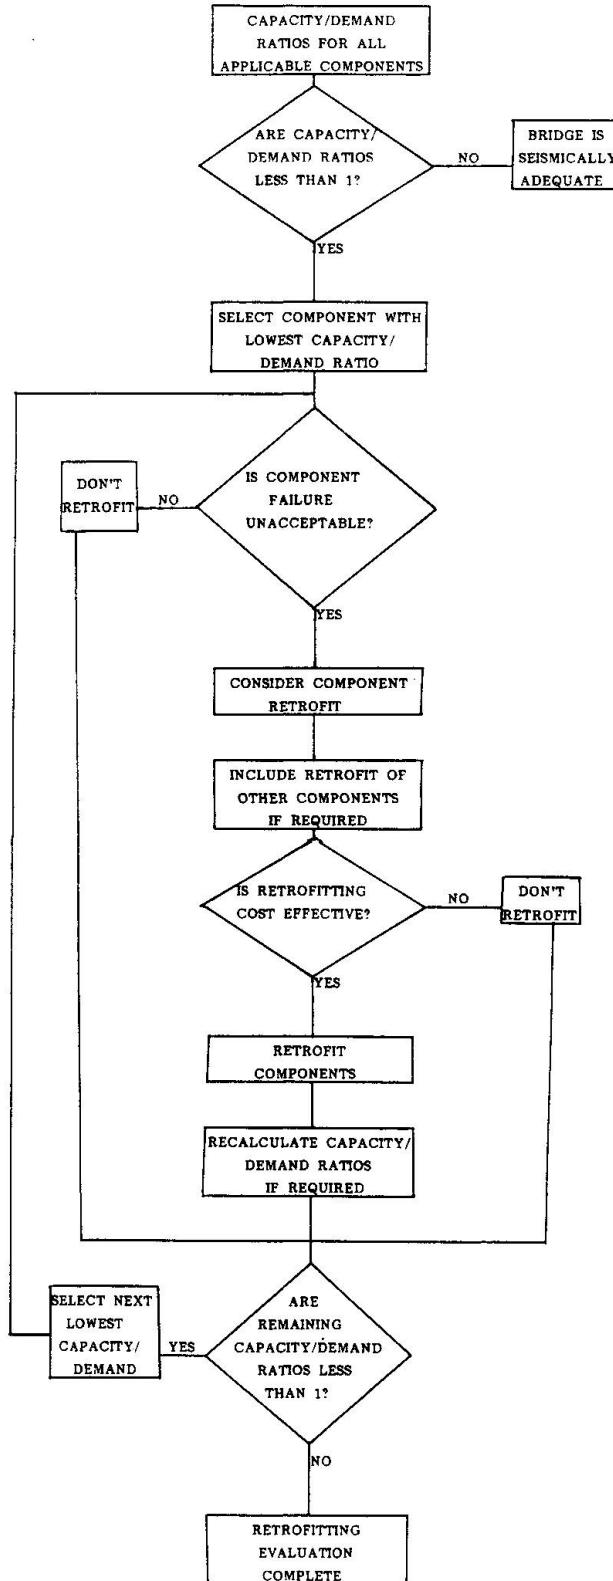
**Fig. 3** Procedure for selecting retrofit methods

Capacity/Demand ratios for bearings will be calculated for both displacement and force. Displacements are investigated in the longitudinal direction at expansion joints or "fixed" bearings where the force capacity is inadequate. The force capacity/demand ratio is calculated for bearings designed to resist lateral loads.

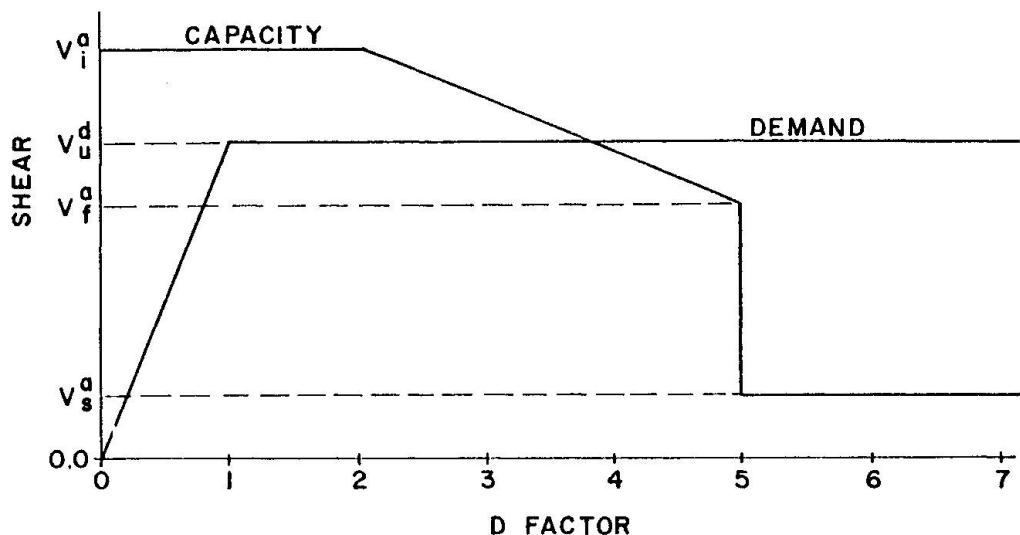
Fig. 4 Shear capacity and demand for reinforced concrete columns subjected to flexural yielding

The applied shear force (demand) is proportional to the elastic moment up to flexural yielding (D=1). Beyond initial flexural yielding the shear force is assumed constant. To account for column overstrength, the maximum shear force is increased by a factor of 1.3. The point at which the shear capacity is equal to the shear force is the point representing the degree of flexural yielding at which shear failure may occur. If this occurs between a D value of 1 and a D value of 5, a reduced ductility capacity due to shear degradation in the column is indicated. This reduced ductility capacity is represented by the D value at which the shear capacity and shear force are equal in Figure 4. Therefore by evaluating the seismic capacity/demand ratio for flexure at this D factor the ratio of acceleration causing shear failure to design acceleration can be found.

If the initial shear capacity is less than the ultimate shear force, then the seismic capacity/demand ratio will be calculated as the ratio of the initial shear capacity to the elastic shear force caused by the design earthquake. If the final shear capacity is greater than the ultimate shear force resulting from plastic hinging of the column, then shear will not be considered a critical mode of failure. When yielding occurs in the footing, column shear capacity will not deteriorate, and shear failure may occur only if the ultimate shear force exceeds the initial shear capacity.

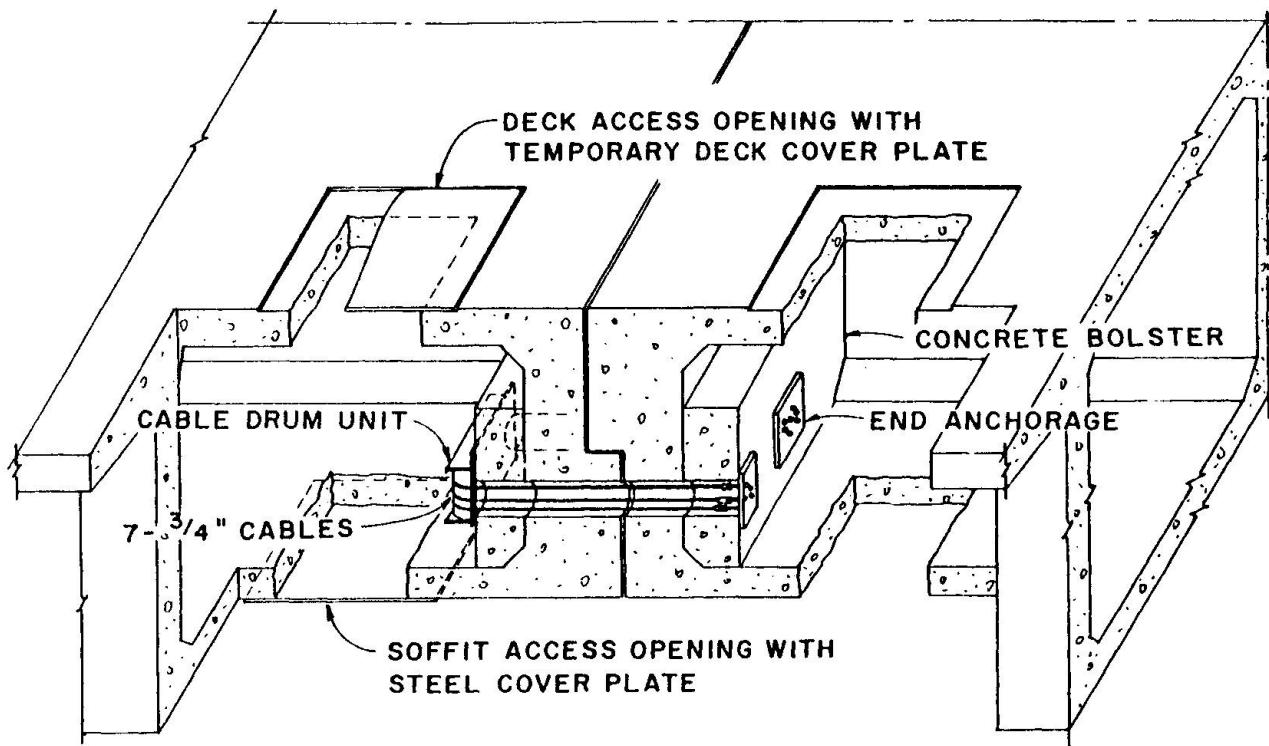
Fig. 5 Longitudinal joint restrainer for concrete box girder

Longitudinal Joint Restrainers are used extensively by the California Department of Transportation<sup>(7)</sup>. The primary function of these devices is to limit relative displacements at joints and thus decrease the chances for a loss of support at these locations. Restrainers are designed to resist force in the elastic range. Careful attention must be given to the methods used to attach restrainers to the superstructure so that existing components will not be damaged during an earthquake. The typical retrofit detail used by the California Department of Transportation on its concrete box girder bridges is shown in Figure 5.

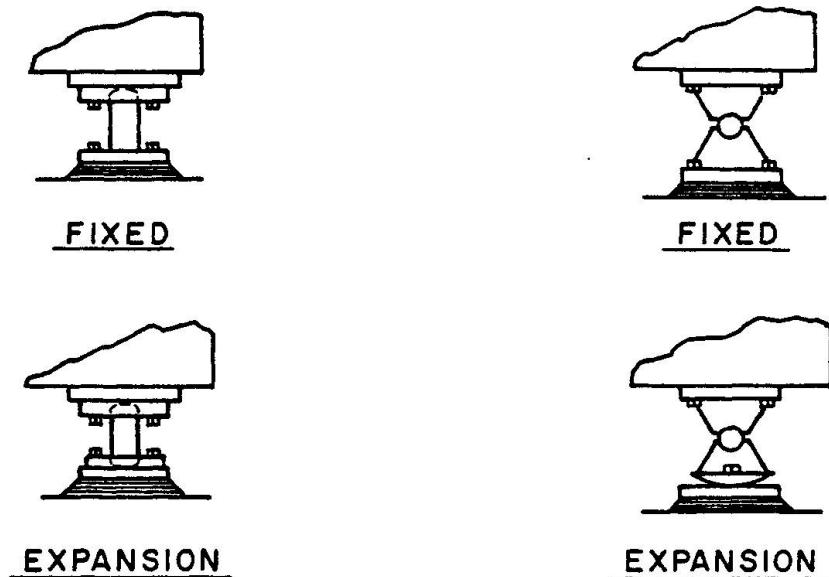
Fig. 6 Seismically vulnerable bridge bearings

Bearings which are damaged or malfunctioning can fail during an earthquake. In addition certain types of bearings, such as those shown in Figure 6, have performed poorly during past earthquakes. A possible retrofit measure in these cases is the replacement of the bearings with modern types such as elastomeric pads which, in conjunction with adequately designed restrainers, are more effective in resisting seismic loading.
