Artikel: Experiences with orthotropic steel deck and cable stayed bridges
Autor: Lebek, Dietrich E.
DOI: <https://doi.org/10.5169/seals-29521>

Experiences with Orthotropic Steel Deck and Cable Stayed Bridges

Dietrich E. LEBEK

Federal Road Research Institute
Köln, Fed. Rep. of Germany

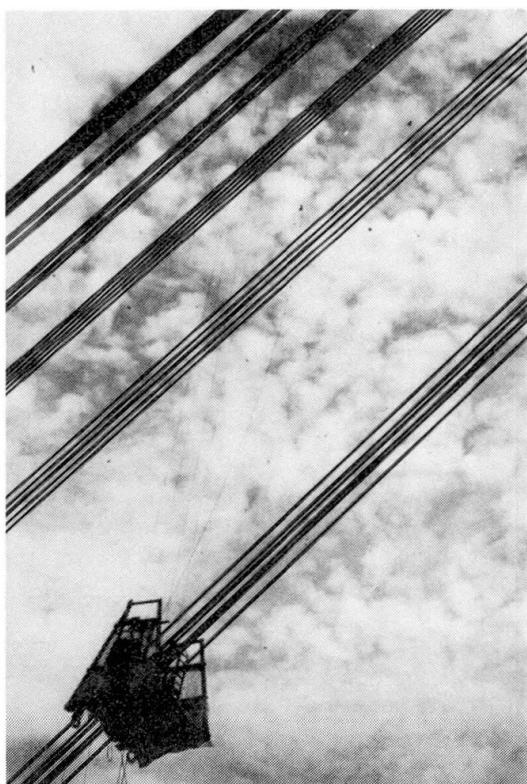
Fig. 10 Inspection of Cables

The development of an appropriate procedure and sequence for the inspection of all parts of a cable is important. In the past, the importance of a thorough and complete inspection of cables was often not acknowledged to the required extent by all designers of cable stayed bridges. Even an appropriate access to cable anchorages and cable sockets has not always been provided for in the design. Access to the free cable length between bridge deck and tower must also be possible and would normally require a special type of traveller. Fig. 10 shows a possible solution to this problem.
