# Experiences with orthotropic steel deck and cable stayed bridges

Autor(en): **Lebek, Dietrich E.**

Zeitschrift: **IABSE reports = Rapports AIPC = IVBH Berichte**

Band (Jahr): **38 (1982)**

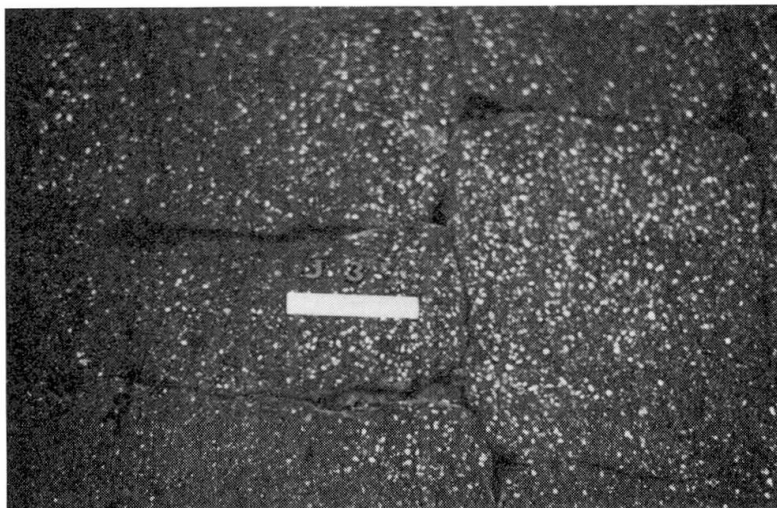
Fig. 3 Severe Cracking of the Surfacing

Cracking of the surfacing may loosely be grouped under the two categories of cracking over elements much stiffer than the orthotropic plate, e.g. webs of main girders, box girders, stiffening girders, etc. and cracking due to insufficient bond to the insulating layer or to the steel plate. When cracks have formed, water may penetrate and this causes corrosion of the steel which gradually spreads under the surfacing away from the cracks. This results in loss of adhesion which, in turn, leads to the formation of a series of parallel cracks as demonstrated in Fig. 3.

Ongoing research in Germany into the interaction of plate stiffness factors and surface cracking suggests that it may be advisable to formulate stiffness criteria for orthotropic plates in addition to the traditional strength requirements to achieve a smoother transition between unfavourable stiffness ratios.
