**Artikel:** Experiences with orthotropic steel deck and cable stayed bridges  
**Autor:** Lebek, Dietrich E.  
**DOI:** <https://doi.org/10.5169/seals-29521>

## Experiences with Orthotropic Steel Deck and Cable Stayed Bridges

### Dietrich E. LEBEK

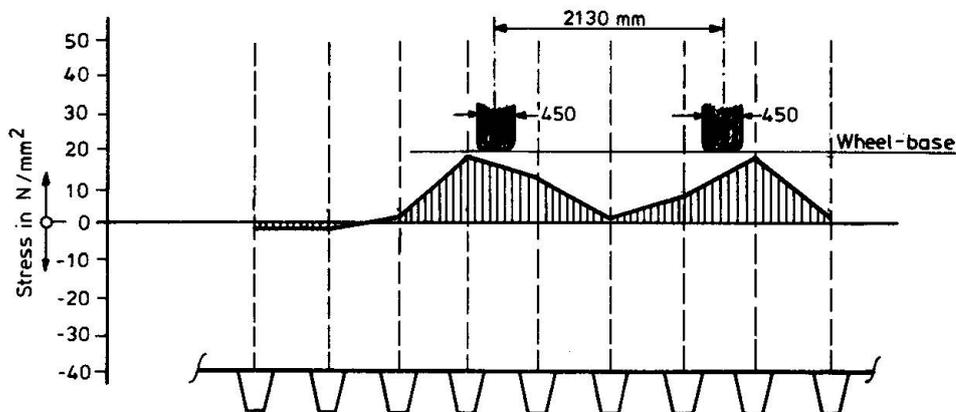
Fig. 1 Transverse Load Distribution

Orthotropic plates, even those with torsionally stiff stiffeners, have a poor transverse load distribution. Results of strain gauge measurements on the bottom flange of stiffeners of a "standard" orthotropic plate are shown in Fig. 1 [1]. Studies made under traffic in motion show that about seventy to eighty per cent of all wheels of commercial vehicles passed within about  $\pm 300$  mm of the centre line of the "ideal" wheel track. These two facts combined indicate that orthotropic plates have heavily loaded and less heavily loaded stiffeners.

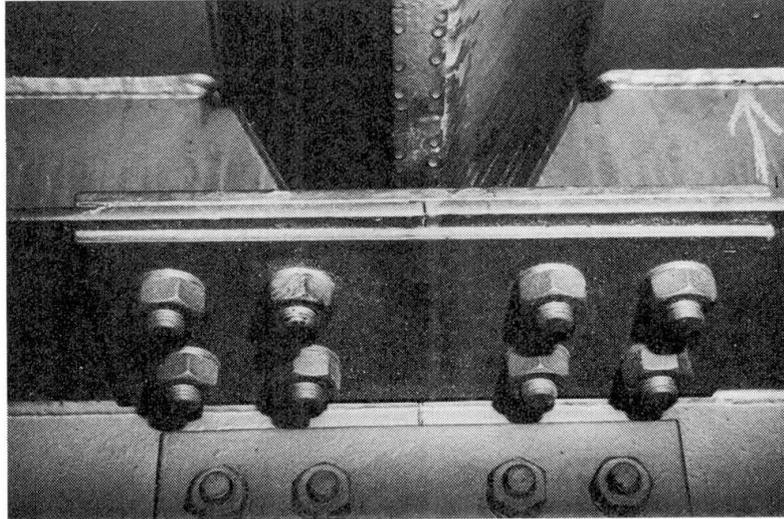
Fig. 2 Dew-Drops on the Underside of Stiffeners

The need for a good, durable and longlasting corrosion protection of the deck plate surface is obvious. Not so obvious is, at first sight, the need for a high class corrosion protection of the underside of an orthotropic plate. The temperature gradients, inherent to orthotropic plates, cause condensation which in turn causes rusting. Dewdrops on the underside of a stiffener and condensation stains on the stiffener web are shown in Fig. 2. Experience has clearly demonstrated that only the best paint systems available are

capable to give the desired corrosion protection. Since condensation is a permanent occurrence, intervals between application of paint layers should be kept as short as possible.

Temperature gradients, inherent to orthotropic plates, cause condensation which in turn causes rusting on the underside of stiffeners. It is recommended to use only the best paint systems available. Since condensation is a permanent occurrence, it is recommended that intervals between application of paint layers be kept as short as possible.

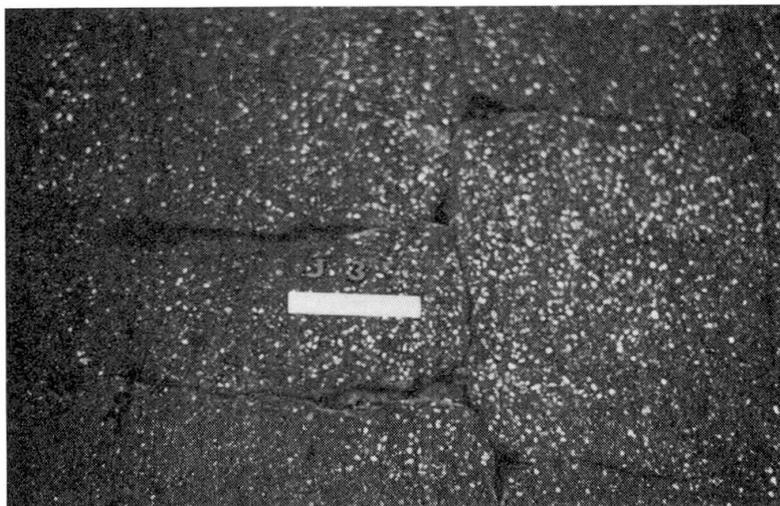
Fig. 3 Severe Cracking of the Surfacing

Cracking of the surfacing may loosely be grouped under the two categories of cracking over elements much stiffer than the orthotropic plate, e.g. webs of main girders, box girders, stiffening girders, etc. and cracking due to insufficient bond to the insulating layer or to the steel plate. When cracks have formed, water may penetrate and this causes corrosion of the steel which gradually spreads under the surfacing away from the cracks. This results in loss of adhesion which, in turn, leads to the formation of a series of parallel cracks as demonstrated in Fig. 3.

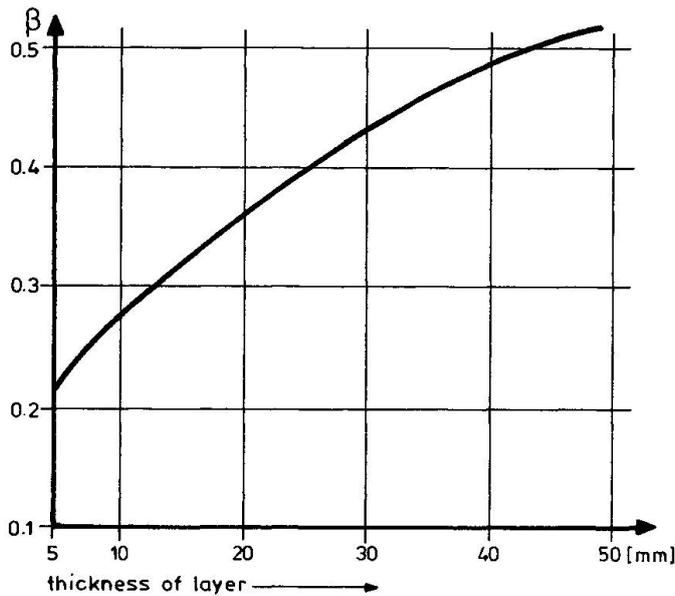
where the variable  $\beta$  is to be used in the case of total resurfacing as presented in Fig. 4 and the variable  $\gamma$  for the case of partial resurfacing as presented in Fig. 5;  $t_S$  is the recommended mixing temperature of the surfacing material and  $t_P$  the existing deck plate temperature at time of laying. The  $\beta$ -values account for an existing layer of a few millimeter thickness. The use of Fig. 4 and Fig. 5 are best illustrated by an example:

- A typical resurfacing operation in Germany would have a first layer of "gussasphalt" with an average thickness of 35 mm laid on an insulating layer about 2 mm thick. The recommended mixing temperature  $t_S$  for "gussasphalt" is 250°C. The deck plate temperature  $t_P$  shall be 40°C, a value typical for the months May and September. From Fig. 4 a  $\beta$ -value = 0.46 is taken for a thickness of 35 mm. With the above values the predicted maximum plate temperature would be

$$t_{\max} = 0.46 (250 - 40) + 40 = 137^\circ\text{C}$$

$$t_{\max} = \beta(t_s - t_p) + t_p$$

In the example, the upper limit is  $0.46 (250 - 35) = 100^{\circ}\text{C}$ , where  $\beta = 0.46$  is taken from Fig. 4, and the lower limit is  $80^{\circ}\text{C} - 35^{\circ}\text{C} = 45^{\circ}\text{C}$ . Consequently, the temperature range is  $100^{\circ}\text{C} - 45^{\circ}\text{C} = 55^{\circ}\text{C}$  as indicated by arrows in Fig. 6.

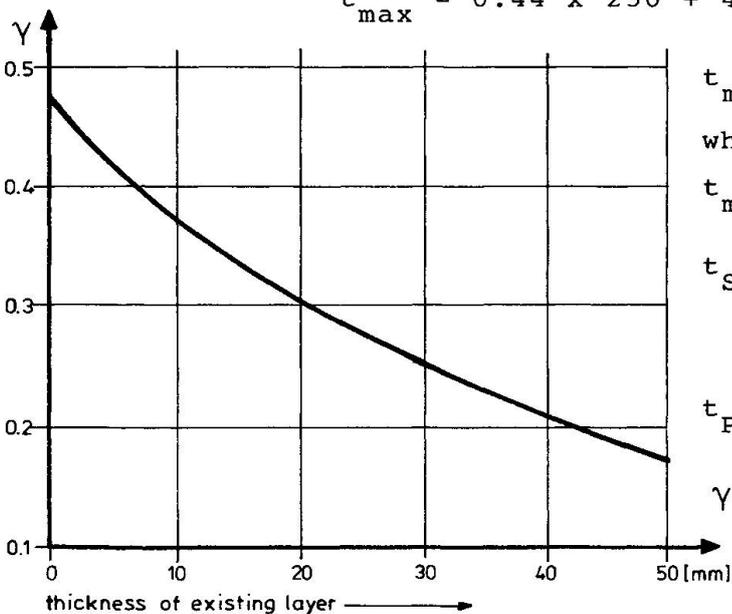
- A typical partial resurfacing operation in Germany would have a wearing course of "gussasphalt" with an average thickness of 35 mm laid on an existing layer about 35 mm thick. The deck plate temperature shall be  $40^\circ\text{C}$ . From Fig. 5 a  $\gamma$ -value = 0.23 is taken for an existing thickness of 35 mm. With the above values the predicted maximum plate temperature would be

- For a typical total resurfacing operation with the condition and values mentioned in the example for Fig. 4, the predicted maximum surface temperature of the insulating layer would be

$$t_{\max} = 0.44 \times 250 + 40 = 150^\circ\text{C}$$

$$t_{\max} = \gamma(t_s - t_p) + t_p$$

Required is again the upper and the lower temperature limit. The upper limit is  $0.44 \times 250^\circ\text{C} = 110^\circ\text{C}$ , the lower limit is  $100^\circ\text{C} - 35^\circ\text{C} = 65^\circ\text{C}$ . Consequently, the temperature range is  $110^\circ\text{C} - 65^\circ\text{C} = 45^\circ\text{C}$  as indicated by arrows in Fig. 7. The predicted average duration for temperatures above 100°C is about 60 min.

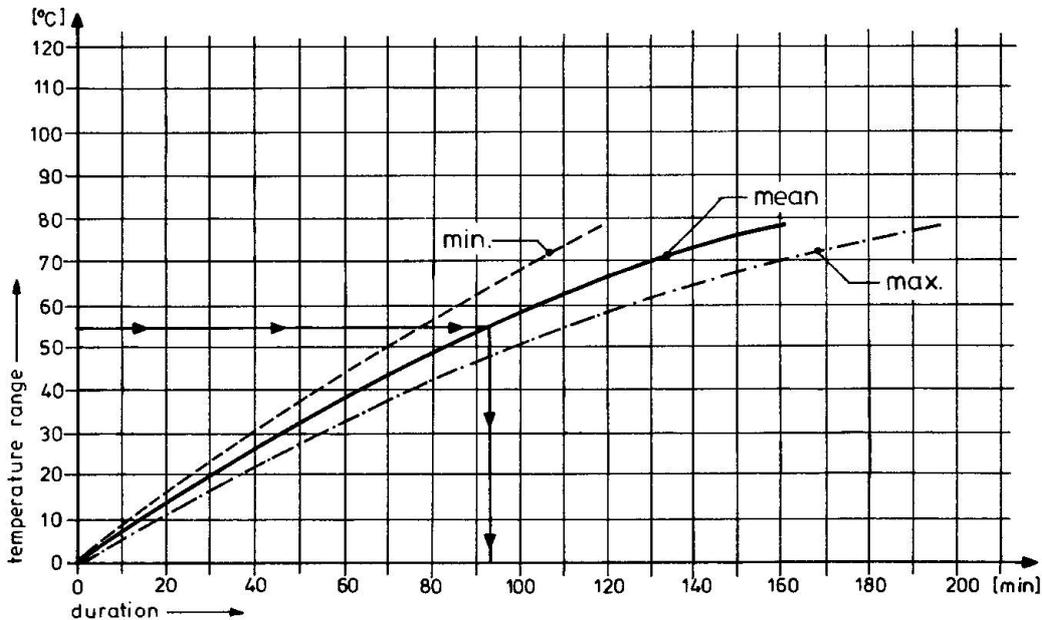
Fig. 6 Duration of Temperature Ranges for Paint Systems

Because the critical temperature range for normally used paint systems starts from  $80^{\circ}\text{C}$ , the duration of the temperature range above  $80^{\circ}\text{C}$  shall be predicted. The following data are needed: the recommended mixing temperature  $t_s$ , the thickness of the surfacing layer and the existing deck plate temperature  $t_p$ .

The predicted duration for a temperature range above  $80^{\circ}\text{C}$  is for:  
the minimum duration 10 min + 75 min = 85 min  
the average duration 10 min + 95 min = 105 min  
the maximum duration 10 min + 110 min = 120 min

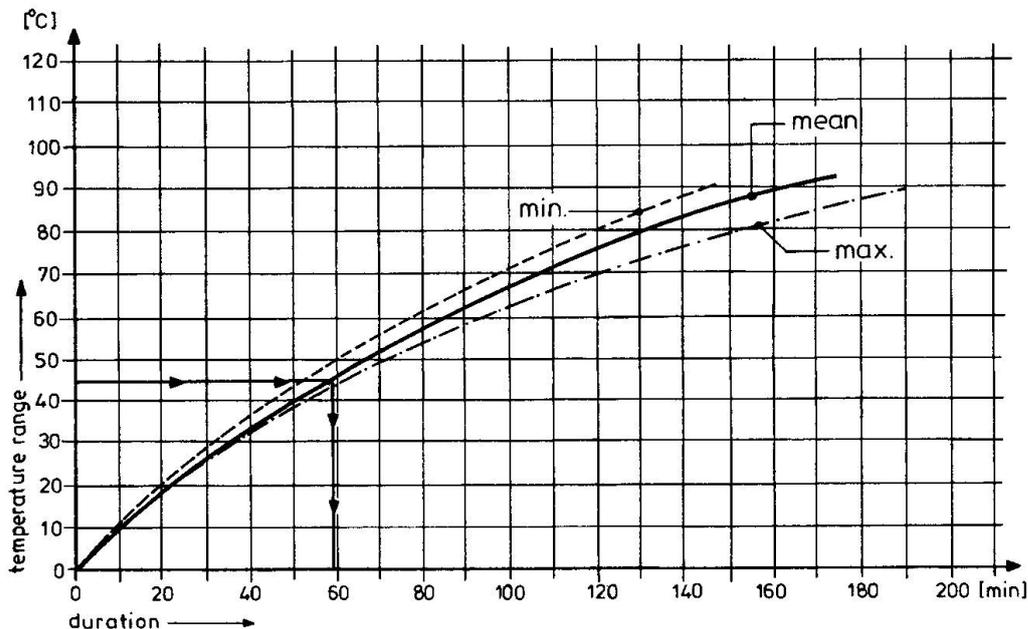
Fig. 7 Duration of temperature Ranges for Insulating Layers

The use of Fig. 7 will be illustrated by a following example. Critical temperatures for tar-epoxy-resin start from above 100°C. The recommended mixing temperature and the existing surface temperature of the insulating layer must be known in order to predict the desired temperature range.

In the example, a layer of 35 mm thick "gussasphalt" is to be laid on an insulating layer with a surface temperature of 35°C. The duration of the temperature range above 100°C shall be predicted.

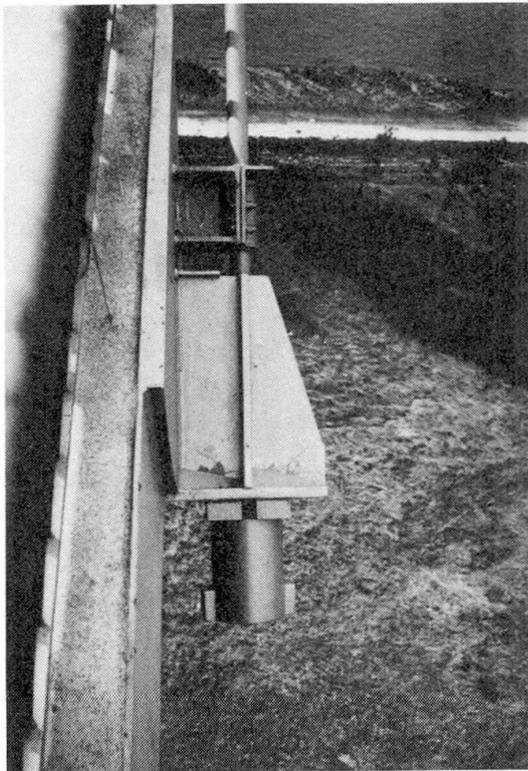
Fig. 8 Elastomeric Damper

It stands to reason that damping devices should be installed wherever dynamic effects can be presumed to have adverse effects on the life expectancy of cables or where the behaviour of an existing bridge suggests that damping devices are installed as a rehabilitation measure. Fig. 8 and 9 present examples of possible solutions for the installation of damping devices as a rehabilitation measure. The spring-type dampers as shown on Fig. 9 were fixed to stiffened hand rails.

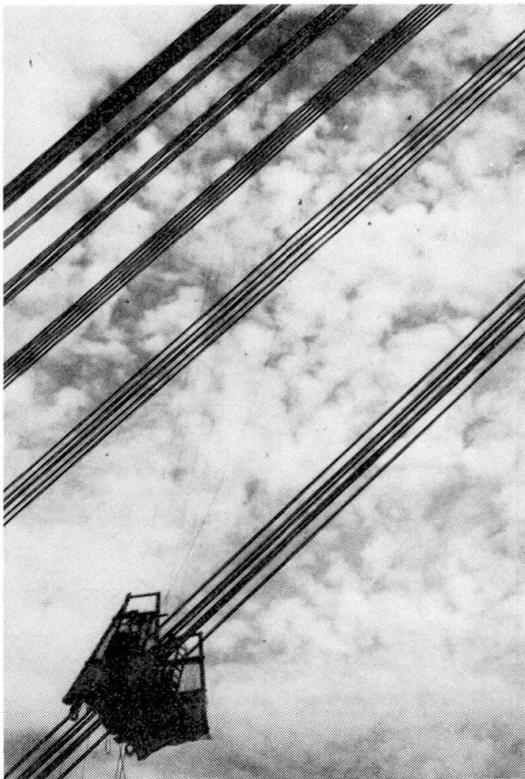
Fig. 10 Inspection of Cables

The development of an appropriate procedure and sequence for the inspection of all parts of a cable is important. In the past, the importance of a thorough and complete inspection of cables was often not acknowledged to the required extent by all designers of cable stayed bridges. Even an appropriate access to cable anchorages and cable sockets has not always been provided for in the design. Access to the free cable length between bridge deck and tower must also be possible and would normally require a special type of traveller. Fig. 10 shows a possible solution to this problem.

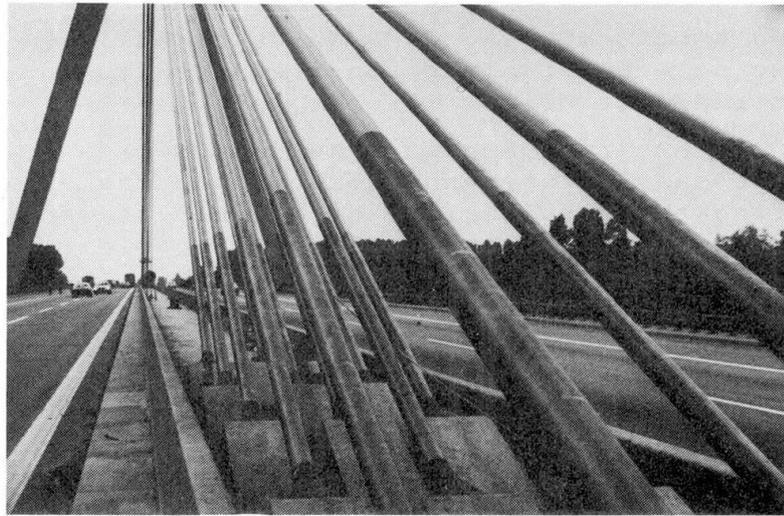
Fig. 11 Additional Wrapping in Splash-Zone

A "standard" rehabilitation measure is now wrapping single cables in the bridge deck area as shown in Fig. 11 in order to provide additional protection in the brine spray zone and against any kind of mechanical damage. Best results can be expected if the wrapping is done before the paint is hardened.

A thorough and complete corrosion protection is vital for the expected durability of all cable elements. Corrosion protection systems should be built-up systematically and should start with the fabrication of cables in the shop. Corrosion protection should only make use of the best paint systems available. As a rehabilitation measure additional protective wrapping in the vicinity of the bridge deck area is recommended.
