Rehabilitation and Repair of Bridges

Robert A.P. SWEENEY
Regional Engineer
CN Rail
Montreal, PQ, Canada

The correct level of maintenance for a bridge structure is a function of its need and the benefit it provides. Structures whose justification for existence is marginal or non-existent or that should not have been built in the first place are not worth maintaining beyond minimum safety levels for their actual use. This paper will illustrate these principles together with a number of repair schemes.

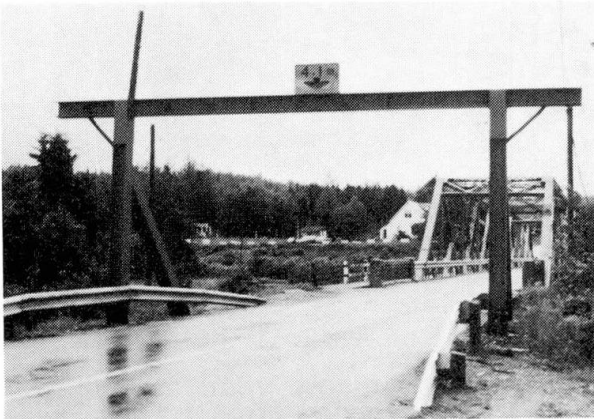
The solution shown in figure 1 is a lot more economical than building a new bridge. The construction of a new bridge can wait until the traffic warrants it, since the occasional high truck can get across by using a short detour.

Figure 1 Height Protection

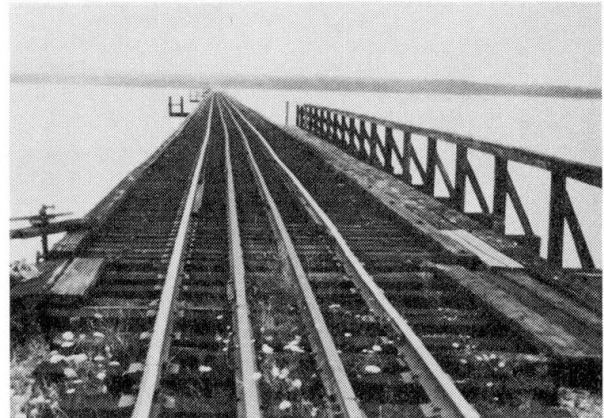
Figure 5 shows a structure over which operations have ceased. This structure became unsafe recently. To rehabilitate it to new condition would cost \$7. million dollars, to fix it to last until the next spring ice movement would cost over \$400,000. The saving to the railway by using the bridge was of the order of \$40,000 before considering any maintenance expenses. I must say that the initial damage to the structure was caused by the action of others who changed the ice conditions. Should the structure be rehabilitated, they will probably be held liable. Nevertheless, we have found another way to adequately serve our customers and are not throwing away money which can be better spent elsewhere.

Figure 5 Moved by ice

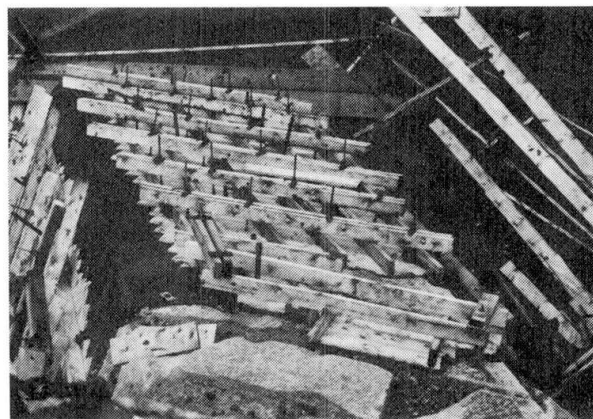
The simple preventative step of keeping stone masonry properly pointed will usually avoid subsequent more costly repairs caused by movement of stones. Once a structure is permitted to loose a stone or two, it becomes costly and technically difficult to repair (Figure 9).

Among the most common techniques are placing bags filled with cement or concrete as a form and either placing tremi concrete or placing aggregate and pumping grout. Larger jobs require extensive forming and reinforcing adequately dowled to the existing structure.

A - Overview

B - Close-up

Figure 9 Repair to pier

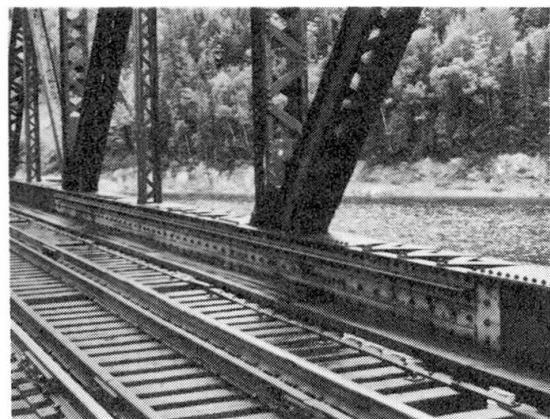
In the case of yielded, buckled or cracked members, it is possible to splice around the failed part in such a way that all load can be carried by the splice. The repair shown in Figure 12 shows a splice around members that cracked after being exposed to a very severe fire. The extent of locked in residual stresses was of such concern that a significant part of the member was spliced.

Figure 12 Member spliced

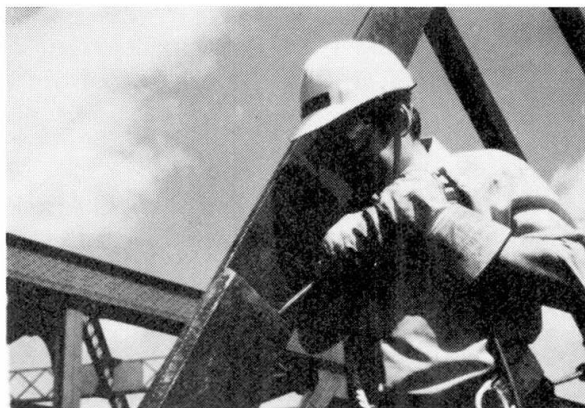
One technique, we have used, is to peen the ends of shallow cracked welds (Figure 19) to prolong their life. In other cases, replacing poorly installed rivets with high-strength bolts can prolong the life of a connection.

Figure 19 Peening welds
