Artikel: Rehabilitation and repair of bridges
Autor: Sweeney, Robert A.P.
DOI: <https://doi.org/10.5169/seals-29522>

Rehabilitation and Repair of Bridges

Robert A.P. SWEENEY
Regional Engineer
CN Rail
Montreal, PQ, Canada

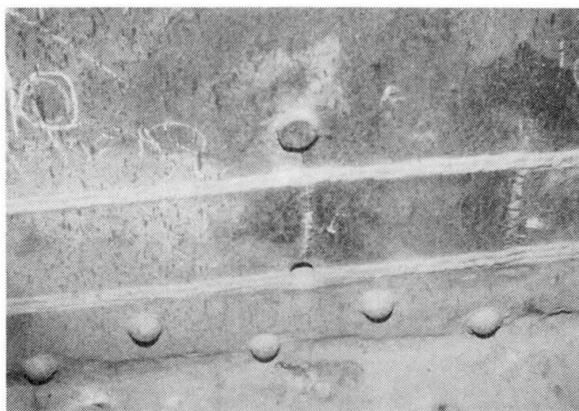
Figure 3 Crack in Girder

The structure shown in Figure 3 has been carrying mainline railway traffic for three years with the cracks shown. The cracks are monitored annually and if they remain dormant the span won't be replaced for at least another 5 years, at which time they will be replaced for other reasons.

I would recommend the repair shown in Figure 11 to replace the section lost due to corrosion of the web just above the bottom flange. This is a much better solution than the one shown in Figure 3 where the welds cracked.

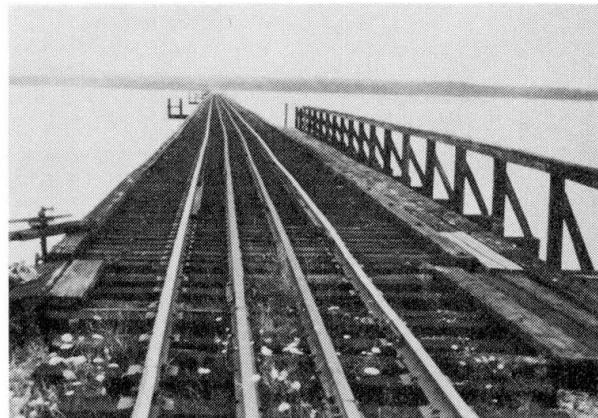
Figure 5 Moved by ice

Figure 5 shows a structure over which operations have ceased. This structure became unsafe recently. To rehabilitate it to new condition would cost \$7. million dollars, to fix it to last until the next spring ice movement would cost over \$400,000. The saving to the railway by using the bridge was of the order of \$40,000 before considering any maintenance expenses. I must say that the initial damage to the structure was caused by the action of others who changed the ice conditions. Should the structure be rehabilitated, they will probably be held liable. Nevertheless, we have found another way to adequately serve our customers and are not throwing away money which can be better spent elsewhere.

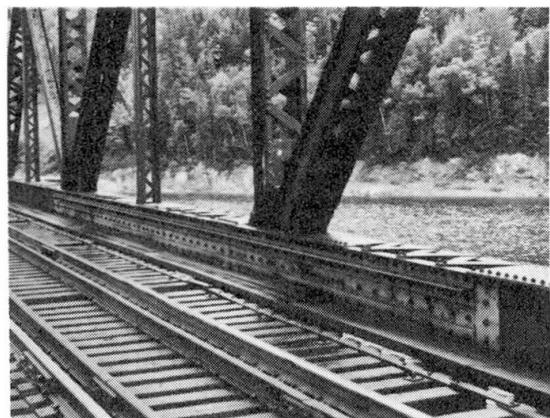
Figure 12 Member spliced

In the case of yielded, buckled or cracked members, it is possible to splice around the failed part in such a way that all load can be carried by the splice. The repair shown in Figure 12 shows a splice around members that cracked after being exposed to a very severe fire. The extent of locked in residual stresses was of such concern that a significant part of the member was spliced.

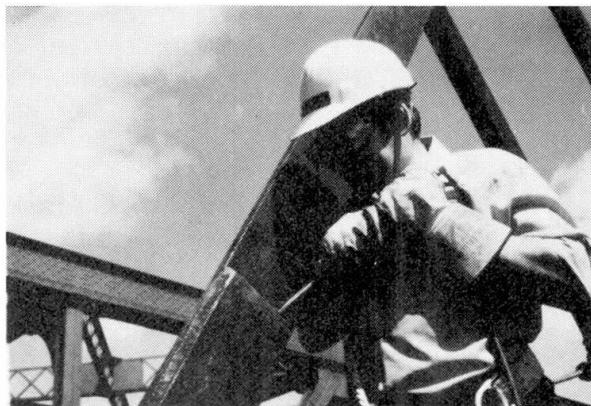
Figure 19 Peening welds

One technique, we have used, is to peen the ends of shallow cracked welds (Figure 19) to prolong their life. In other cases, replacing poorly installed rivets with high-strength bolts can prolong the life of a connection.
