Rehabilitation and Repair of Bridges

Robert A.P. SWEENEY
Regional Engineer
CN Rail
Montreal, PQ, Canada

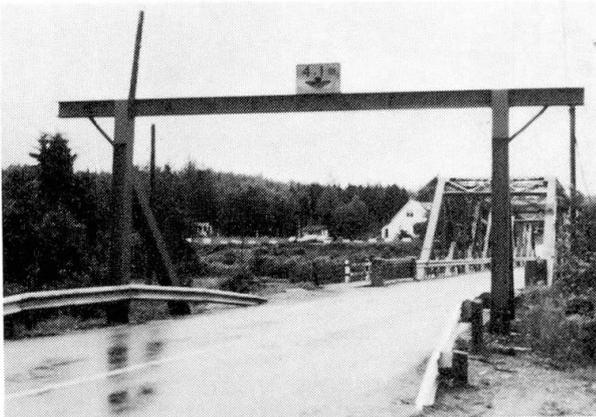
Figure 1 Height Protection

The solution shown in figure 1 is a lot more economical than building a new bridge. The construction of a new bridge can wait until the traffic warrants it, since the occasional high truck can get across by using a short detour.

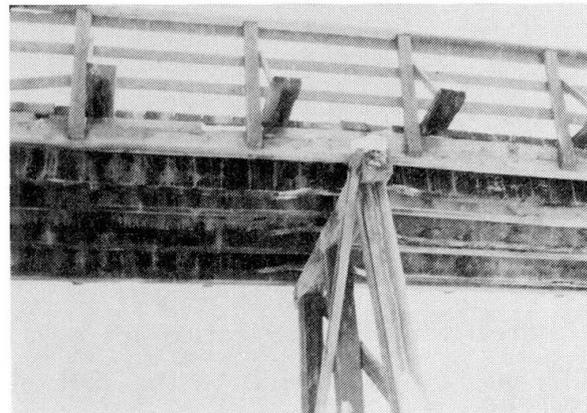
Figure 2 Crushing Timber

The structure shown in Figure 2 shows crushing of the outside stringers and floor beams which are wooden beams. Nevertheless, the center of the structure is used to get one farm tractor across daily. By blocking off the edges, repairs or replacement are avoided.

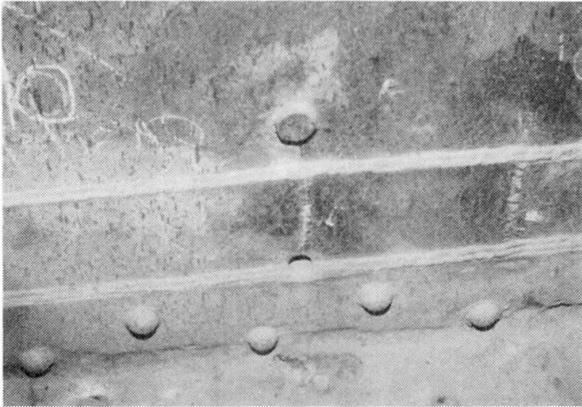
Figure 3 Crack in Girder

The structure shown in Figure 3 has been carrying mainline railway traffic for three years with the cracks shown. The cracks are monitored annually and if they remain dormant the span won't be replaced for at least another 5 years, at which time they will be replaced for other reasons.

I would recommend the repair shown in Figure 11 to replace the section lost due to corrosion of the web just above the bottom flange. This is a much better solution than the one shown in Figure 3 where the welds cracked.

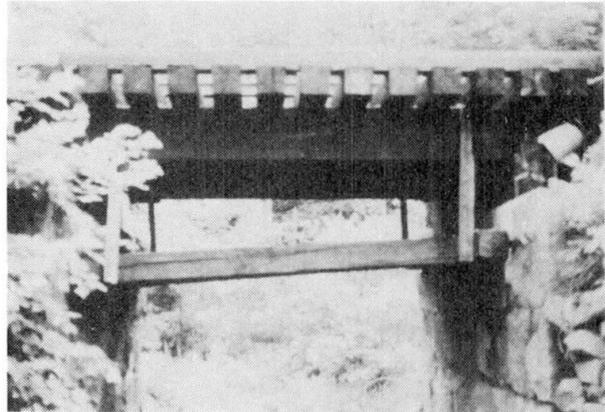
Figure 4 Temporary Support

Figure 4 shows a structure which has been strengthened sufficiently to last one more winter at which time the railway line is to be closed. Traffic will then be re-routed.

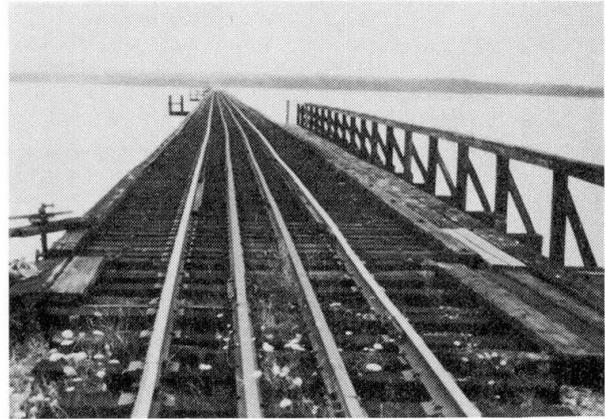
Figure 5 Moved by ice

Figure 5 shows a structure over which operations have ceased. This structure became unsafe recently. To rehabilitate it to new condition would cost \$7. million dollars, to fix it to last until the next spring ice movement would cost over \$400,000. The saving to the railway by using the bridge was of the order of \$40,000 before considering any maintenance expenses. I must say that the initial damage to the structure was caused by the action of others who changed the ice conditions. Should the structure be rehabilitated, they will probably be held liable. Nevertheless, we have found another way to adequately serve our customers and are not throwing away money which can be better spent elsewhere.

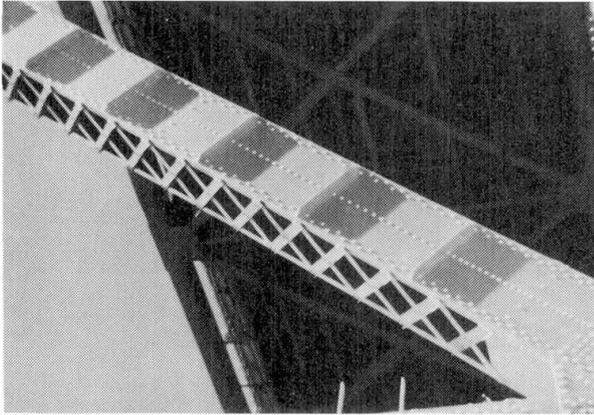
Figure 6 Well painted
(Photo by C. Seim)

There are (5) studies which show that preventive maintenance is the least expensive way of maintaining a structure that has full economic justification for existence. The structure shown in Figure 6, built in 1935, is so well maintained

that you could almost eat off it, and it has proved over the years to be very inexpensive to maintain. Contrast this with the member shown in Figure 7, built the same year, whose painting has been neglected.

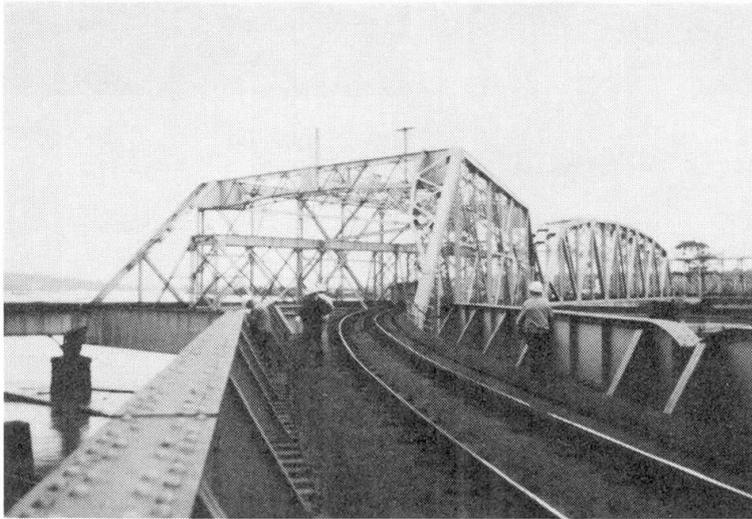
Figure 8 Well maintained

Structurally weak bridges should be maintained to a higher than normal level consistent with their use. The bridge shown in Figure 8, built in 1904 is one of the heaviest travelled and yet weakest of our main line bridges (6, 7). Because of extremely good preventative maintenance the structure serves us well.

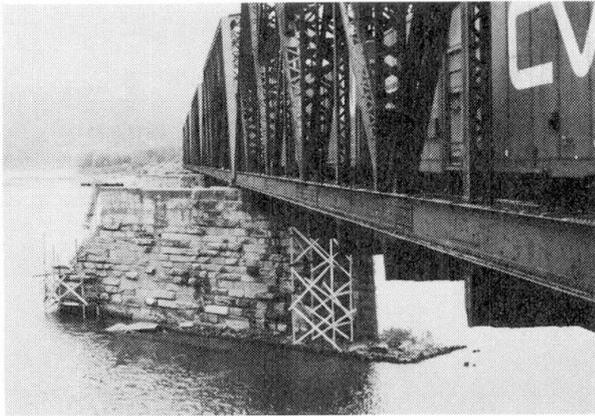
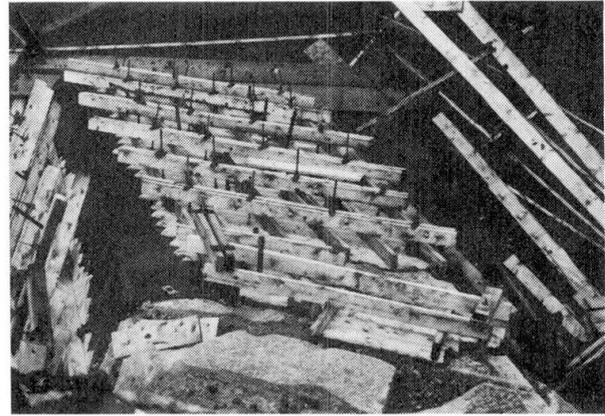
Figure 9 Repair to pier

The simple preventative step of keeping stone masonry properly pointed will usually avoid subsequent more costly repairs caused by movement of stones. Once a structure is permitted to loose a stone or two, it becomes costly and technically difficult to repair (Figure 9).

Among the most common techniques are placing bags filled with cement or concrete as a form and either placing tremi concrete or placing aggregate and pumping grout. Larger jobs require extensive forming and reinforcing adequately dowed to the existing structure.

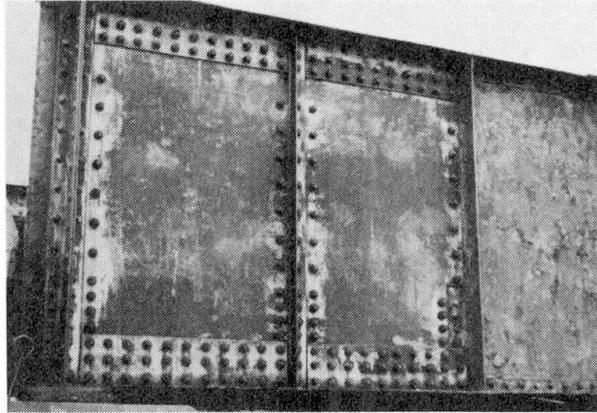
Figure 10 Replacement Web

When the web of a girder has reached a stage where it can no longer adequately carry the load, then a bolted replacement web Figure 10, is possible. If the

corrosion is confined to the web near the stiffener, the stiffener can be removed and a small plate added to the web before replacing the stiffener.

I must warn against welding these replacements as weld terminations have very low fatigue strength. Cracks initiated in patch plate welds can go into the original web causing a potentially dangerous situation. Welding to a non-welded structure can destroy the inherent component redundancy in the structure (8). In a bolted or riveted girder, a crack in one plate or angle will not propagate to the rest of the member. Join these with a weld and the crack can propagate.

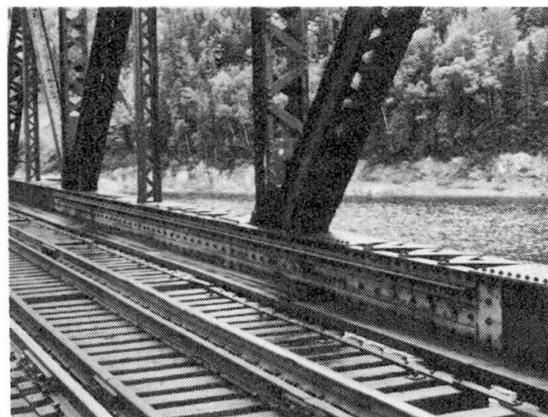
Figure 12 Member spliced

In the case of yielded, buckled or cracked members, it is possible to splice around the failed part in such a way that all load can be carried by the splice. The repair shown in Figure 12 shows a splice around members that cracked after being exposed to a very severe fire. The extent of locked in residual stresses was of such concern that a significant part of the member was spliced.

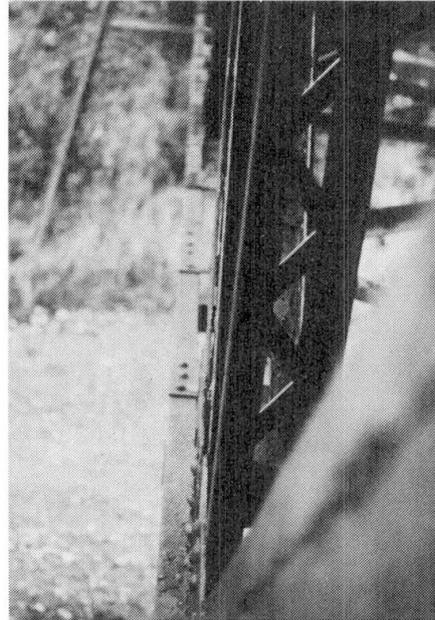
Figure 13 Broken welds

Care must be taken in the connection of all repair and rehabilitation schemes. The strengthening of a deck truss shown in Figure 13 was not very successful. The staggered welds eventually broke.

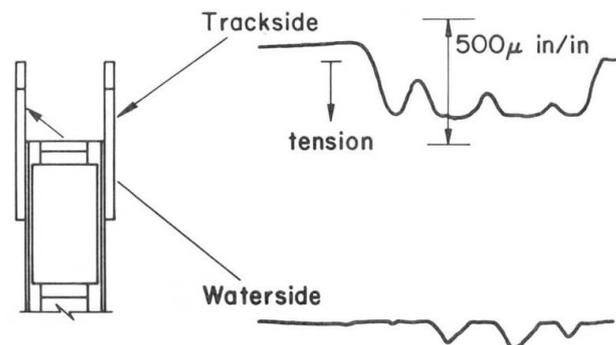
Figure 14 Unequal loading

In trusses, when the pins or pinplates wear they can be replaced by larger pins after reaming to make the hole larger. If this is not possible, then a pin joint can sometimes be replaced by gusset plates. In order to minimize future fatigue problems, it is important to be very careful about compatible deflections to ensure that the replacement gusset plates equally share all loads (Figure 14). If one plate carries no load, then the doubled stress range in the other could lead to unexpected fatigue problems (6,7).

In older mild steel structures, a differential strain of one thousand of an inch can cause the relief of stress approaching the yield point. Rehabilitation schemes must be planned so that the replacement parts take the load in the way expected. This is not something that can be left to skilled tradesmen. It must be engineered.

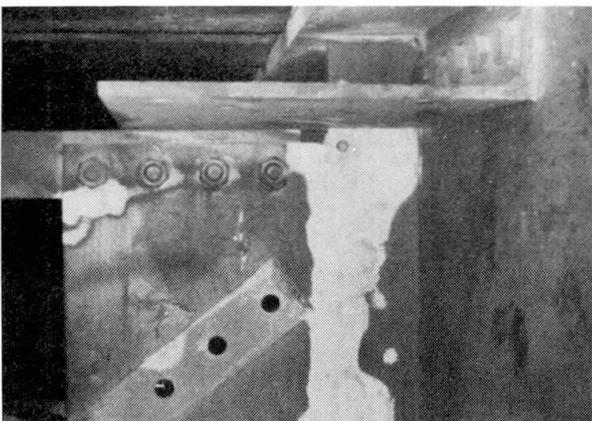
Figure 15 Crack at sharp notch

The crack shown in Figure 15 started where the gusset plate to vertical stiffener weld terminates (10). Many of these cracks were not detected until the crack front had reached the stiffener to web weld. In order to stop the crack from proceeding up or down this weld, holes were drilled. These holes, which were drilled from both sides of the interior stiffener and then from the outside, were quite difficult to do. If the crack is not stopped then a more costly retrofit would be necessary. A permanent repair is shown in Figure 16 (9).

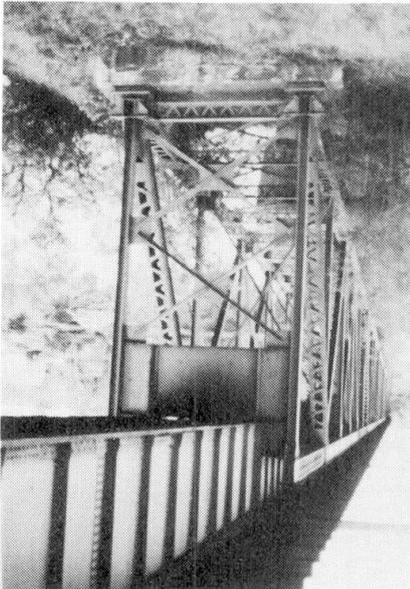
Figure 17 End of deck truss

The structure shown in Figure 17 has cracked and been repaired once every ten years when in fact the problem is that there is no where for breaking forces to be dissipated.

The traction bracing ends at the top of the deck truss (Figure 18). Since the end post is relatively flexible, the load is forced to try and go through the deck plate girder. The connection is not designed for this force and movement, so it cracks. Changing the location of traction bracing in order to get it directly to the bearings of the truss would permanently solve the problem.

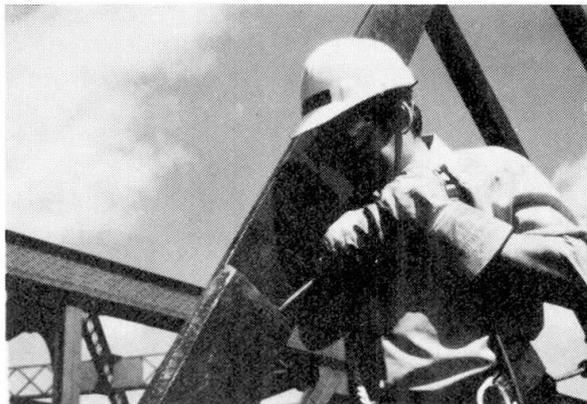
Figure 19 Peening welds

One technique, we have used, is to peen the ends of shallow cracked welds (Figure 19) to prolong their life. In other cases, replacing poorly installed rivets with high-strength bolts can prolong the life of a connection.
