Artikel: Maintenance of reinforced and prestressed concrete bridges in the

Federal Republic of Germany

Autor: Thul, Heribert

Maintenance of Reinforced and Prestressed Concrete Bridges in the Federal Republic of Germany

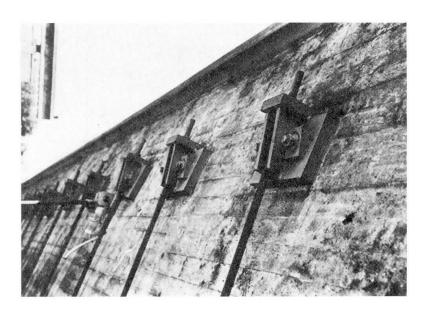
Fig. 16 Underside view with anchoring of outside additional tendons (1st rehabilitation) (Schmargendorf bridge)

it was not possible to restore the service level of this bridge permanently. We decided, therefore, to dismantle the existing bridge and to build a new one at the same place for about 60 million DM (Figures 15 and 16).

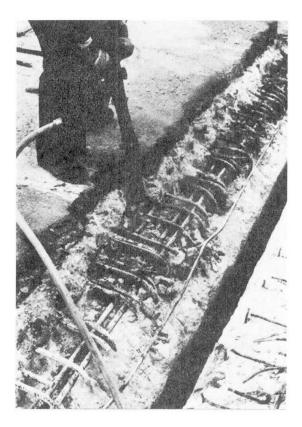
A great number of cracks and surface scaling of the concrete, especially at the ends of the prefabricated girders and at the cross beams, constituted a risk to the stability at the points of support (Figures 17 and 18).

Fig. 17 Expansion joint removed (valley bridge Pfädchensgraben)

- Different causes led to extensive damage to three neighbouring 15-year-old valley bridges on the Krefeld - Ludwigshafen motorway west of the Rhine. Rehabilitation costs amounted to a total of 45 million DM. The bridges were built as a single-span girder system with prefabricated main girders. The numerous expansion joints required became leaky and to some extent broke under the high traffic loads. This enabled surface water containing de-icing salt to penetrate to the ends of the prefabricated girders and to cause severe damage there.

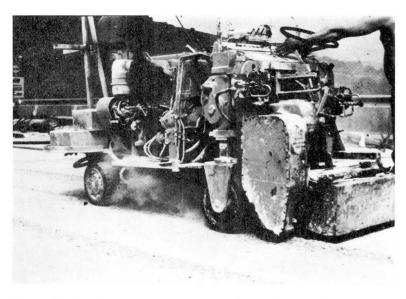
Fig. 20 Mechanical removal of carbonated top concrete layer from carriageway (bridge over the river Nahe at Dietersheim)

- In the case of damage to the concrete deck slab due to chloride, both the pavement and the waterproofing must first be removed. In case of surface contamination the concrete is either treated mechanically or by high-pressure water. If required, deteriorated concrete should be removed. In case of contamination to greater depths, contaminated concrete is completely removed and replaced by new concrete with resin applied as a bonding agent. After that a bituminous waterproofing or an elastic plastic coating is applied by spraying. The advantage of the spraying method is that subsequently occurring cracks can be bridged and the structure thus be permanently protected.
- Chloride-contaminated surface concrete is often removed from small horizontal and vertical areas (concrete footpaths, kerbs) by flame cleaning; exposed reinforcement will receive a double corrosion protection.

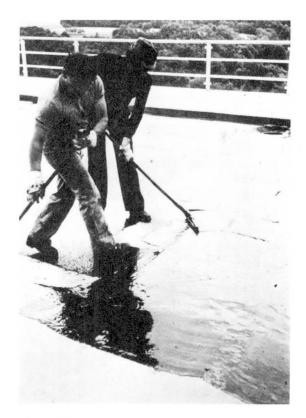
Fig. 21 Spreading of the bitumen epoxy resin waterproofing by hand (bridge over the Kocher valley at Geislingen)

Damaged parts of the concrete will be filled with resin mortar, especially where the concrete protective covering of the reinforcement has to be strengthened. After that footpaths and kerbs receive, as a rule, a clorideresistant coating.

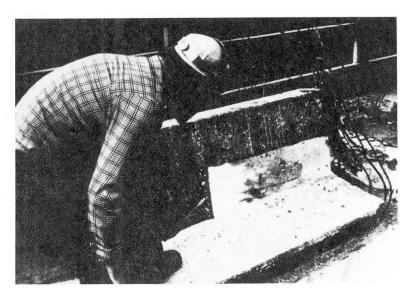
Fig. 22 Flame-cleaning of carbonated top concrete layer of concrete guard kerbs (valley bridge Pfädchensgraben)
