**Zeitschrift:** IABSE reports = Rapports AIPC = IVBH Berichte

**Band:** 39 (1982)

## **SESSION 4**

## Bridge Deck Expansion Joint Transition Areas

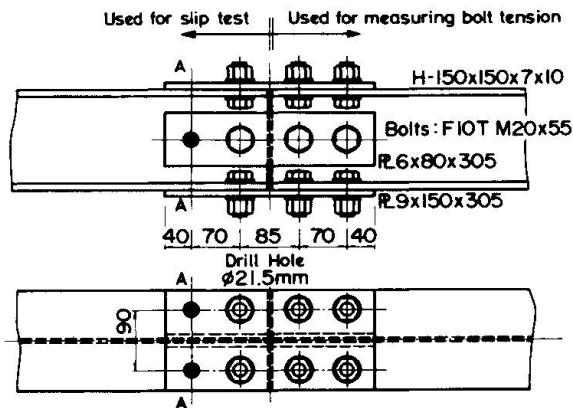
Fig. 1 Tested Joint for Series C

Slip tests were conducted for series C, D and E. The joint slip was determined by relative displacements measured with clip gages set between the main plate and the splice plate of the joint.

Note: A half number of bolts(5bolts) in A-A were loosened before slip tests.

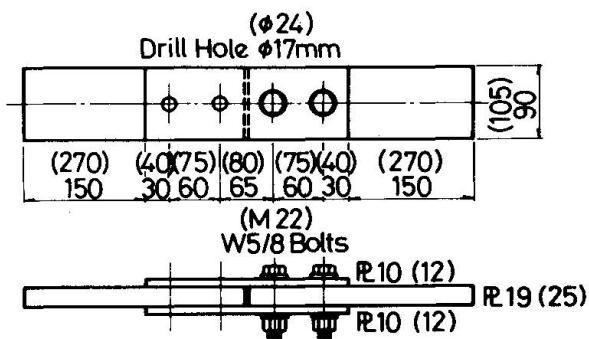
Fig. 2 Tested Joints for Series D and E

Descriptions in parentheses show those of series E.

Table 3 shows the results of slip loads obtained by slip tests conducted 24 to 48 hours after installation and after long duration. It is clearly shown that the slip load of surface blasted joints increases as the years pass. The slip load of surface coated joints showed two types of results, i.e., a gradual decrease 3 years after installation for series E-1 and conversely a slight increase for series E-2.

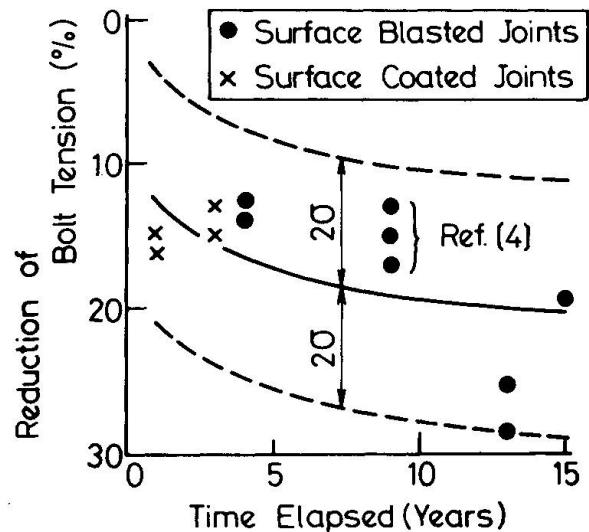
Fig. 3 Aging in Bolt Tensions

Table 2 shows the results of bolt tensions measured immediately after installation and after various long durations. Fig. 3 shows the reduction of bolt tension against that of immediately after installation. Furthermore, Fig. 3 shows the past test data [4] which were obtained when F8T, F10T and F11T bolts were tightened by the turn-of-nut method. From these test results, it has been concluded that the reduction of bolt tension after long duration is about 20% regardless of the differences in the tightening methods, kind of bolt sets and steel grade of joints, or in the faying surface conditions with or without coatings.

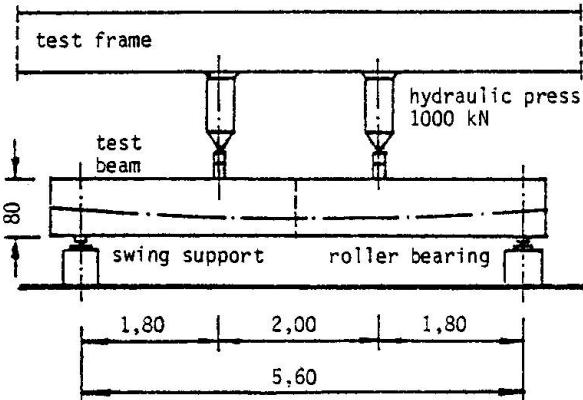
Fig.1 Test set-up

made expect a failure before 1,000,000 cycles. Only 40 cycles/minute were executable. Detailed results are published in the report [8] and in [9].

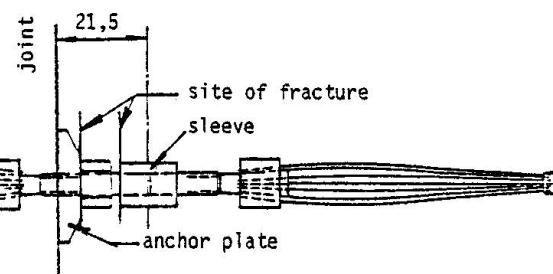
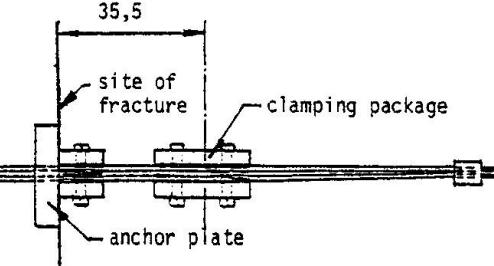
Fig.2 Characteristics of the tendons and their couplings

bundle with 33 flat ribbed wires  
St 1420/1570

tot  $A = 13,2 \text{ cm}^2$   
adm  $F = 1140 \text{ kN}$   
adm  $\sigma = 864 \text{ MPa}$   
adm  $\Delta\sigma = 54 \text{ MPa}$

Philipp Holzmann

bundle with 16 flat ribbed wires  
St 1420/1570

tot  $A = 6,4 \text{ cm}^2$   
adm  $F = 552 \text{ kN}$   
adm  $\sigma = 864 \text{ MPa}$   
adm  $\Delta\sigma = 68 \text{ MPa}$

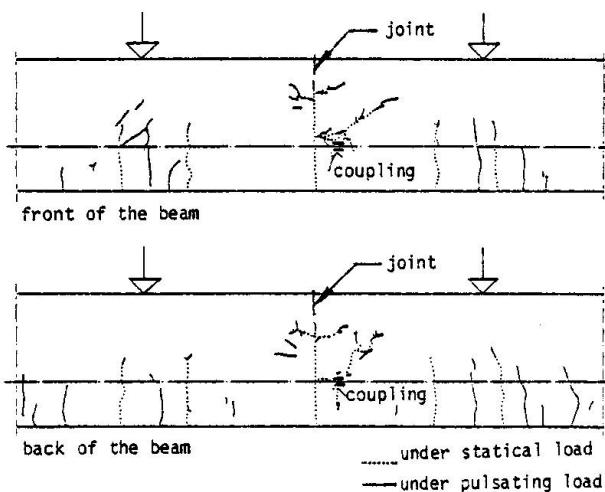
Fig.4 Typical cracks (beam no.10)

Fig.4 shows a typical crack pattern. Exceeding the decompression load, the joint opened immediately because an appreciable tensile strength did not exist.

When reaching the maximum load, the height of the crack corresponded to the height of the calculated tensile zone. Near the neutral axis horizontal cracks formed, as they are also typical for elements with unbonded tendons. Only in that part of the beam, where the coupling was installed, some diagonal cracks formed near the coupling. Flexural bending cracks starting from the bottom formed at some distance from the joint. During the fatigue loading, some cracks elongated and new cracks were initiated. The change of the crack width difference  $\Delta w$  in the joint is presented in Fig.5. It increases at first, then remains constant for a long period and increases once again shortly before failure.

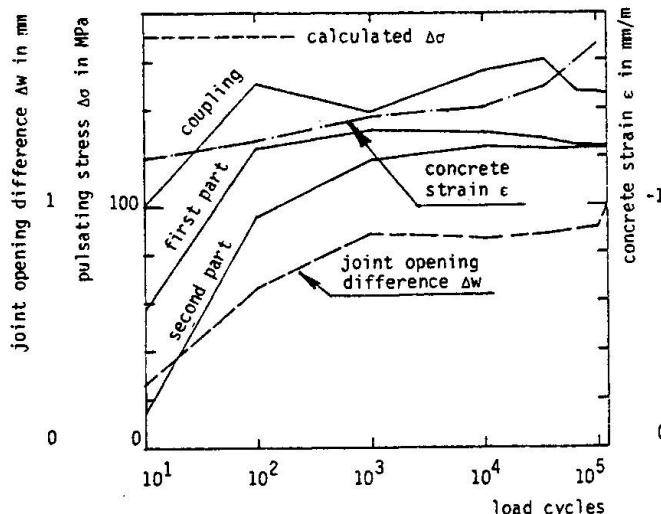
Fig.5 Typical variation of pulsating stress  $\Delta\sigma$ , joint opening difference  $\Deltaw$  and concrete strain  $\epsilon$  (beam no.5)

The course of the means of the measured pulsating stresses  $\Delta\sigma$  for several points of the tendons is presented in Fig.5. The corresponding steel value at the coupling is growing with increasing load cycles but often does not fully reach the calculated value. The stress difference  $\Delta\sigma$  decreases sometimes considerably before the failure. The stress differences  $\Delta\sigma$  of the prestressing steel near the couplings remain clearly below the value at the coupling. It is also remarkable, that the values for the second part of the beam, where the coupling is installed, remain always somewhat more below the calculated value. At the beginning of the fatigue loading the stress differences increase clearly, reach their maximum and decrease sometimes before the failure. The increase of the stress values at the beginning has to be attributed to gradual bond destruction. This contributes also to the contraction of the compression zone at the end of the fatigue loading. Thereby the distance of the inner forces increases and this explains the decrease of the stress difference before the failure.

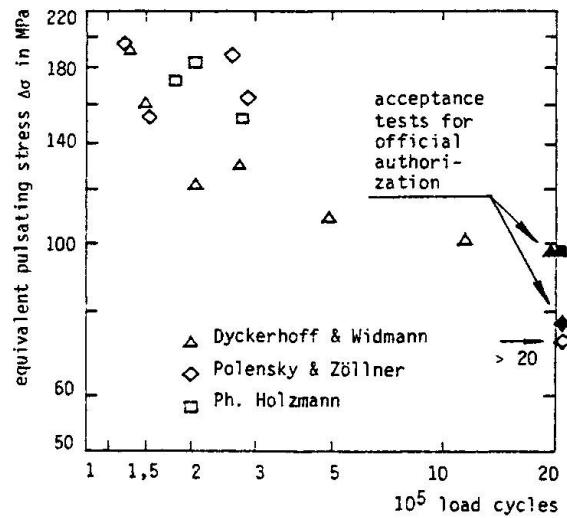
Fig.6 Withstood load cycles as a function of the applied equivalent pulsating stress

The withstood number of load cycles for different pulsating stresses  $\Delta\sigma$  are presented in Fig.6 in double-logarithmic scale. The withstood stresses for 2 million load cycles from the acceptance tests are also shown for comparison. Tests with embedded tendons do not seem to result in reduced fatigue strength compared with acceptance tests on unembedded tendons. As shown in Fig.2 fractures occurred only within the thread or next to the ribs on the wires at the end of the clamp anchoring, just as this was observed with the acceptance tests.

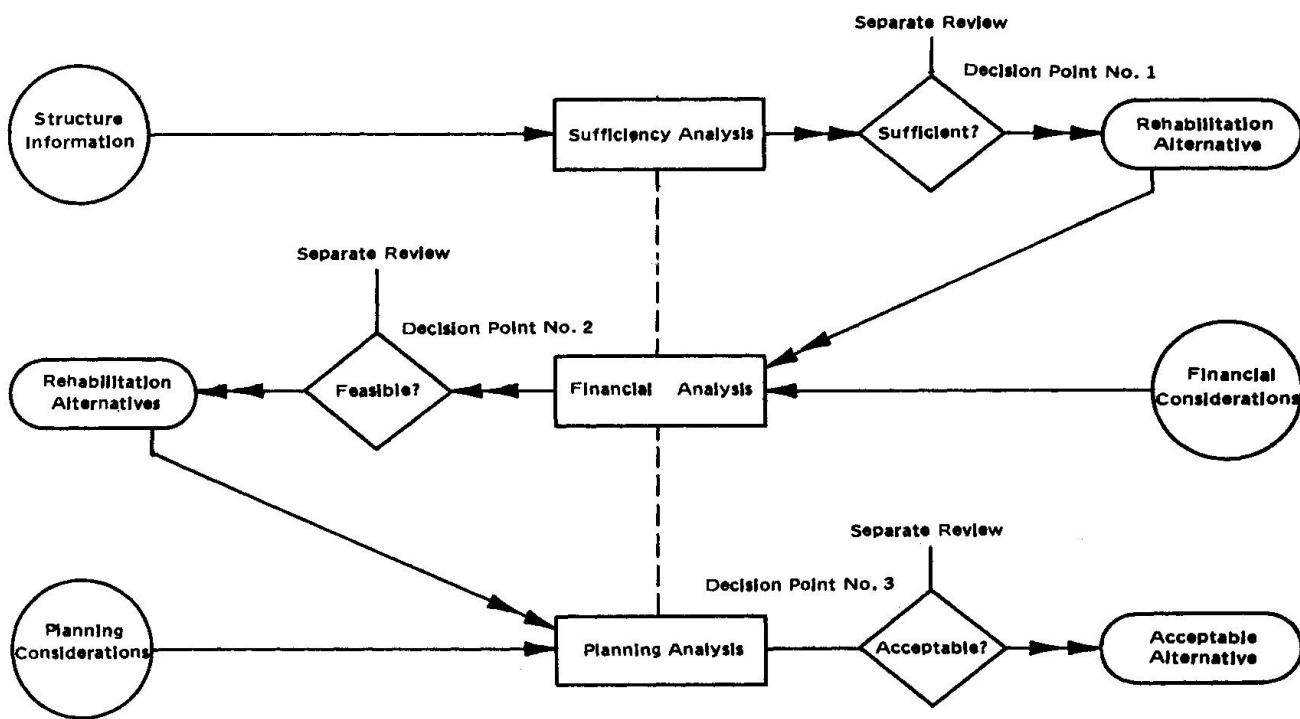
#### 4. FLOW CHART OF REHABILITATION DECISION MAKING

4.1 A step by step procedure as outlined in this paper is shown in the above flow chart.
