SESSION 1

Inspection, Records and Maintenance

Conflict between Structurally Deficient and Historically Significant Bridges

Michel VIRLOGEUX

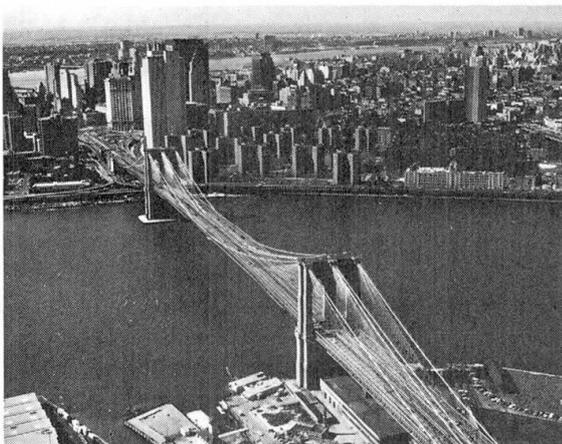
Fig.1. The Brooklyn Bridge, one of the most famous bridges in the world, celebrates its Centennial in 1983. Though no one would dream of replacing it, a cable corroded by pigeon dung snapped last year, killing a pedestrian; rehabilitation costs are estimated at \$105 million. Jack Boucher, HAER.

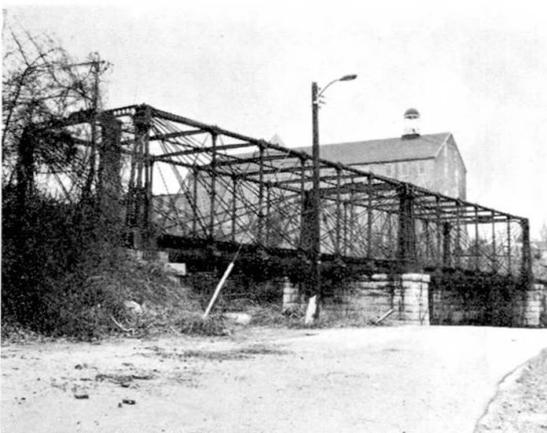
Fig.2. Bollman's Suspended & Trussed Bridge (1869) was relocated from a main line of the Baltimore & Ohio RR to service the mill at Savage, Maryland. It is the only known example of its type and facilitated the rapid expansion of early American railroads westward. Robert Vogel, Smithsonian Institution.

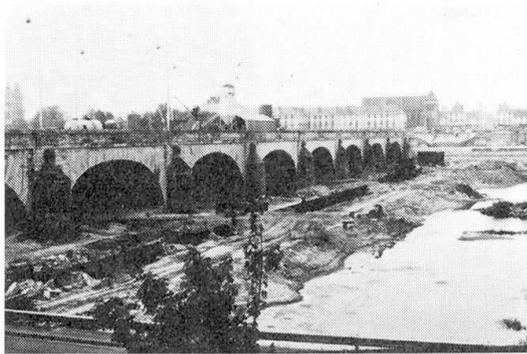
Photograph 5 : General view of cofferdam construction works.

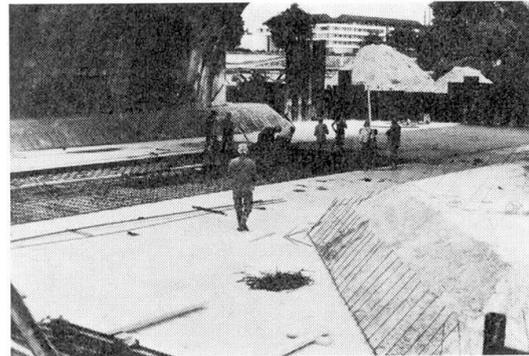
Photograph 6 : Slab casting.

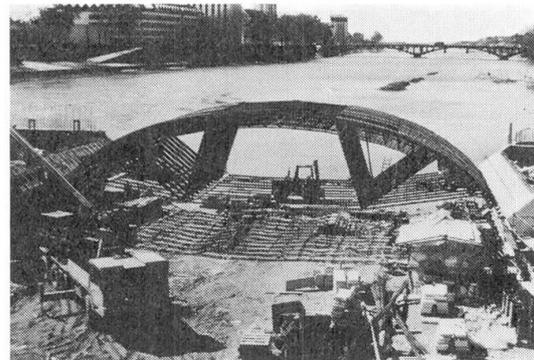
Photograph 11 : A centre of Tours' bridge.
