Zeitschrift: IABSE reports = Rapports AIPC = IVBH Berichte
Band: 39 (1982)

Rubrik: Session 1: Inspection, records and maintenance

SESSION 1

Inspection, Records and Maintenance

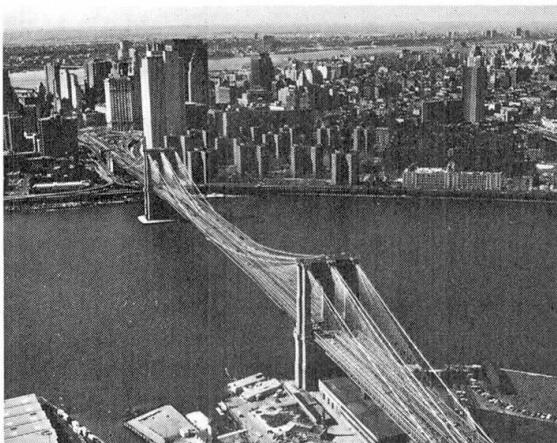
Fig.1. The Brooklyn Bridge, one of the most famous bridges in the world, celebrates its Centennial in 1983. Though no one would dream of replacing it, a cable corroded by pigeon dung snapped last year, killing a pedestrian; rehabilitation costs are estimated at \$105 million. Jack Boucher, HAER.

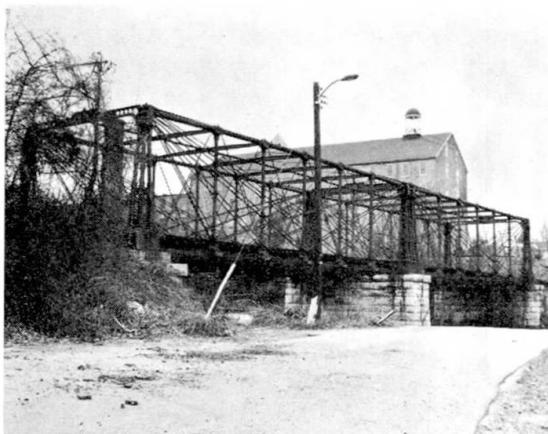
Fig.2. Bollman's Suspended & Trussed Bridge (1869) was relocated from a main line of the Baltimore & Ohio RR to service the mill at Savage, Maryland. It is the only known example of its type and facilitated the rapid expansion of early American railroads westward. Robert Vogel, Smithsonian Institution.

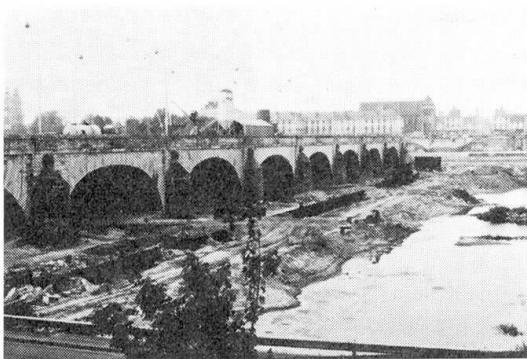
Photograph 5 : General view of cofferdam construction works.
