**Symposium on Civil Engineering Structure Management Brussels – Paris, 1981  
and An Example of an Ancient Bridge Rehabilitation**

This article first presents a summary of the Symposium in Brussels and Paris, which took place on April 13 – 17, 1981 and was dedicated to the civil engineering structure management. It further presents an example of a rehabilitation of a bridge from the 18th century, the Wilson bridge, in Tours.

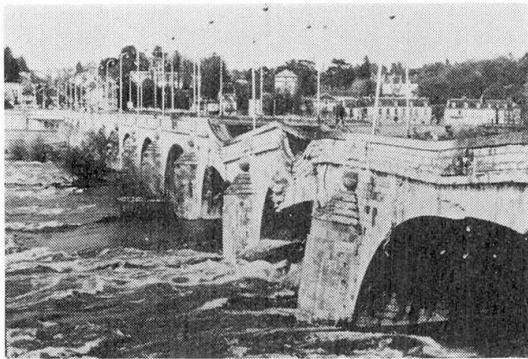
Then on April 9th, 1978, at 9.27 a.m., pier 2 sinks and brings down the upstream-faced part of the 2nd arch. At 2.15 p.m., the upstream-faced part of the 3rd arch collapses in turn. At 4.02 p.m., pier 2 sinks by one metre, and arches 2, 3 and 4 crash down. On April 10th, pier 4 sinks downstream, spans 5 and 6 fall and pier 5 tilts down. Finally, on May 3rd, pier 1's collapse induces span 1's fall. Most fortunately, there was no victim.

**Photographs 1 & 2 : The collapse of the bridge, on April 9th, 1978, at 4.02 p.m. (Photographs by Pierre Fitou – La Nouvelle République)**

The reason for this collapse was, once again, the removal of sand between the piers unprotected by adjoining wood piles, and the resulting transverse-force induced instability.
