## **Symposium on Civil Engineering Structure Management Brussels — Paris, 1981 and An Example of an Ancient Bridge Rehabilitation**

## AN EXAMPLE OF AN ANCIENT BRIDGE REHABILITATION : TOURS BRIDGE

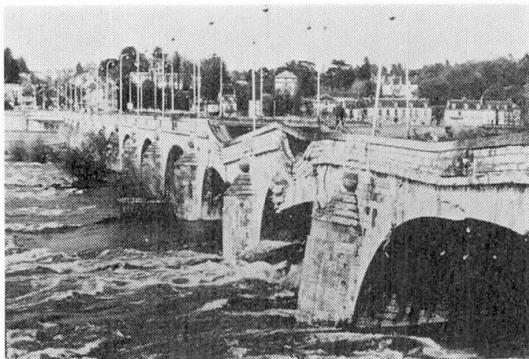
Then on April 9th, 1978, at 9.27 a.m., pier 2 sinks and brings down the upstream-faced part of the 2nd arch. At 2.15 p.m., the upstream-faced part of the 3rd arch collapses in turn. At 4.02 p.m., pier 2 sinks by one metre, and arches 2, 3 and 4 crash down. On April 10th, pier 4 sinks downstream, spans 5 and 6 fall and pier 5 tilts down. Finally, on May 3rd, pier 1's collapse induces span 1's fall. Most fortunately, there was no victim.

**Photographs 1 & 2 : The collapse of the bridge, on April 9th, 1978, at 4.02 p.m. (Photographs by Pierre Fitou – La Nouvelle République)**

The reason for this collapse was, once again, the removal of sand between the piers unprotected by adjoining wood piles, and the resulting transverse-force induced instability.

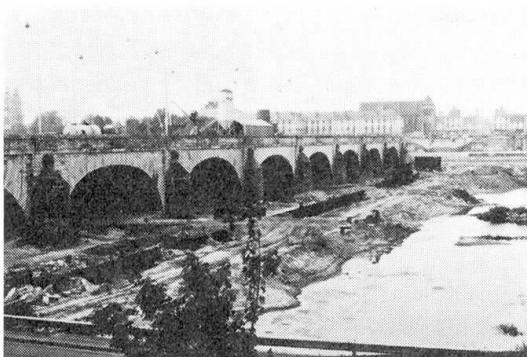
**Photograph 5 : General view of cofferdam construction works.**

After completion of this cofferdam, 40 metres wide and almost 300 metres long, and of the top slab, all the cavities under the piers were injected, even the small ones. The volume of injection could be reduced by a primary injection around each pier.

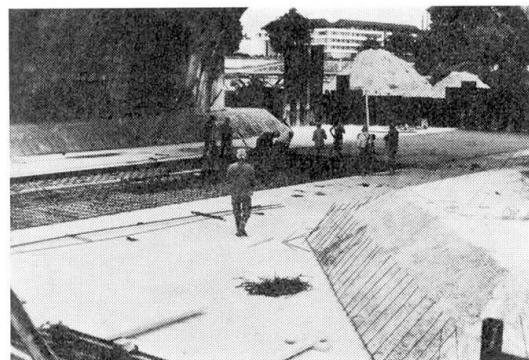
**Photograph 6 : Slab casting.**

An overall reinforced concrete slab, surrounding the piers, over the whole cofferdam, is intended to prevent the sand removal.
