## Strengthening of Building Structures — Therapy

### Carlo CESTELLI-GUIDI

### SUMMARY

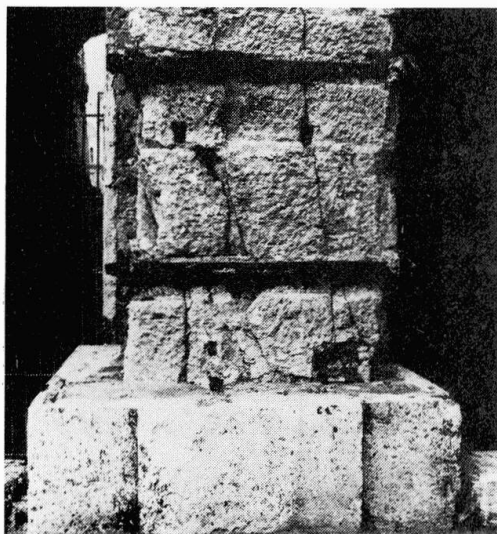
Fig. 19

Closed stirrups have been used in rectangular columns: their confining action is however much lower, as demonstrated for example by the case of the large stirrups used in the past for the rectangular pylons of the roman Colosseo (fig. 19). Cracking of the masonry has continued, so that recently the injection of cement and epoxy mortars has become necessary.

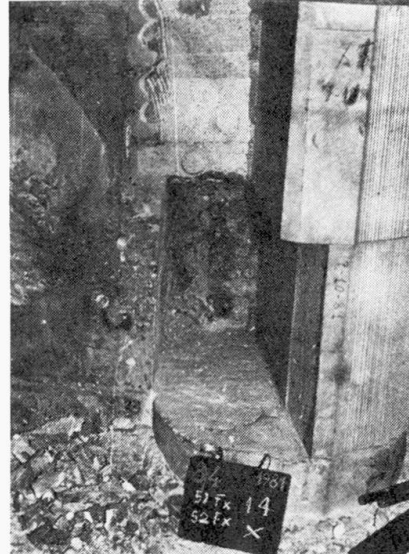
Fig. 23

The operations illustrated in fig. 23 have been carefully tested in order to ensure that the elastic deformations of the columns be conveniently limited.

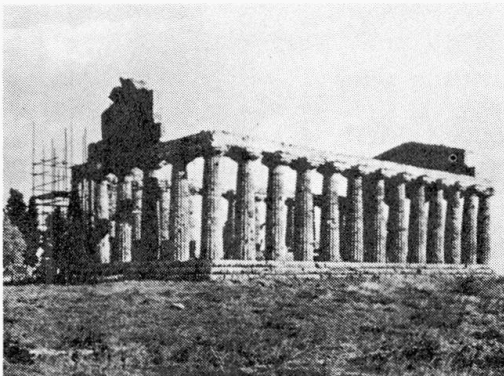
Fig. 24a

In the temple of ~~Cerere~~ Ceres at Paestum (fig. 24) the connection between vertical and horizontal elements has been ensured by drilling holes and inserting steel bars. The second example is given by the pylons of the Arena of Verona (fig 25) which have been prestressed vertically in order to stabilize the entire structure principally against horizontal actions: wind and earthquake.

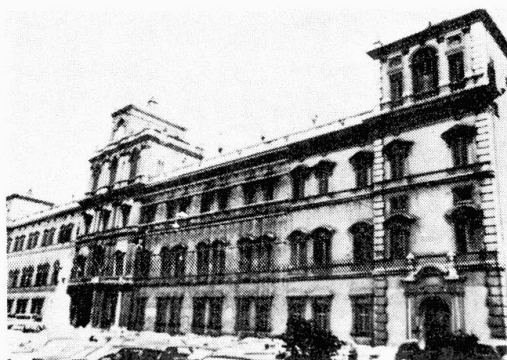
Fig. 35a

3.2 The differential settlements are obviously larger in case of nonhomogeneous subsoil. An example is provided by the Palazzo Ducale in Modena (fig. 35a), where a joint had to be inserted in correspondence to the variation of soil type (35b). In this case differential settlements were also due to subsidence phenomena. It is visible in the figure the cut crossing a vault (35c).

Differential settlements are quite likely in large buildings founded on soft soil, and the corresponding states of stress may well lead to cracks formation. The distress can be halted by introducing joints between parts the buildings.

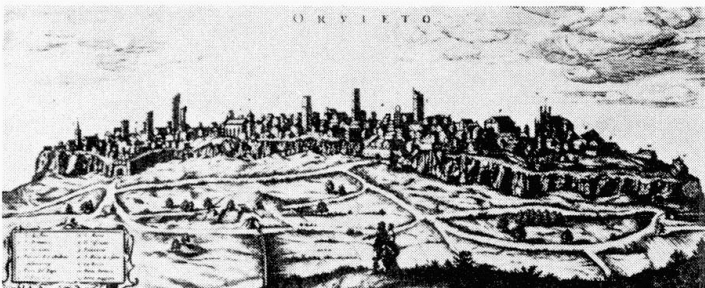
Fig. 66

the town of Orvieto, represented in the ancient print in fig. 66, which is located on a rocky cliff, like many towns in Italy. Given the presence of buildings on the edge, their conservation requires the prevention of further spalling and sliding of cliffs, whose degradation is due to both natural and human action.
