## Strengthening of Building Structures — Therapy

### Carlo CESTELLI-GUIDI

### SUMMARY

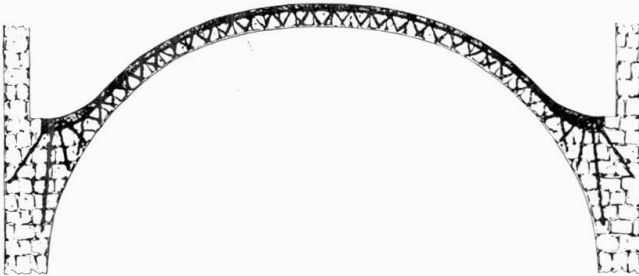
Fig. 10a

2.3.6 An example of use of a reinforcement mesh is that on the vault of the S. Silvestro church in Rome, illustrated in fig. 10.

Foundation settlements had induced cracks in the vaults, which are made of tuffaceous blocks only 30 cm thick. Reinforced holes cross the vault with the bars anchored in the topping gunite slab 10 cm thick shown in the figure.
