Zeitschrift: IABSE reports = Rapports AIPC = IVBH Berichte
Band: 46 (1983)

Artikel: Corrosion deterioration of reinforcement in concrete structures
Autor: Rasheeduzzafar / Dakhil, Fahd H. / Ahmad, Fouad A.
DOI: <https://doi.org/10.5169/seals-35845>

Corrosion Deterioration of Reinforcement in Concrete Structures

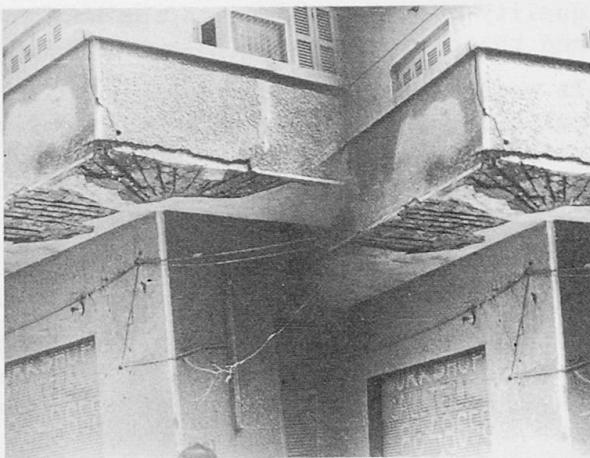
Figs. 5 and 6 show two structures which were condition surveyed and where concrete spalling has occurred as a direct outcome of visible heavy rebar corrosion. In each of these figures two pictures appear of the same structure on one photographic slide. Photogrammetric technique has been used for measuring the area of spalling and the results are shown in Table 2.

Fig. 6 Structure 2 showing concrete spalling due to rebar corrosion

Structure No.	Total area under observation (m ²)	Area showing cracking and initiation of Spalling (m ²)	Spalled Area (m ²)
1	4.65	1.19 (26%)	1.77 (38%)
2	4	0.13 (3%)	1.35 (34%)
