Zeitschrift: IABSE reports = Rapports AIPC = IVBH Berichte
Band: 46 (1983)

Artikel: Corrosion deterioration of reinforcement in concrete structures
Autor: Rasheeduzzafar / Dakhil, Fahd H. / Ahmad, Fouad A.
DOI: <https://doi.org/10.5169/seals-35845>

Corrosion Deterioration of Reinforcement in Concrete Structures

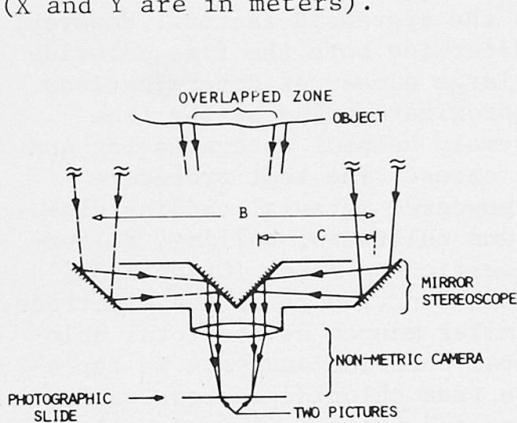
Fig.1: The mirror stereoscopic photographic arrangement

A simple pictorial technique has been developed to measure the three dimensions of an object at any distance from 5 to 20 meters. A mirror stereoscope is mounted in front of a normal hand-held non-metric camera as shown in Fig.1. Two pictures will appear on the same photographic slide. Since the two photographs are not taken from the same point the two pictures will not be exactly identical and a part of the object will appear twice.

Referring to Figs.1 and 2 the distance between the centers of the two apertures of the mirror stereoscope is the stereoscopic base B. This produces a parallax P_x which is the difference between the two locations of the same photographed object. It is equal to $(M - N)$ where M is the distance between the centers of the two pictures and N is the distance between the two object photographs. If the focal length of the camera is F and the coordinate system is chosen as shown in Fig.2, the space coordinates of a point object are computed from:

Nikon F3 with a normal 50mm lens was used in the present investigations. If it is focussed to infinity the minimum photographing distance, corresponding to a circle of confusion of 0.05mm, is 5m. The base B of the mirror stereoscopic adapter was chosen approximately to be 70cm. Experiments were carried out to find with high precision the most probable values of the three constants, namely; the focal length F, the base B of the mirror stereoscope and the distance between the centers of the slide stereopairs M. A test area was established where distances to 25 scales were measured precisely with a steel tape. The total length of each scale was 4 meters and residual equations are formed from equations (1), (2) and (3). The required unknowns have been determined from the least squares solution and found to be: $F = 4.975\text{mm}$, $B = 70.740\text{mm}$ and $M = 18.641\text{mm}$. These values are used in Equations 1, 2 and 3 to determine the object dimensions. Experiments show that the standard error (in mm) of the object dimensions in a plane perpendicular to the camera axis is given by $4 \times X \times Y$ (X and Y are in meters).

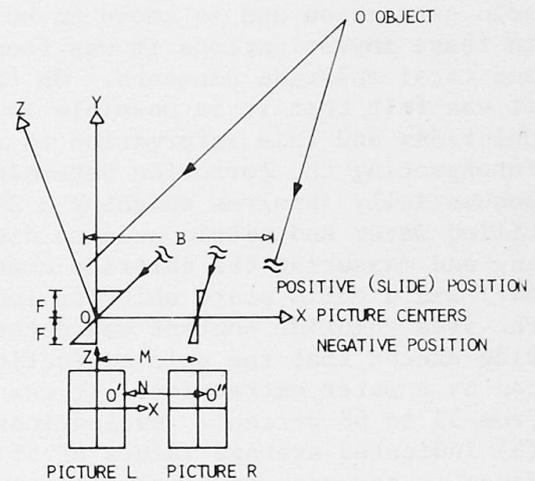
Fig.2: The geometry of the photogrammetric technique

$$Y = \frac{FB}{P_x} \quad (1)$$

$$X = \frac{Y}{F} x \quad (2)$$

$$Z = \frac{Y}{F} z \quad (3)$$

where x and z are the photo-coordinates of the object in the left photograph. The first equation is used in the determination of the scale factor $S=Y/F$ for a body object at an average distance of Y which includes the distance C between the two parallel mirrors. The components of the object dimensions can be obtained from the first derivatives of equations (1) to (3).

$$dY = \frac{F}{(M - N)} S \, dP_x \quad (4)$$

$$dX = S \, dx \quad (5)$$

$$dZ = S \, dz \quad (6)$$

dP_x , dx and dz can be measured from the pictures by using a special 0.1mm optical scale. If the photographic slide is placed on an illuminated table the measurements can be conveniently carried out to the nearest 0.02mm by estimation.

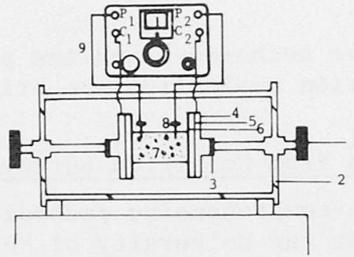
Fig.3: Electrical Resistivity Measurement of Concrete.

The electrical resistivity of concrete ranges from around 10^3 ohm-cm when saturated to 10^{11} ohm-cm when oven dried. Rebar corrosion is an electrochemical reaction necessitating a potential difference along the bar in order to activate a current from the anode to the cathode. The magnitude of the corrosion current is primarily controlled by the resistivity of the concrete. High resistivity reduces current and also the probability of corrosion. Resistivity measurements on concrete samples were made according to a set up shown in Fig.3, using an integrated and compact instrument commercially available as Nilson 400. The instrument is a 4 terminal null balancing ohm-meter (0.01 ohm to 1.1 meg-ohms) which generates a low voltage 97 HZ square wave current between the binding posts C_1 and C_2 (Fig.3). The detector with its input connected between binding posts P_1 and P_2 is only responsive to 97 HZ and remains insensitive to any spurious potentials or stray currents. This eliminates a frequently occurring source of error. Copper pins were inserted in concrete cores and were directly connected to binding posts P_1 and P_2 for voltage drop measurements. The cores were held horizontally in a steel frame with end plates made of copper and covered with a cloth pad which was kept wetted with water. The copper plate-wet cloth combination ensured a uniform distribution of current density across the face of the core.

- 1. Screw for gripping the block
- 2. Steel frame
- 3. Insulator
- 4. Steel plate
- 5. Copper plate
- 6. Cloth pad
- 7. Concrete core
- 8. Copper pins inserted in concrete cores
- 9. Nilson 400 resistivity meter

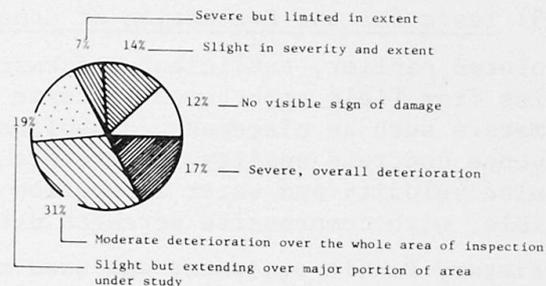
Fig.4: Classification of condition of 168 observations from concrete structures located in Eastern Saudi Arabia.

Condition surveys accompanied by comprehensive recordings and photographic documentation were carried out at the University of Petroleum and Minerals on 42 concrete framed structures located in Al-Khobar, Dhahran, and Dammam habitations along the Gulf coast in the Eastern Province of Saudi Arabia. The objectives were limited to an establishment of the boundaries and parameters of the concrete deterioration problem and an investigation of the relative importance of the operative causal factors. The results show an alarming condition of structures constructed 15-20 years hence. The surveyed structures were constructed during the years 1960-64. Although the general condition of each structure was recorded as comprehensively as possible, the detailed deterioration recordings were made only on concrete exposed to the ambient environment. This made it possible to hold at least two variables - age and inservice exposure - reasonably constant in order to study the effect of other variables on concrete deterioration. Fig.4 classifies on a six point scale the general condition rating of 168 study areas from these 42 structures. The figure shows that 48% of the observations group in the classifications 5 and 4 which corresponds to a very unsatisfactory condition range of the rating and about 19% in classifications 3 which is also far from satisfactory. Only 36% manifest slight or no deterioration. Illustrations of classifications 4 and 2 are shown in Figs.5 and 6 respectively.

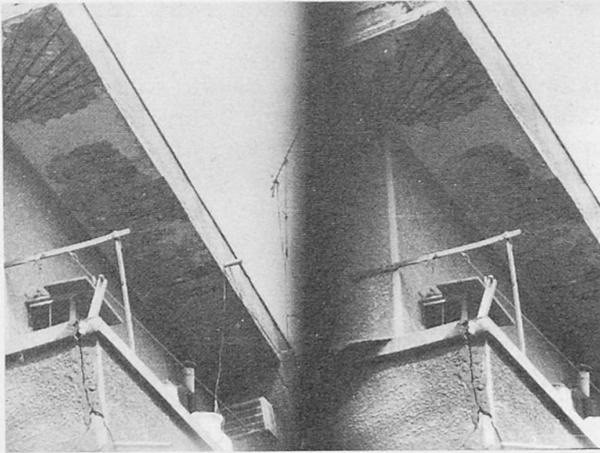
Figs. 5 and 6 show two structures which were condition surveyed and where concrete spalling has occurred as a direct outcome of visible heavy rebar corrosion. In each of these figures two pictures appear of the same structure on one photographic slide. Photogrammetric technique has been used for measuring the area of spalling and the results are shown in Table 2.

Fig. 5 Structure 1 showing concrete spalling due to rebar corrosion

| Structure No. | Total area under observation (m ²) | Area showing cracking and initiation of Spalling (m ²) | Spalled Area (m ²) |
|---|--|--|---|
| 1 | 4.65 | 1.19 (26%) | 1.77 (38%) |

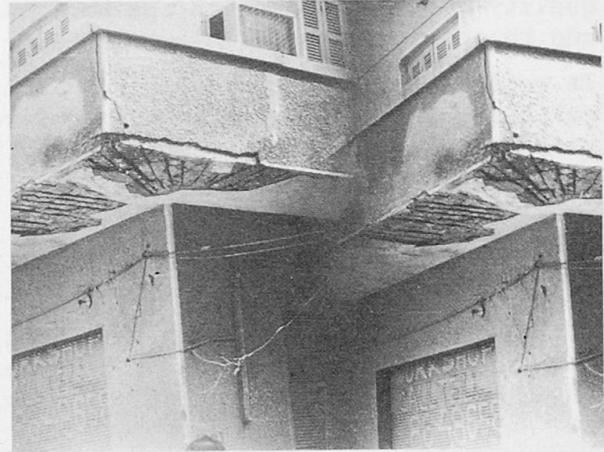
Fig. 6 Structure 2 showing concrete spalling due to rebar corrosion

| Structure No. | Total area under observation (m ²) | Area showing cracking and initiation of Spalling (m ²) | Spalled Area (m ²) |
|---|--|--|---|
| 2 | 4 | 0.13 (3%) | 1.35 (34%) |

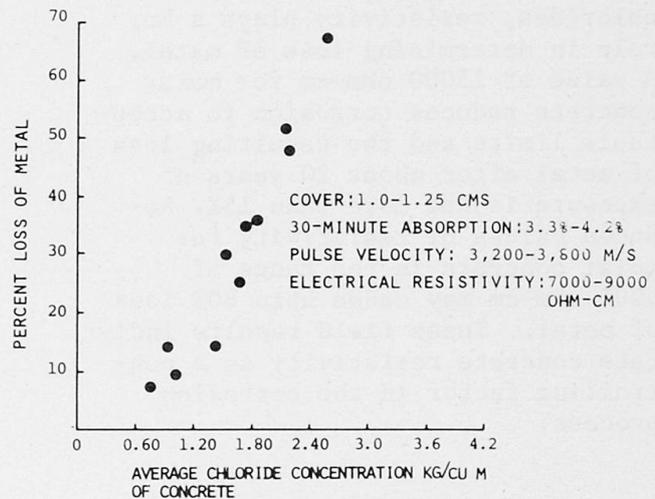
Fig.7: Relationship between Chloride content and metal loss.

Concrete cores from exposed slabs of 24 structures 17-22 years old were obtained for laboratory analysis of chloride levels at the steel-concrete interface. Fragments of concrete were removed from the steel-concrete interface and were analyzed for chloride content. For each sample six to ten points were obtained and standard deviations worked out for this data. Steel corrosion was measured by removing from each specimen six to ten 7.5cm pieces of rebars. The loose rust was removed by an emery paper and the weight loss was measured. The results of this analysis for selected samples pertaining to 1.25cm cover are plotted in Fig.7. As concrete quality, cover, electrical conductance characteristics, and the soluble chloride content are the four supposedly dominant parameters affecting corrosion, samples were selected for the plot which enabled the first three variables to be held reasonably constant. Understandably, from among one hundred available observations only a few met the aforesaid criterion (Fig.7). Concrete

quality was ascertained on the basis of a 30 min. water absorption test (BS 1881) and the pulse velocity measurements.

- (i) The chloride ion and its concentration in concrete have a very definite influence on corrosion deterioration.
- (ii) For a 1.25cm cover the threshold chloride concentration for the exposure conditions of Eastern Saudi Arabia is about 0.6 kg/m^3 . This value is close to the concentration of chlorides permitted by ACI Committee 201 on Durability of Concrete.
- (iii) Gulf concretes generally show a high chloride concentration.

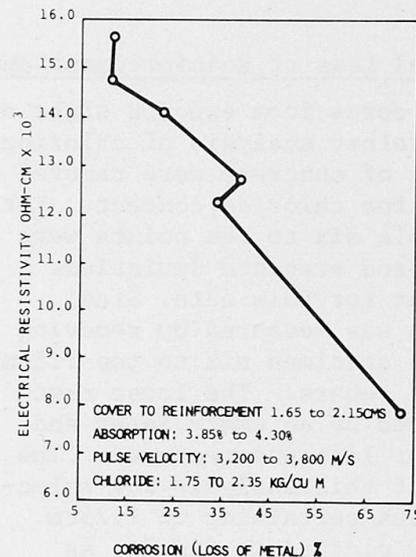
Fig.8: Relationship between electrical resistivity of concrete cored from field structures and metal loss.

The significant effect of concrete resistivity on corrosion is seen in Fig.8 where the loss of metal is plotted against resistivity for narrow variations in the values of cover to reinforcement, chloride content and concrete quality. The results show that given sufficient chlorides, resistivity plays a key role in determining loss of metal. A value of 15000 ohm-cm for moist concrete reduces corrosion to acceptable limits and the resulting loss of metal after about 20 years of exposure is not more than 15%. Reduced values of resistivity for moist concrete in the range of 6000 ohm-cm may cause upto 80% loss of metal. These field results indicate concrete resistivity as a controlling factor in the corrosion process.

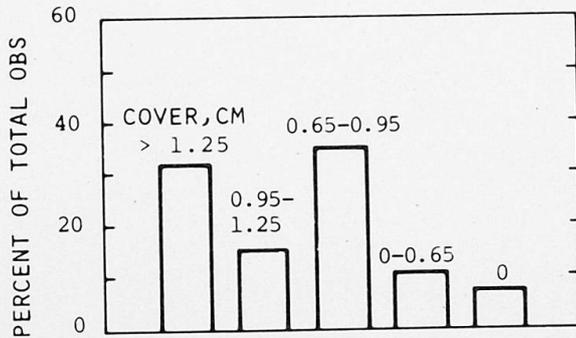
Fig.9: Distribution of concrete cover in spalled concrete

In the condition survey carried out on 42 concrete framed structures 15-20 years old, 76 spalls of varying dimensions and severity were observed during 168 observations covering approximately 112 sq.m. of concrete area. In 68% of the observed spalls the thickness of concrete cover was less than 1.25 cms, in 53% it was less than 0.95 cms and in 18 observations it was less than 0.65 cms. There were 7 cases (9.2%) where there was almost no cover to steel reinforcement. Fig.9 shows the distribution of concrete cover observed in spalled concrete. Fig.10 is the typical presentation of cover measurements on floor slabs with partial spalling. The spalls were found to be invariably located in regions of insufficient concrete cover.
