Strengthening of Wooden Ceiling Constructions

Josef POSTULKA

Civil Eng.
Inst. for Culture-building Design
Bratislava, CSSR

The loading capacity and the stiffness of wooden ceiling constructions in historical buildings is usually not sufficient for modern demands. A method for strengthening of such wooden ceilings is recommended by coupling the wooden beams with an additional reinforced-concrete slab over them. After this strengthening the loading capacity and the stiffness increases cca 4x.

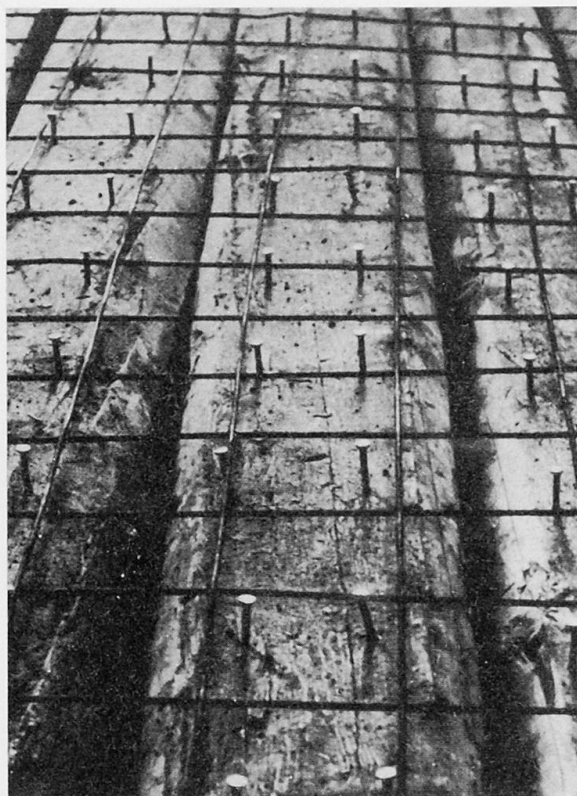
In figure 3 are the wooden beams tightly together, and in figure 4 there is the same ceiling under strengthening operation. The surface of the old wooden ceiling gets coupling elements such as steel nails driven in distances fixed by statical analysis. The nails stick out of the surface cca 40 mm.

Fig. 4. The strengthening of a wooden ceiling under construction

The nails are driven in by an electric percussion drill with a special inserted tool head in order to let the nails stick out of the surface with 40 mm. Fig. 4. Over the nails we lay down the wire net and the concrete slab can be made.

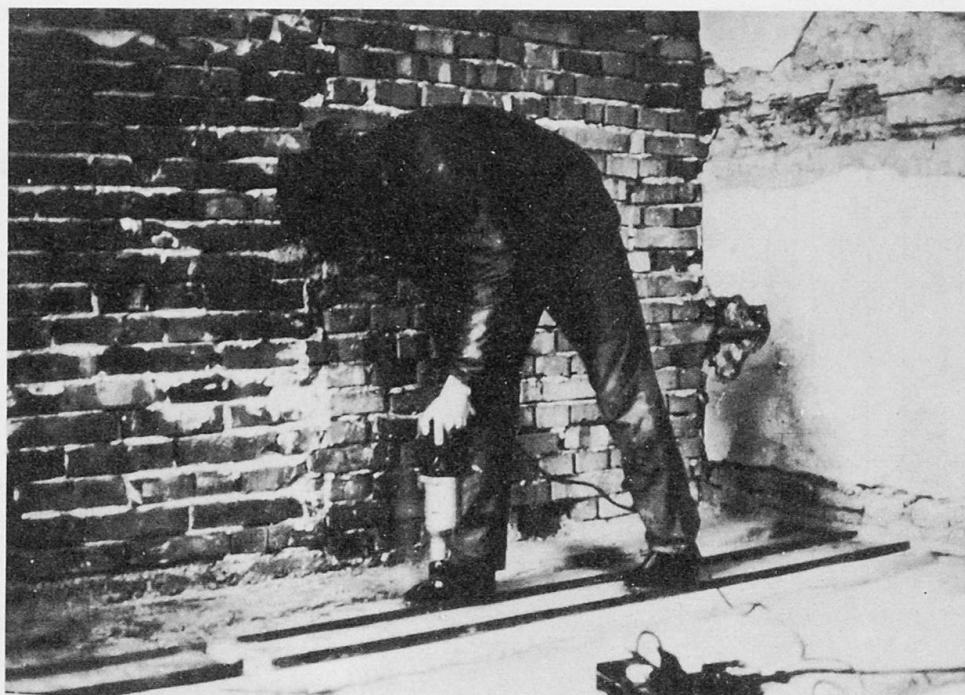
For the rough drilling we use a drilling template made of a thin perforated steel sheet. Fig. 6. The perforation of the template is made in distances ordered by the statical analysis.

Fig. 6. Rough drilling with a drilling template

After cleaning of the ceiling surface and after the chemical protection of wood by penetration it is necessary to rough drill the holes for the nails in the upper surface of the wooden ceiling. The depth of the holes has to be more than a half length of the nails driven in.
