## Strengthening of Wooden Ceiling Constructions

### Josef POSTULKA

Civil Eng.  
Inst. for Culture-building Design  
Bratislava, CSSR

The loading capacity and the stiffness of wooden ceiling constructions in historical buildings is usually not sufficient for modern demands. A method for strengthening of such wooden ceilings is recommended by coupling the wooden beams with an additional reinforced-concrete slab over them. After this strengthening the loading capacity and the stiffness increases cca 4x.

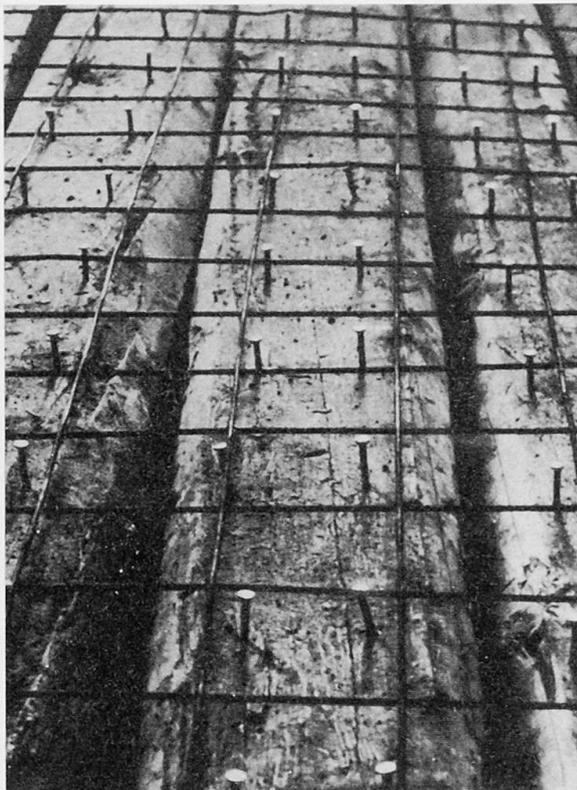
In figure 3 are the wooden beams tightly together, and in figure 4 there is the same ceiling under strengthening operation. The surface of the old wooden ceiling gets coupling elements such as steel nails driven in distances fixed by statical analysis. The nails stick out of the surface cca 40 mm.

Fig. 4. The strengthening of a wooden ceiling under construction

The nails are driven in by an electric percussion drill with a special inserted tool head in order to let the nails stick out of the surface with 40 mm. Fig. 4. Over the nails we lay down the wire net and the concrete slab can be made.

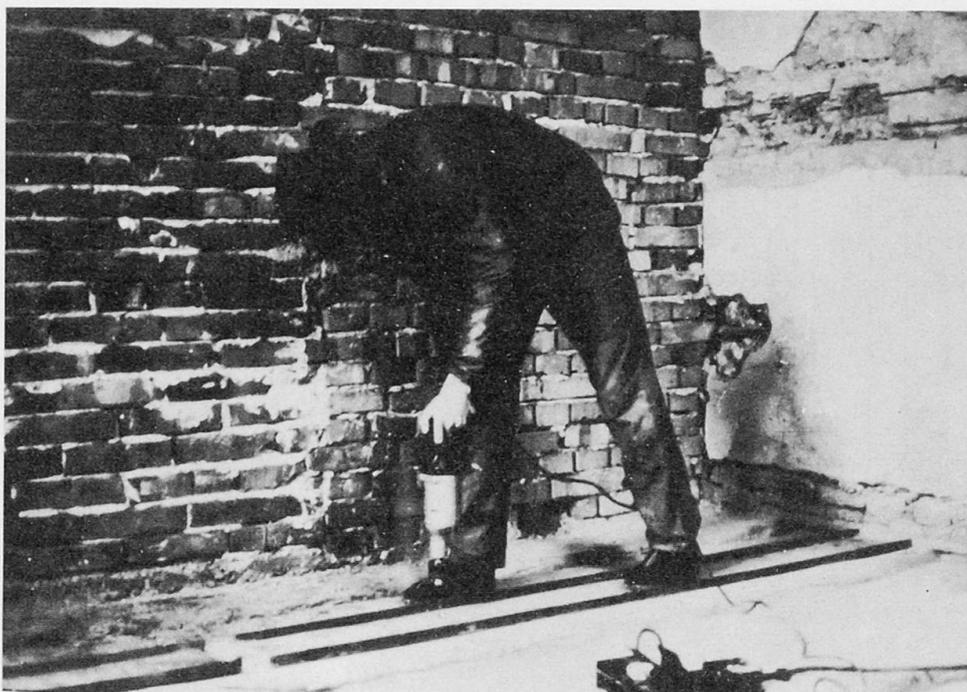
For the rough drilling we use a drilling template made of a thin perforated steel sheet. Fig. 6. The perforation of the template is made in distances ordered by the statical analysis.

Fig. 6. Rough drilling with a drilling template

After cleaning of the ceiling surface and after the chemical protection of wood by penetration it is necessary to rough drill the holes for the nails in the upper surface of the wooden ceiling. The depth of the holes has to be more than a half length of the nails driven in.
