Zeitschrift: IABSE reports = Rapports AIPC = IVBH Berichte
Band: 46 (1983)

Rubrik: Session 2: Inspection and monitoring

SESSION 2

Inspection and Monitoring

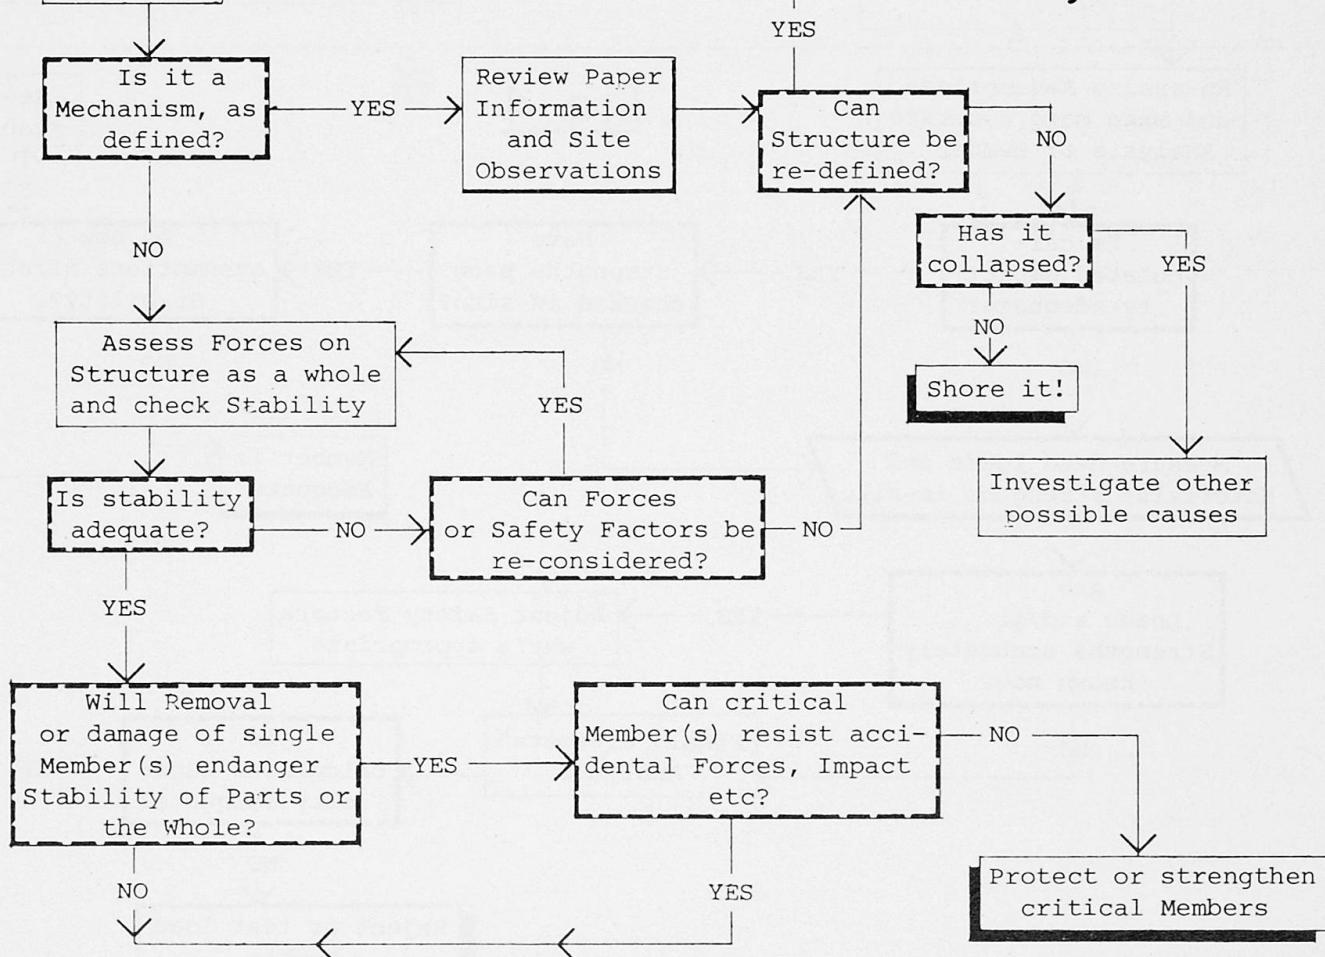
**Fig. 2**

Fig. 2 shows the processes which may be involved in ensuring that the structure is a stable configuration and not liable to progressive collapse in case of relatively minor accidental damage. It is important here, as elsewhere in appraising, to choose a mathematical model which not only is easily understood, in terms of stability, but also takes advantage of such physical features, which in ordinary design might be ignored but which, in the actual building, contribute significantly to stability (eg. infill brickwork panels in a framed structure).

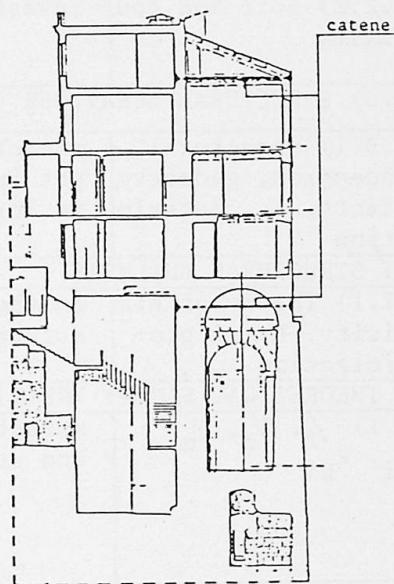
Fig. 5 - The emergency interventions.

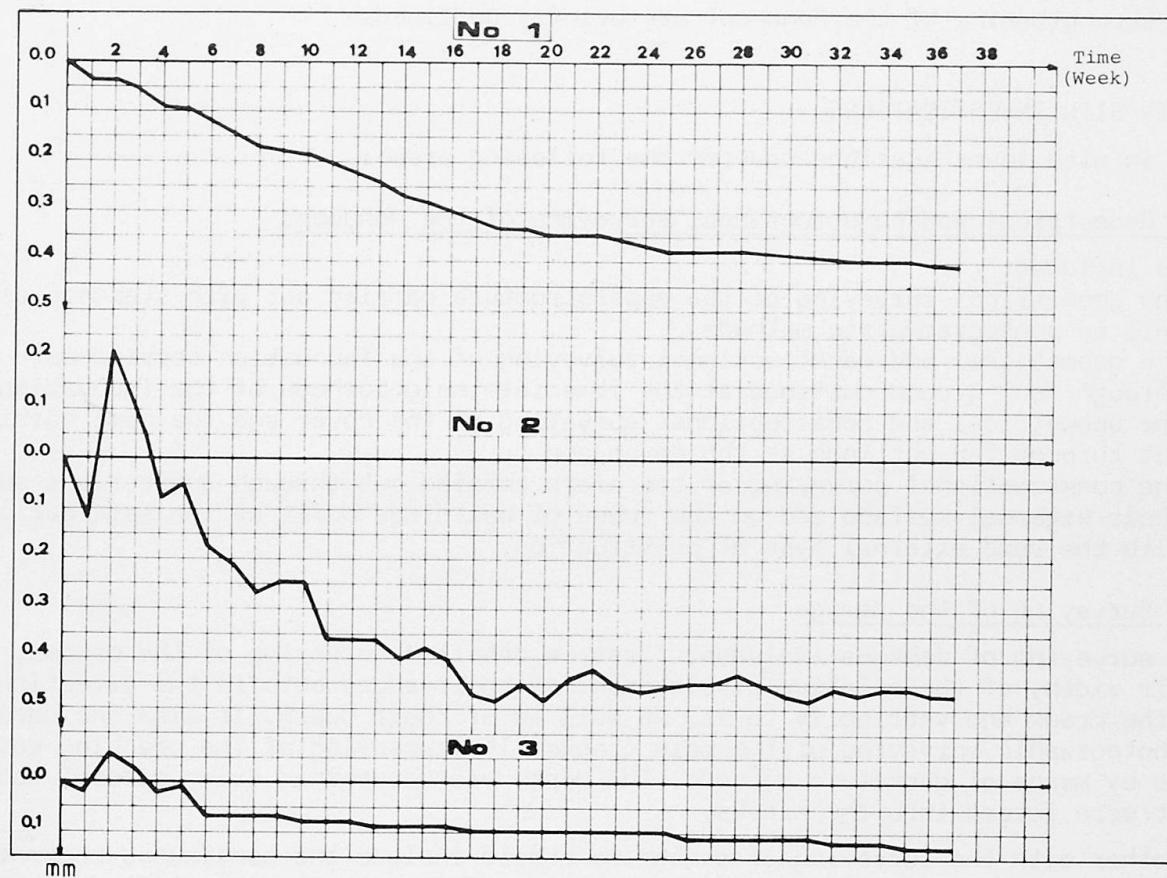
Fig.3 Variation of crack width with time

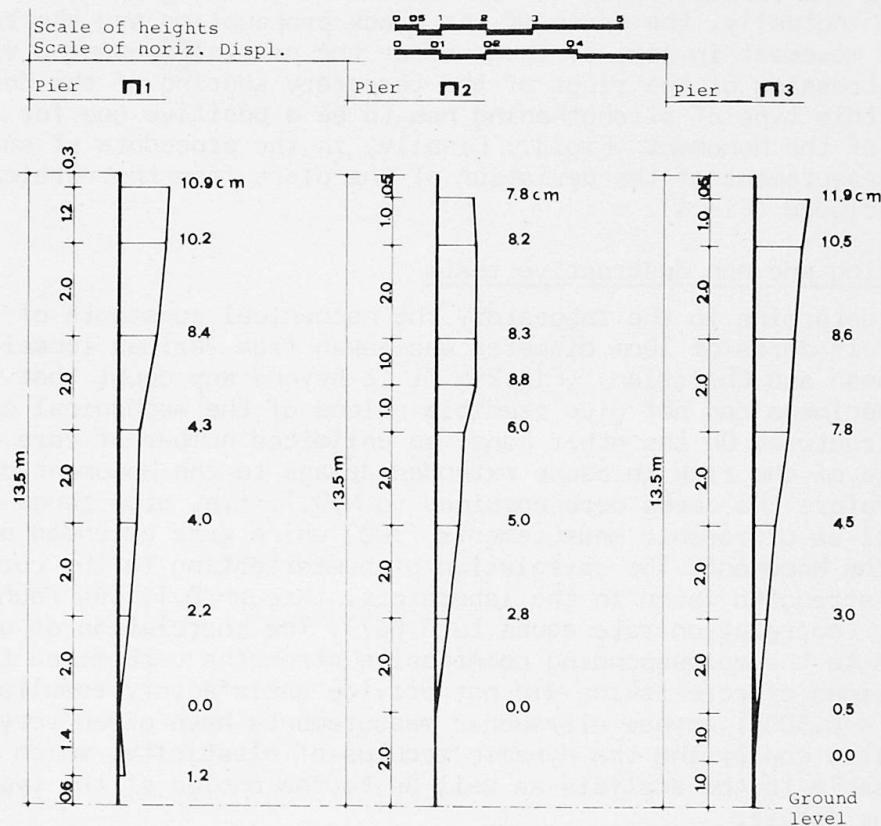
Fig.4 Horizontal displacements of the piers

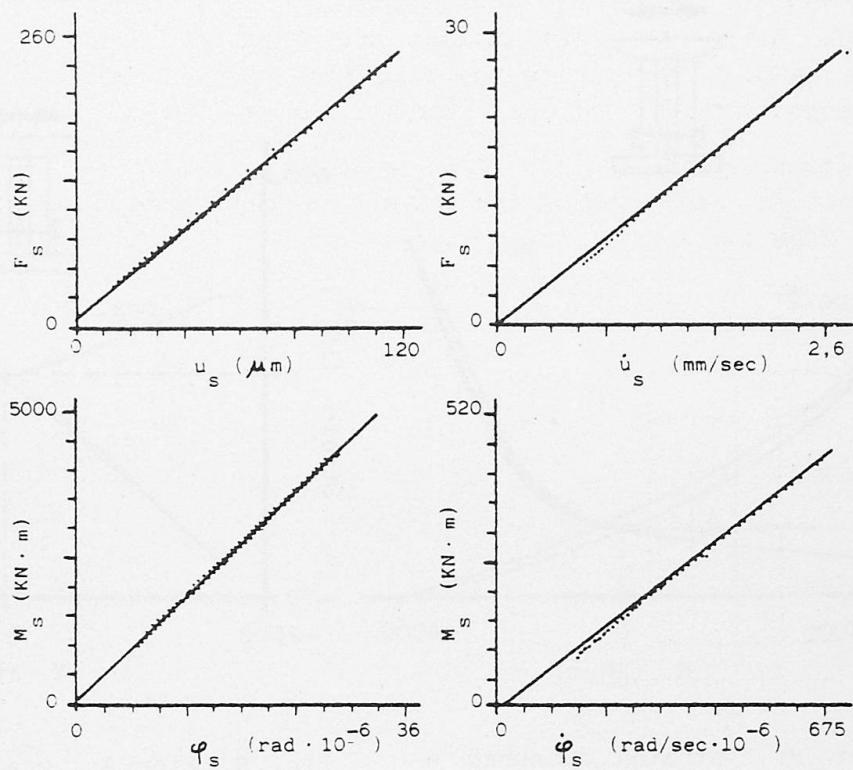
Fig. 4 Experimental correlation between applied loadings and foundation motions.

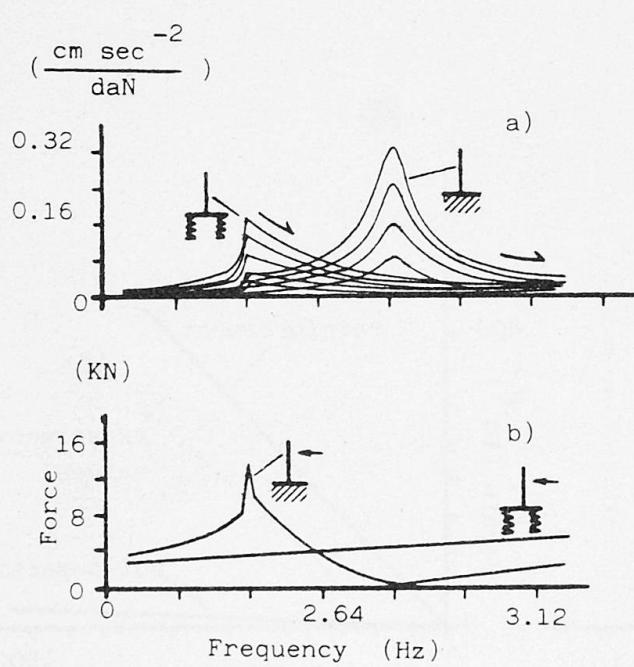
Fig. 5 Pier A: transfer functions (a) and exciting forces (b) for actual and "clamped" pier.

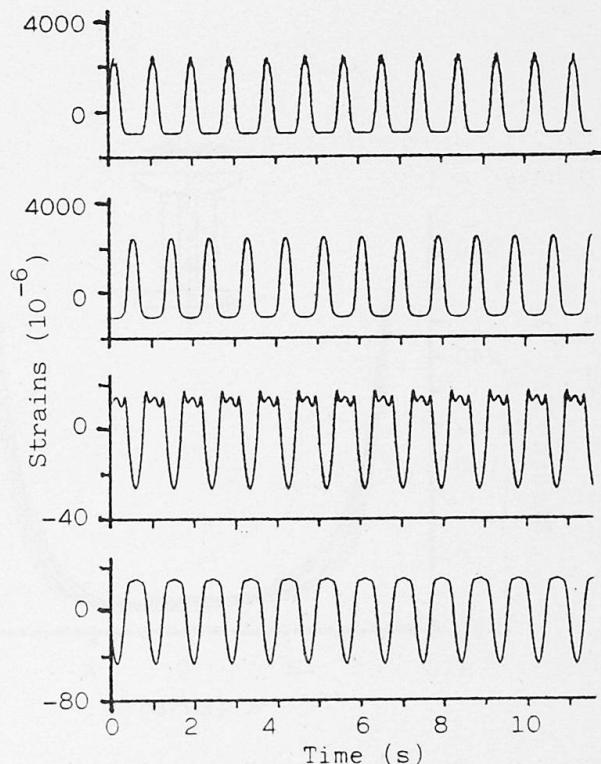
Fig. 6 Pier B: examples of strain behaviour showing contact of crack edges with shocks.

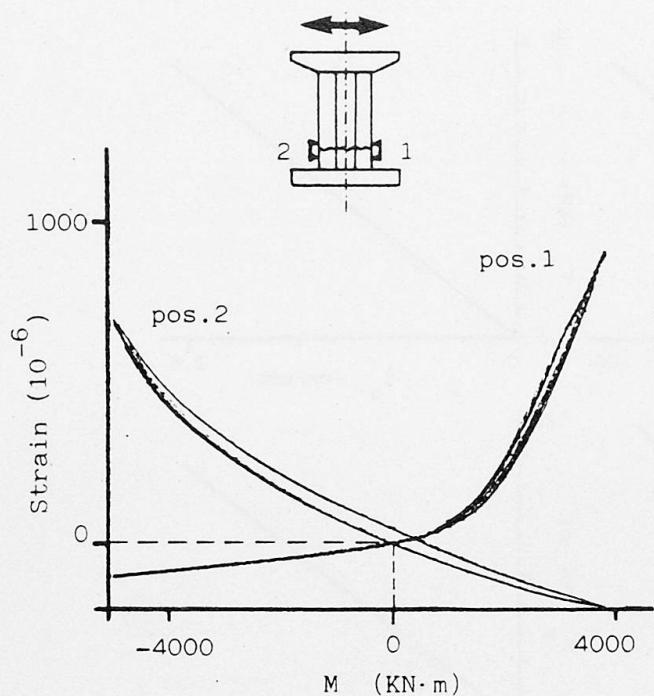
Fig. 7 Pier B: strains measured across cracks versus overturning moment. The non symmetric behaviour of the crack openings is clearly shown.

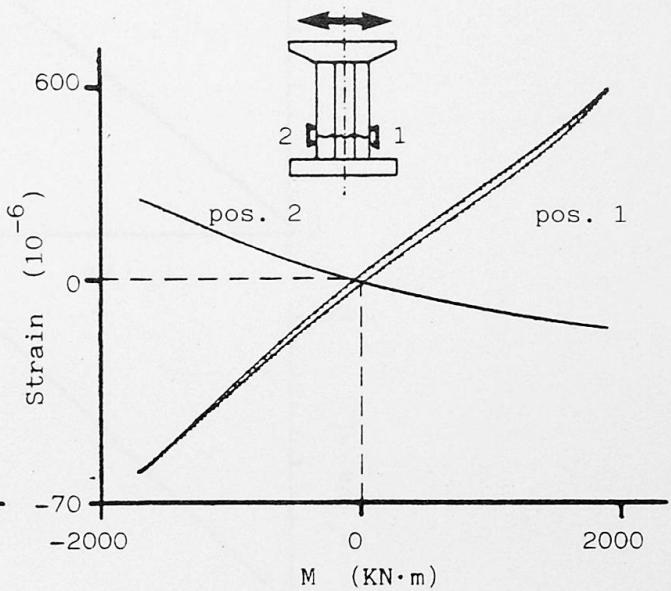
Fig. 8 Pier A: crack opening versus overturning moment. Position 1 shows mobilization of reinforcement in compression.

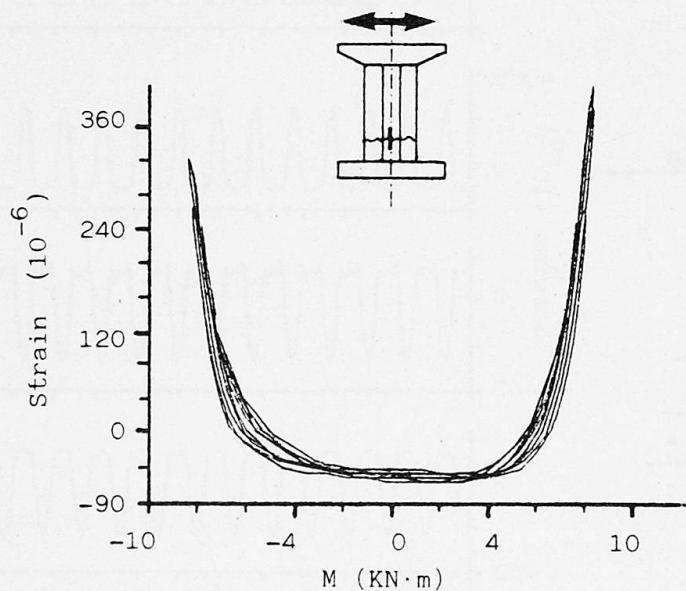
Fig. 9 Pier B: strains measured versus overturning moment across a crack on the "neutral axis" of the shaft.

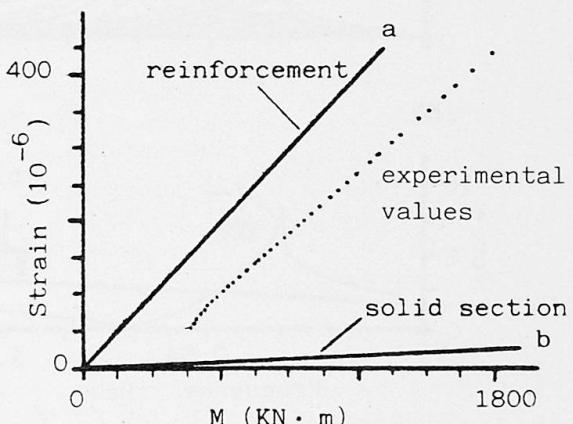
Fig. 10 Maximum strains versus overturning moment.

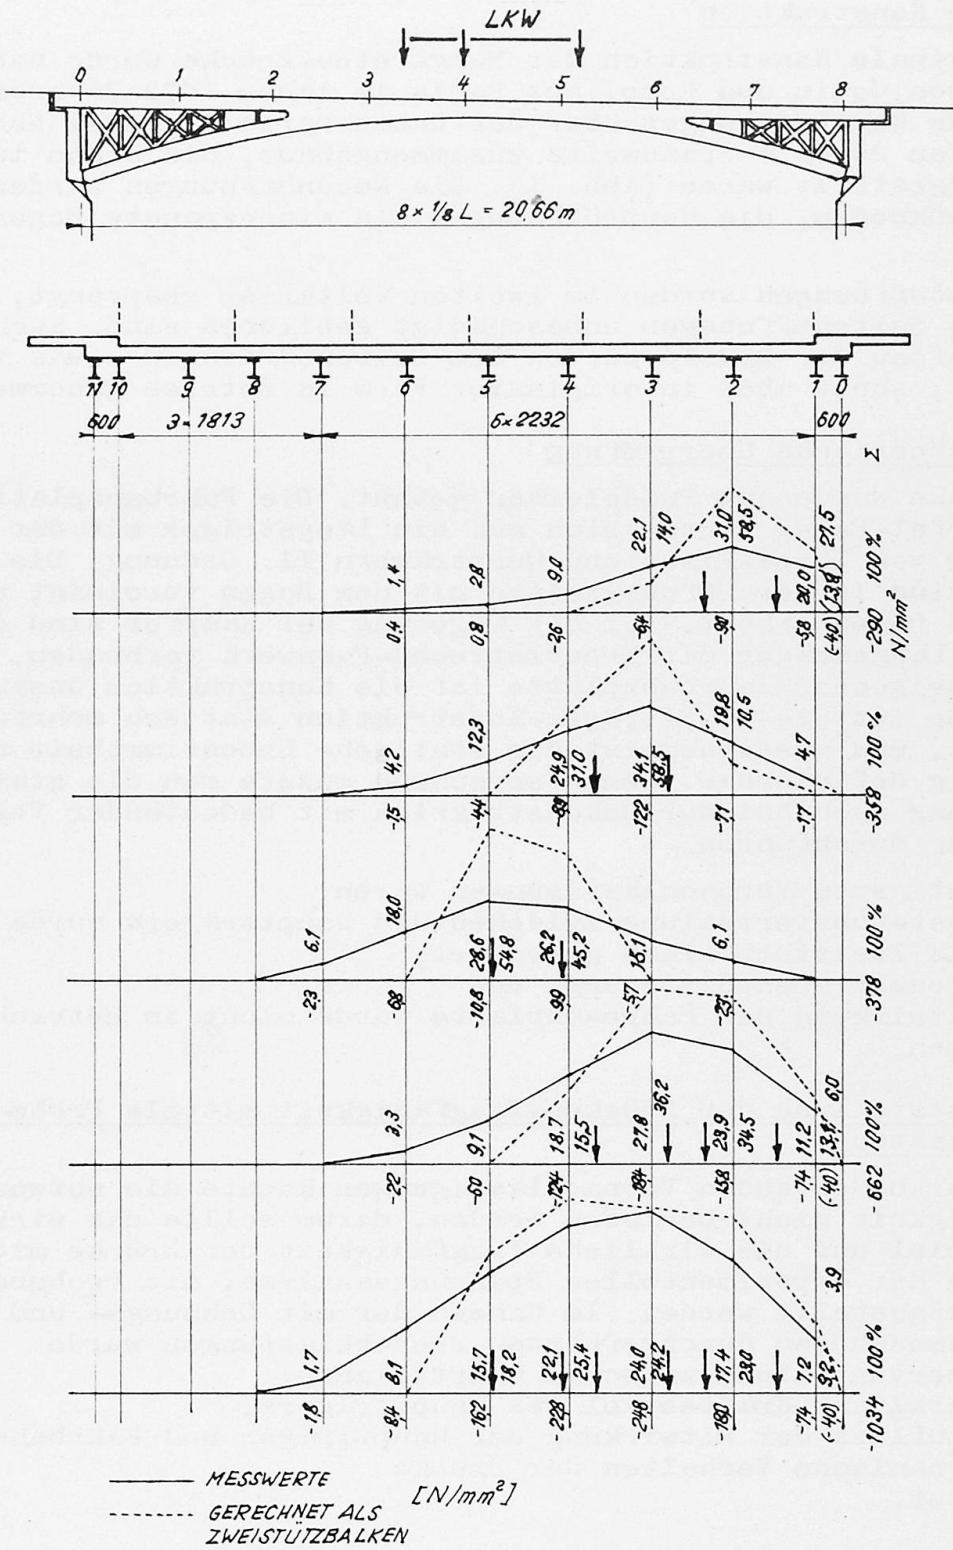
Abb. 2. Spannungen auf dem unteren Gurtblech der Bogenträgern in dem Viertelquerschnitt

Die Untersuchung wurde mit in den Bogenvierteln auf den unteren Gurt aufgeklebten Dehnungsmess-Streifen durchgeföhr. Die Position der in der Brückenhälfte stehenden LKW wurde in Querrichtung verändert. Dehnungen, bzw. Spannungen an den Hauptträgern deren Proportion die Erfassung der tatsächlichen Querverteilungs-umständen ermöglichte, wurden inzwischen gemessen.

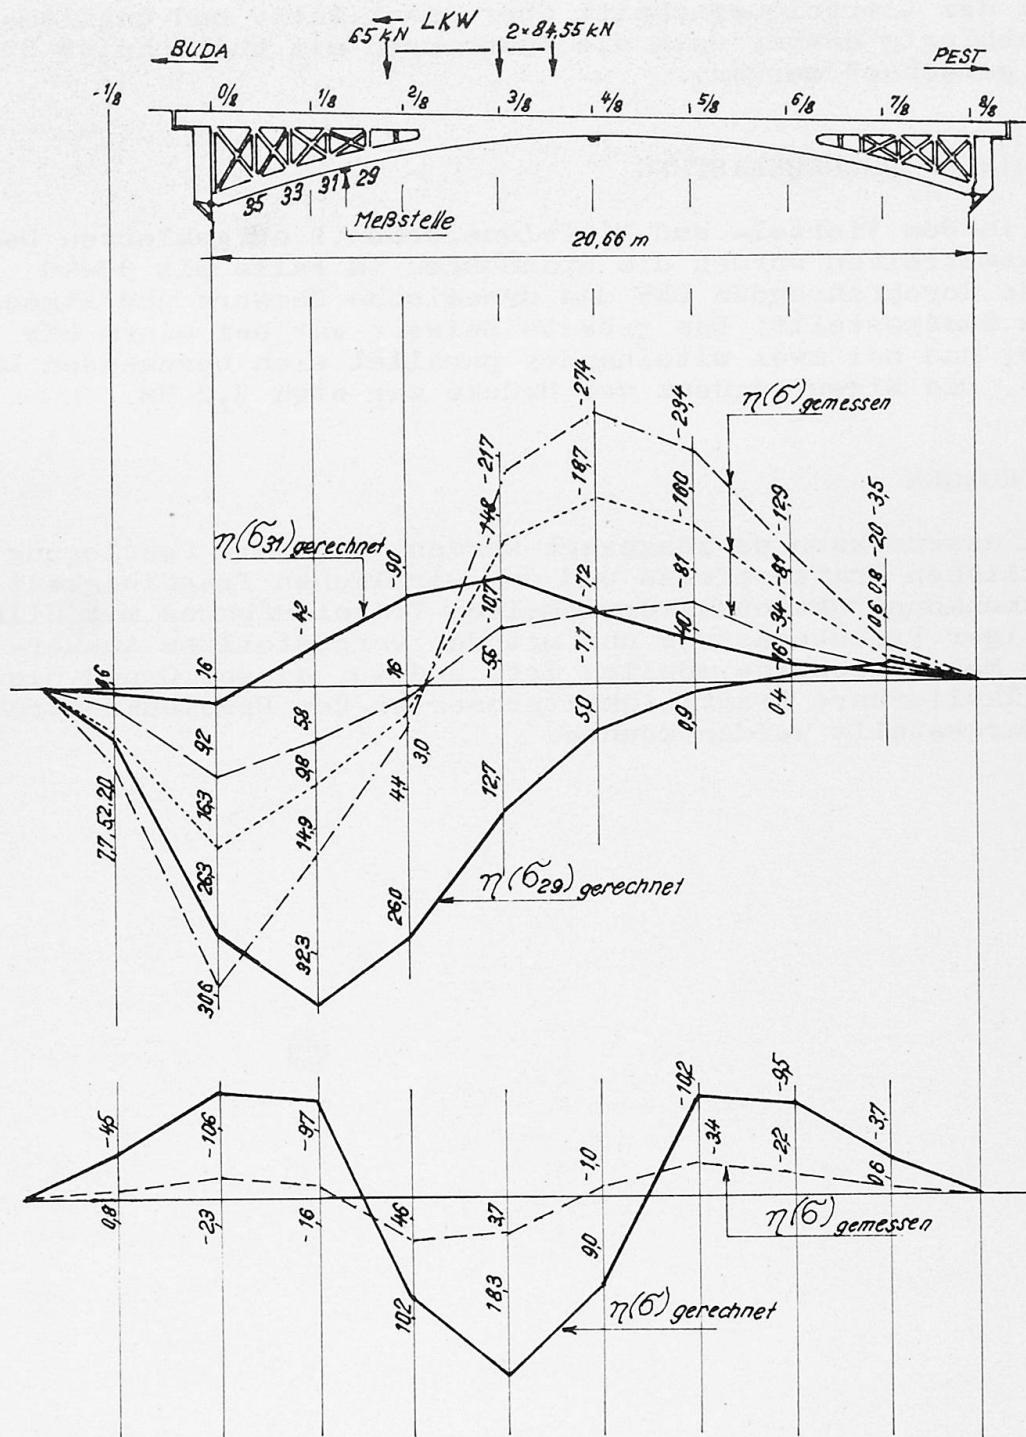
Abb. 4. Gerechnete und gemessene Lastenzug-Einflusslinie der Randfaser-Spannungen (N/mm^2) in dem Viertel- und Mittelquerschnitt der Bogenbrücke

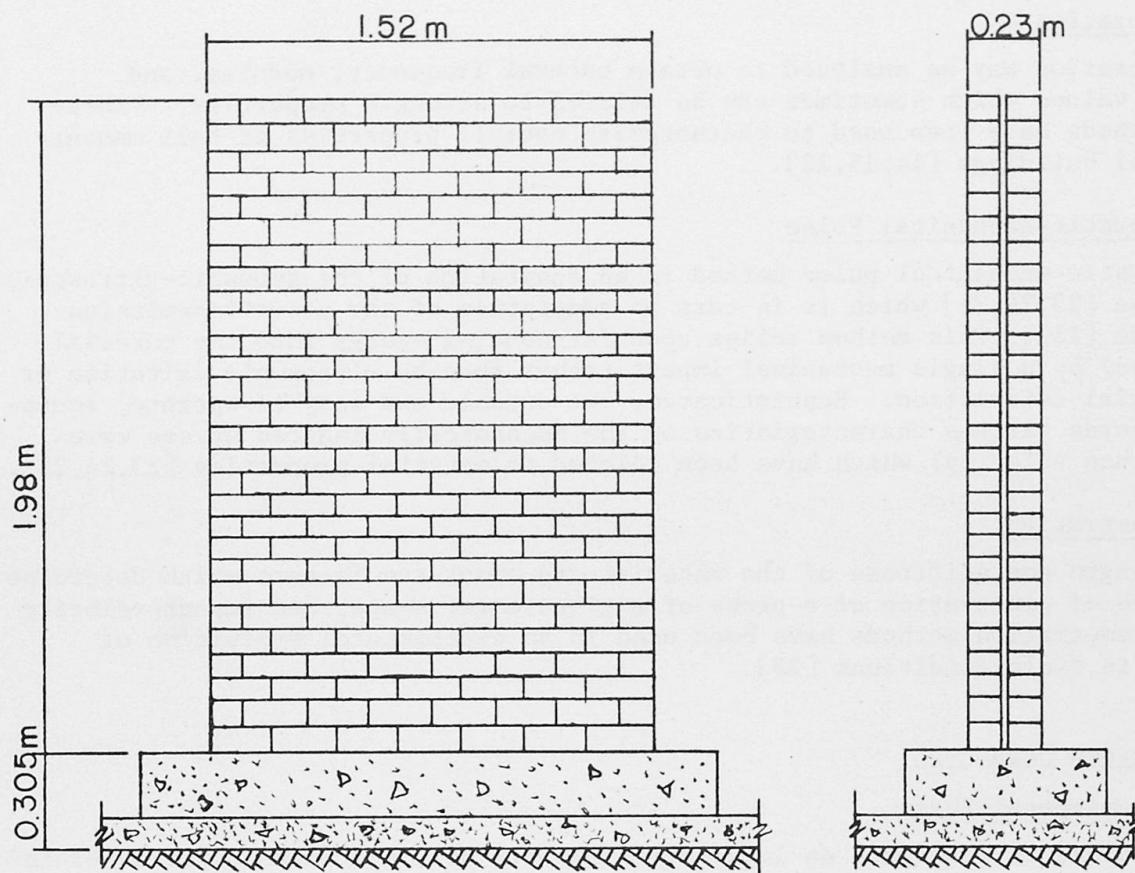
FIGURE 1 - BRICK MASONRY WALL SPECIMEN

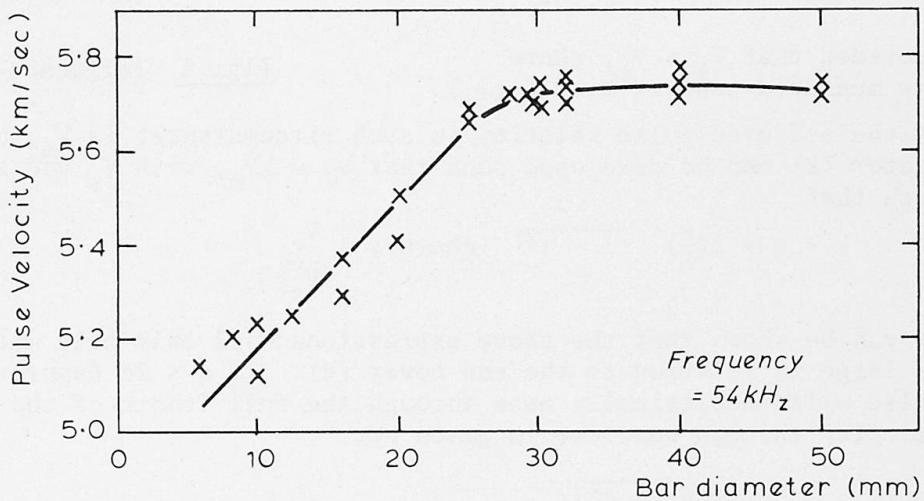
Fig. 3 Results for bars in air

These values are plotted in Fig. 3 for transducers with a frequency of 54 kHz which is the type most commonly used for insitu concrete investigations. Measured values using a frequency of 82 kHz were found to be approximately 2% higher.

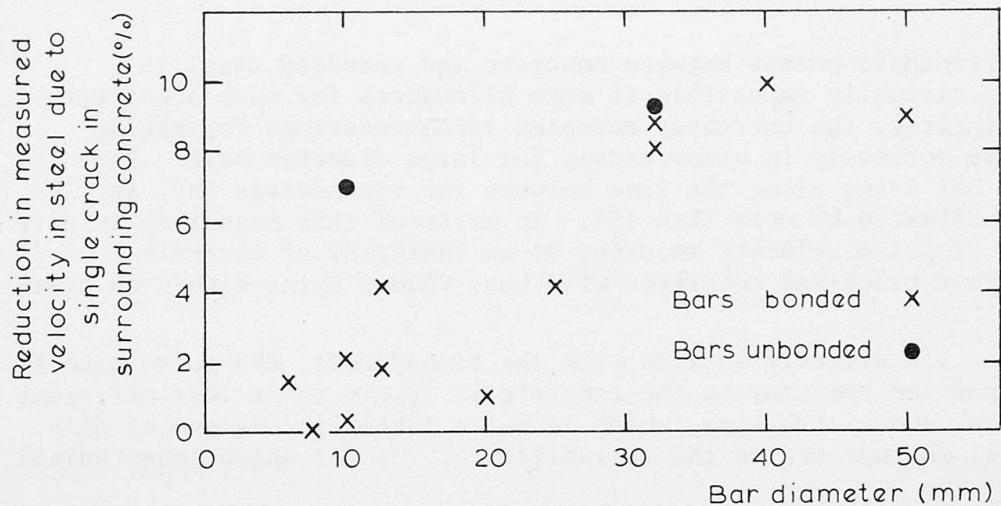
Fig. 7
Effects of
cracking

Cracking of the concrete results in a reduction of the measured pulse velocity, which is related to the diameter of the bar concerned. The results are summarised in Fig. 7. This follows the general pattern of Fig. 3 for bars in air, and shows that the effect is greatest for those bars with the largest differential between steel and concrete pulse velocities. Since velocities in bars embedded in concrete are lower than for similar bars in air this result is surprising and suggests that the presence of the crack disrupts the pulse passing through the steel. The increased effect on bars debonded by greasing is perhaps even more surprising.

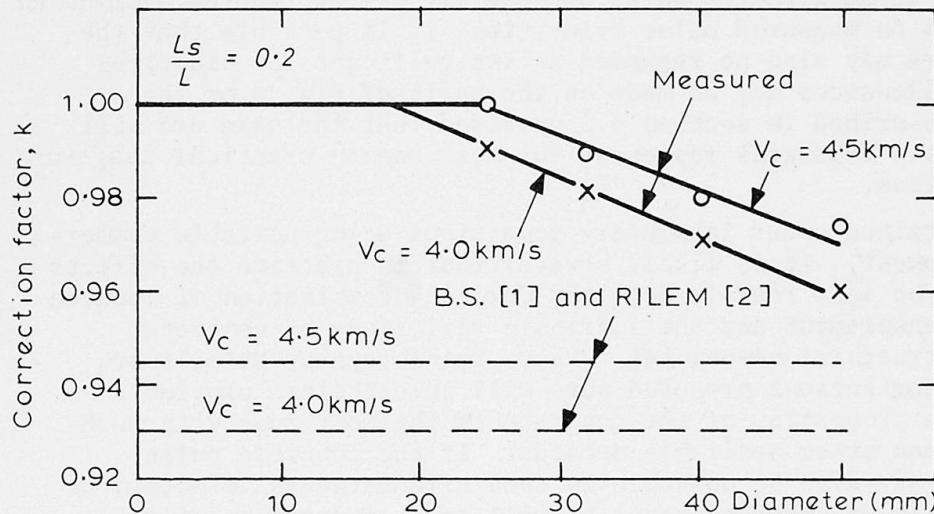
Fig. 8
Correction
factors for
transverse bars

Calculated effective pulse velocities in the steel yield values of low accuracy due to the small path in steel. Consequently, these results have been presented directly in the form of the correction factor k required to convert measured pulse velocity to concrete pulse velocity. For ease of presentation, the values corresponding to $L_s/L = 0.2$ have been computed from the measured readings and are plotted in Fig. 8 for two values of concrete pulse velocity.

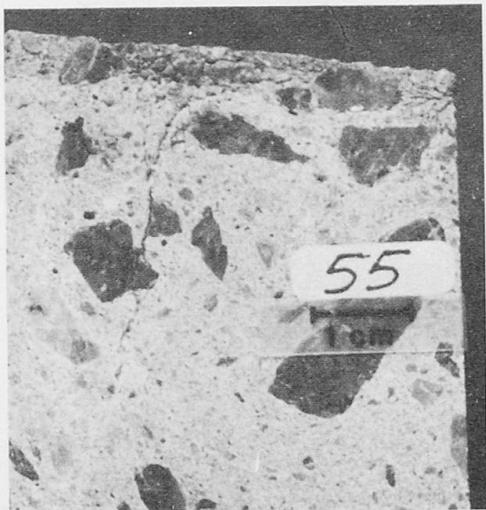
Fig. 1. Sawn cut of a concrete core with internal crack and low stone content.

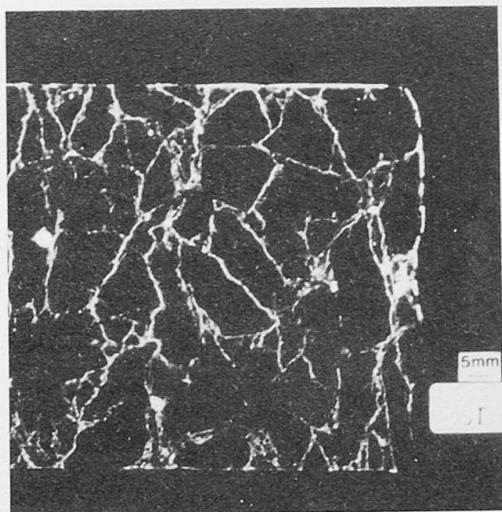
Fig. 2. Crack detection on prepared sawn cut. Heavily cracked concrete.

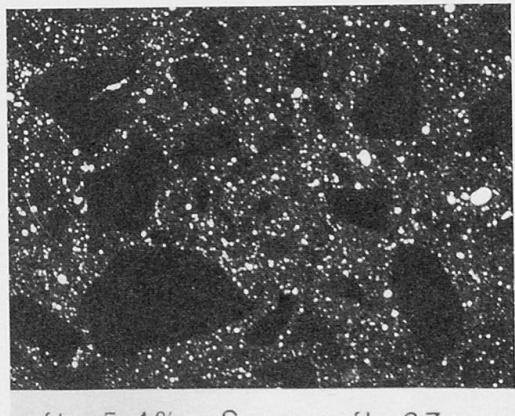
Fig. 3. Air pore analysis on contrast impregnated plane cut. A concrete with good air pore distribution.

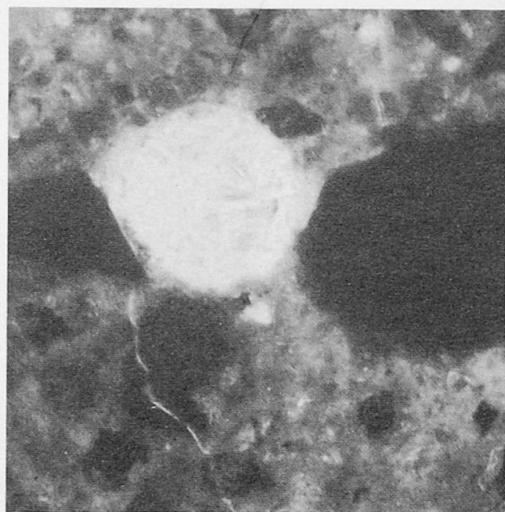
Fig. 6. Fluorescence. 160x.
The same area as Fig. 5. Small cracks in the cement paste.

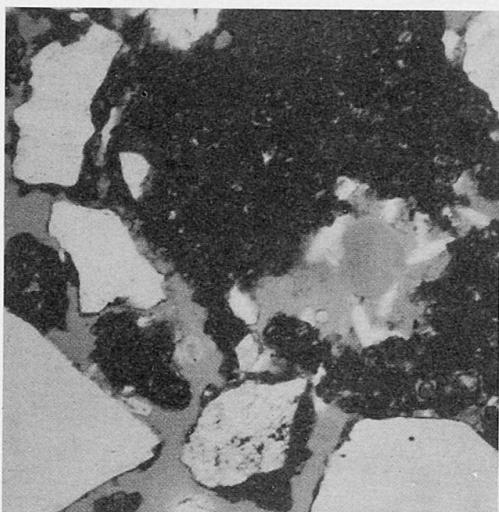
Fig. 7. Polarization. 65x.
Badly mixed cement mortar with cement paste lumps and entrapped air. Big $\text{Ca}(\text{OH})_2$ -crystals in the air pores.

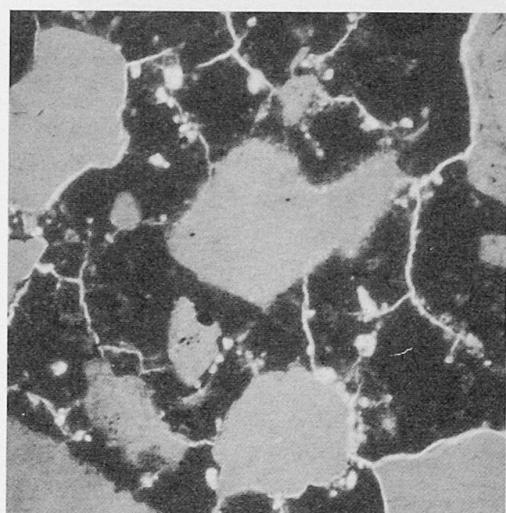
Fig. 8. Fluorescence. 65x.
Dense cement paste with many micro cracks in a concrete containing silica dust.

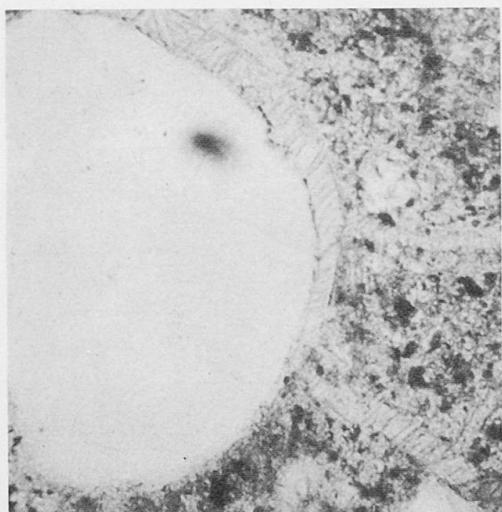
Fig. 9. Polarization. 160x.
Micro cracks filled with ettringite.

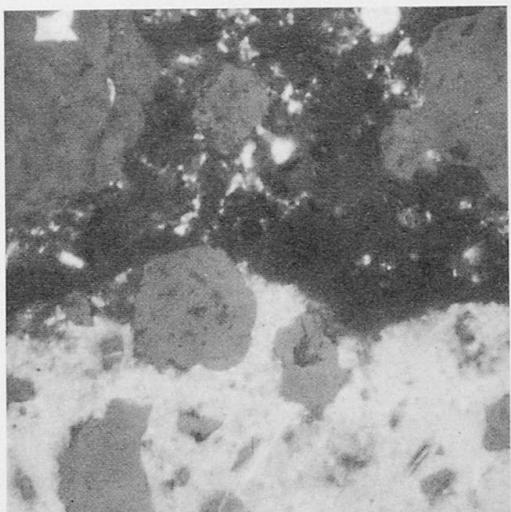
Fig. 10. Fluorescence. 65x.
Joint between old (porous) and new (dense) concrete.

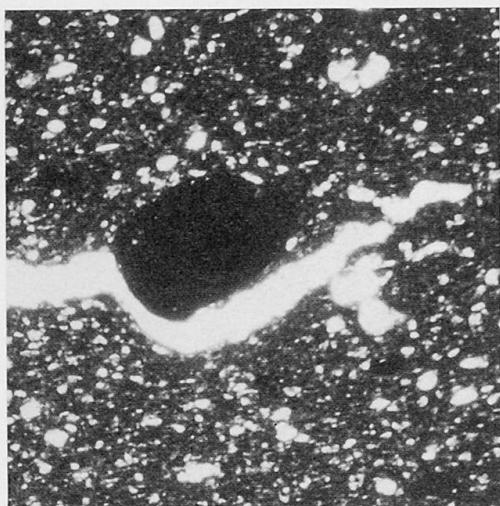
Fig. 11. Polarization. 65x.
Production crack in a tile with bad frost durability.

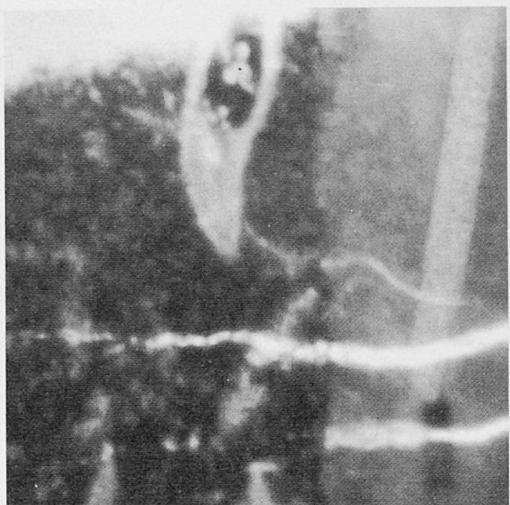
Fig. 12. Fluorescence. 65x.
Surface parallel cracks in a clay containing limestone used as building stone.

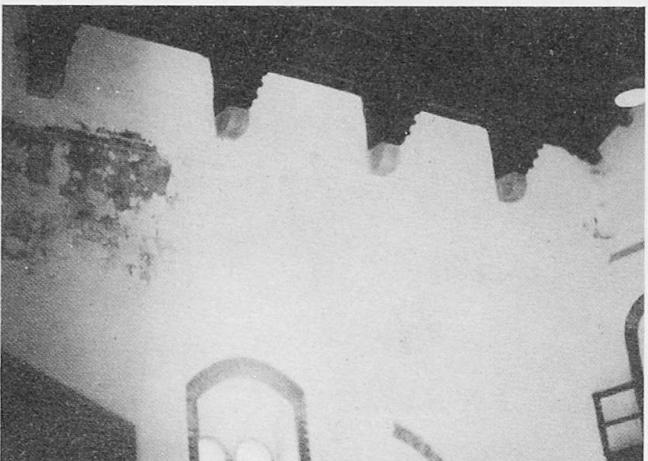
Fig. 5 Mur Nord dans le visible

La photographie du mur Nord dans le visible montre une marque d'humidité sur la partie gauche du document. Le reste de la structure semble sain.

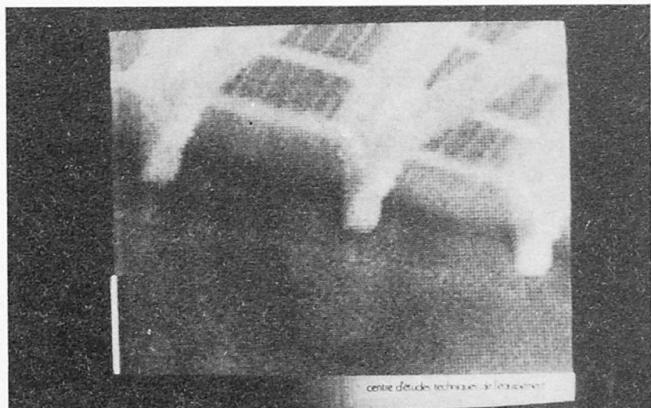
Fig. 6 Thermogramme du mur Nord

Les clichés infrarouge sur les mêmes parties de la structure révèlent la présence d'une trace rectiligne entre les corbeaux. Cette trace très bien délimitée fait penser à une poutre.

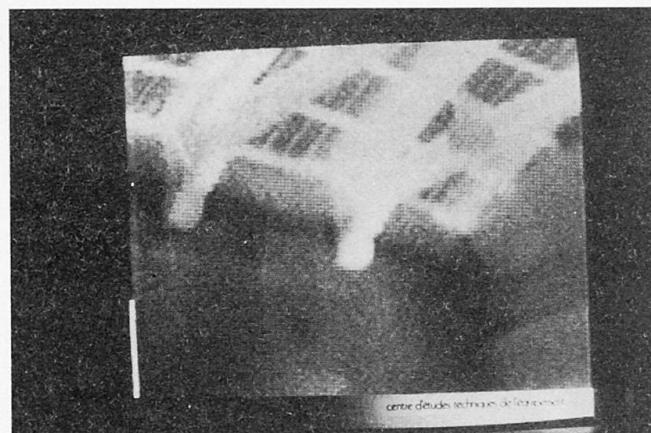
Fig. 7 Extrémité du mur Nord

On note que la marque observée se prolonge jusqu'au mur Est. La présence d'une zone sombre dans l'angle de la pièce révèle que cet angle est pollué par l'humidité.

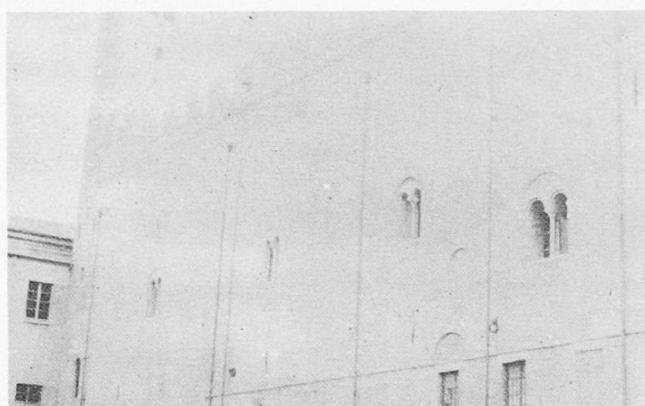
Fig. 8 Façade Nord

La photo ci-contre représente la façade Nord de l'édifice dont la Salle de Conseil occupe toute la partie supérieure. L'angle de la pièce montré sur l'image infrarouge précédente correspond à l'emplacement de la gouttière la plus à gauche.

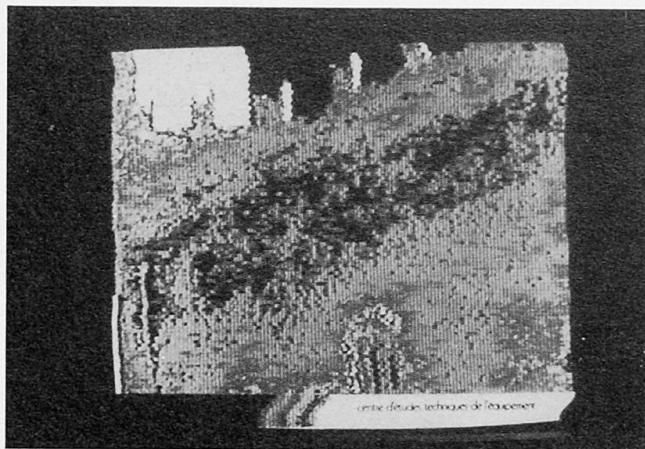
Fig.9 Traces d'humidité

La prise de vue infrarouge sur cette partie de la façade montre une zone sombre, localisée dans la partie supérieure du mur, qui révèle la présence d'humidité et confirme les constatations faites à l'intérieur.

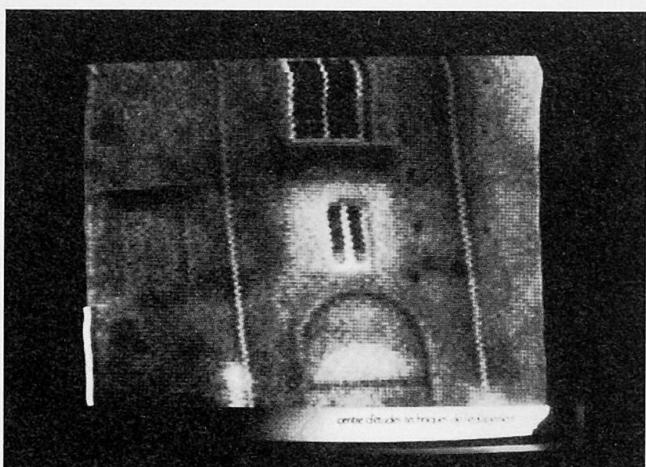
Fig.10 Différence de structure

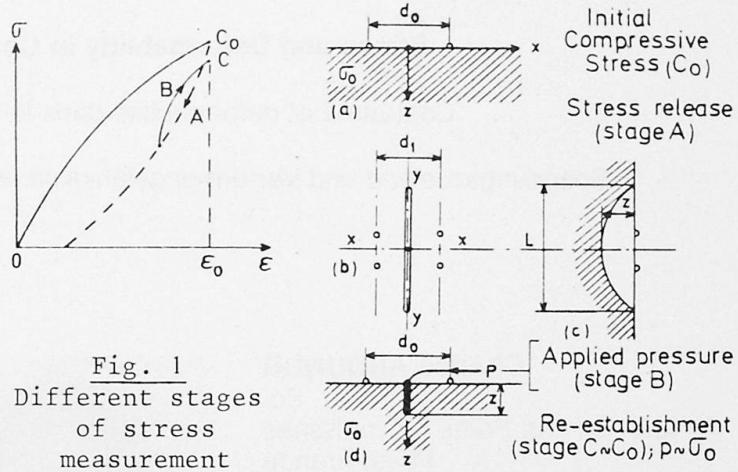
Fig. 1
Different stages
of stress
measurement

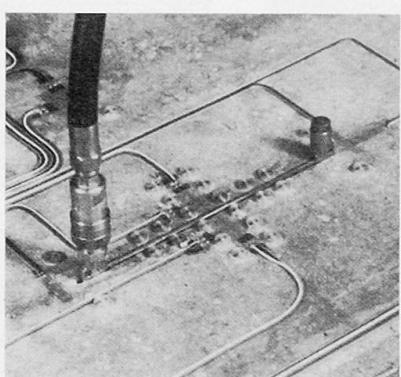
Fig. 8
Measurement apparatus on concrete

The tests undertaken on plexiglass by optical methods, were repeated on uncracked concrete models by extensometry (fig. 8). They were carried out within the elastic limit and at different slot depths. The results were in close agreement with those already obtained on the idealised models. Fig. 9 shows the essentials of this study, i.e. for a model subjected to pure compression, a maximum error margin of 0.3 MPa was found between the cancelling pressures and the actual applied stresses.

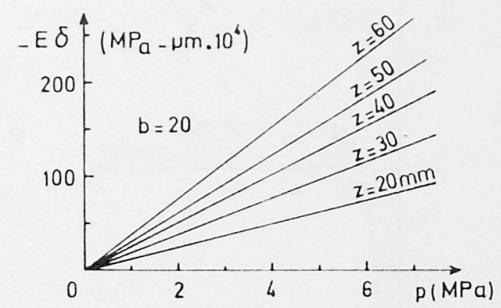
Fig. 14
Graphical estimation of the modulus E from actual p - δ cycles at different slot depths z

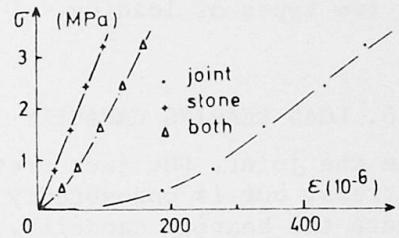
Fig. 17
Stress-strain diagram
for a masonry model
and its constituents

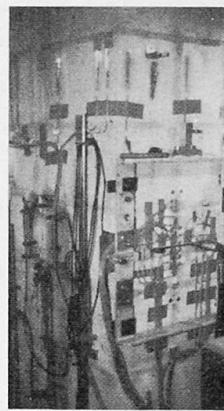
Fig. 21
Masonry model
and test set-up

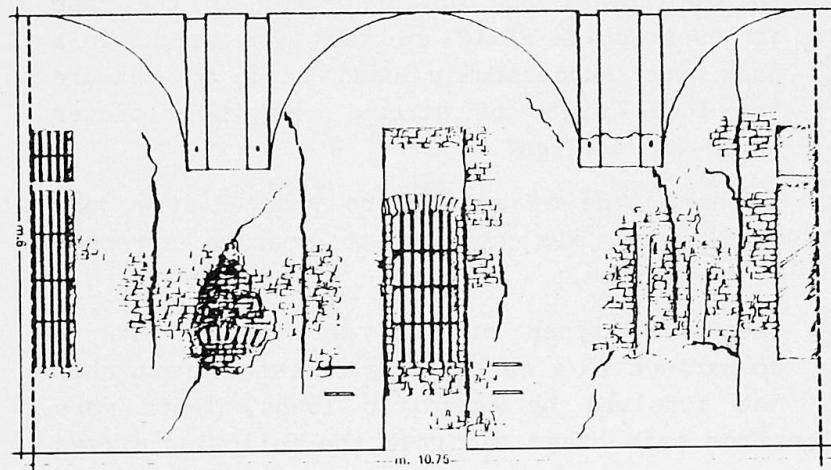
Fig. 5 Crack pattern representation.

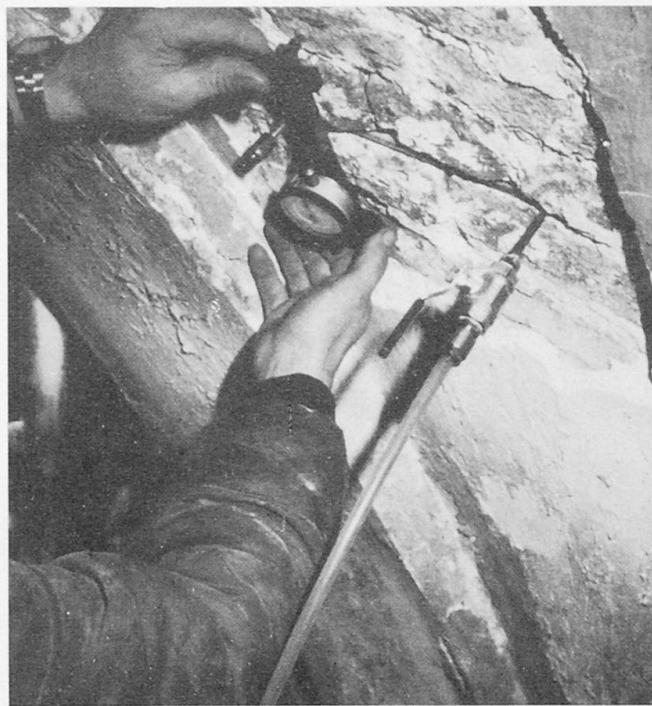
Fig. 8 Tests on the cross vault with a 24x12 cm flat jack.

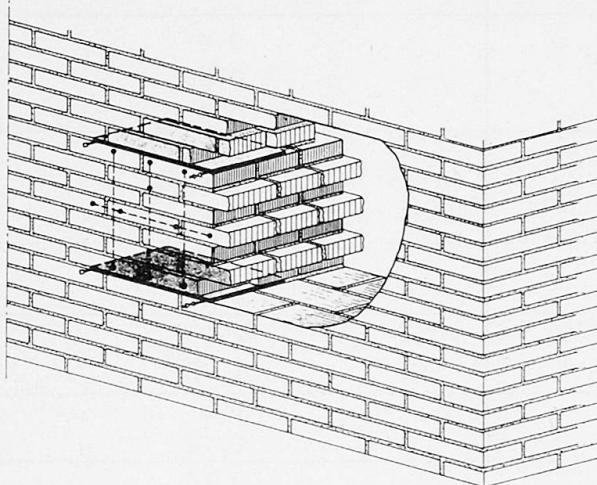
Fig. 10 Deformability test.

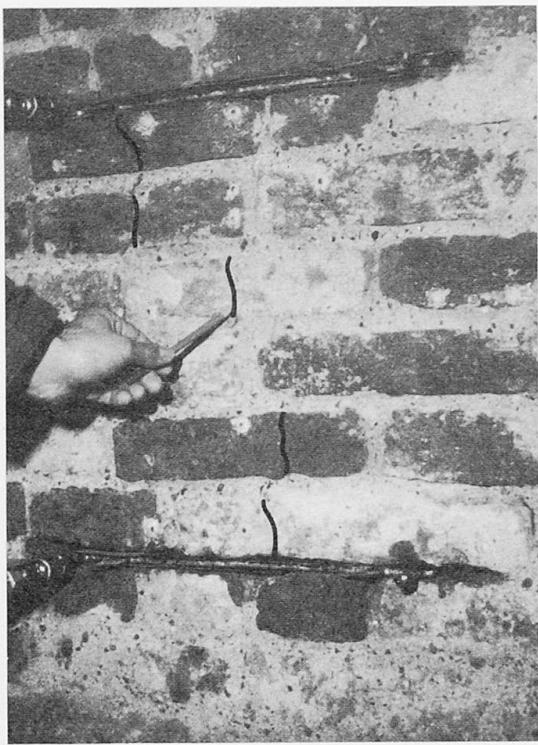
Fig. 12 Photo showing the appearance of first cracks.

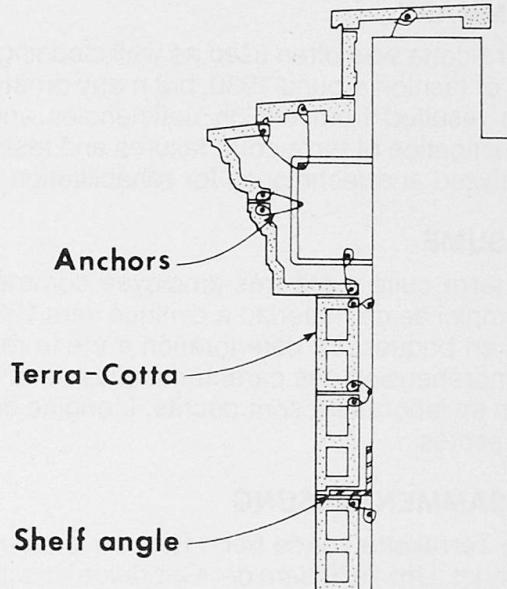
Fig. 1: Terra-Cotta Anchors

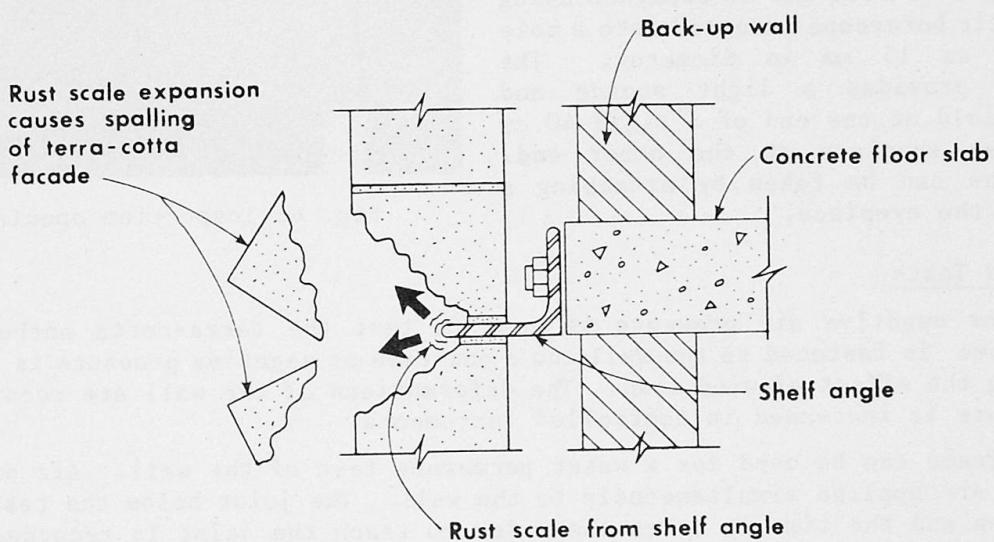
Fig. 3: Terra-cotta spalling caused by corrosion of shelf angle.

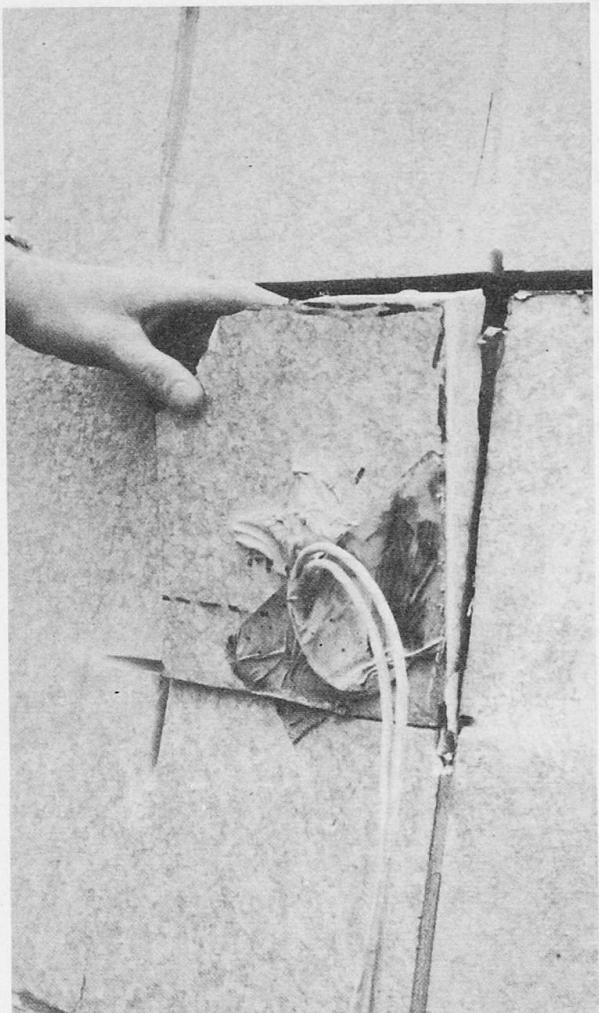
Fig. 6: Terra-cotta block, with strain gages attached, is cut loose.

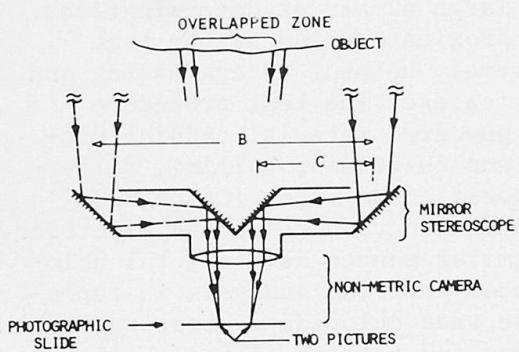
Fig.1: The mirror stereoscopic photographic arrangement

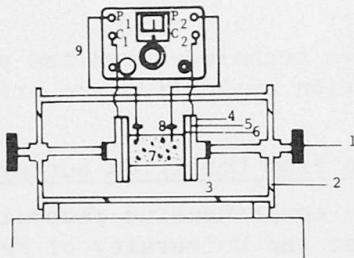
1. Screw for gripping the block
2. Steel frame
3. Insulator
4. Steel plate
5. Copper plate
6. Cloth pad
7. Concrete core
8. Copper pins inserted in concrete cores
9. Nilson 400 resistivity meter

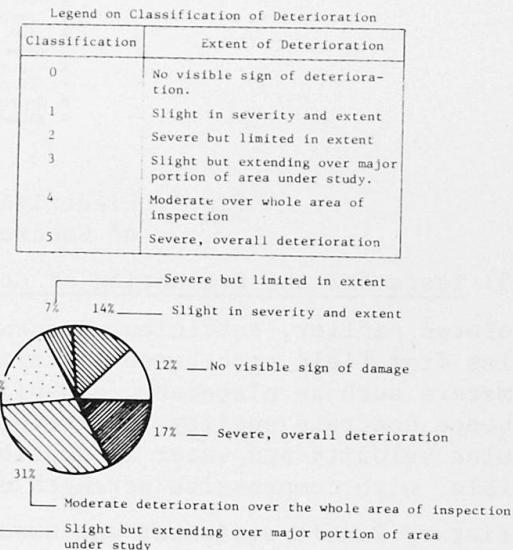
Fig.4: Classification of condition of 168 observations from concrete structures located in Eastern Saudi Arabia.

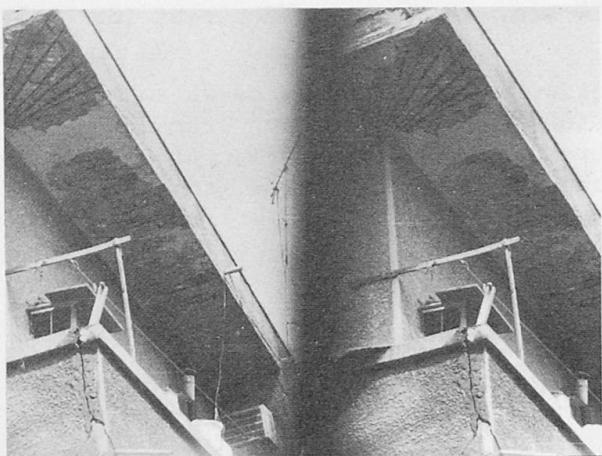
Fig. 5 Structure 1 showing concrete spalling due to rebar corrosion

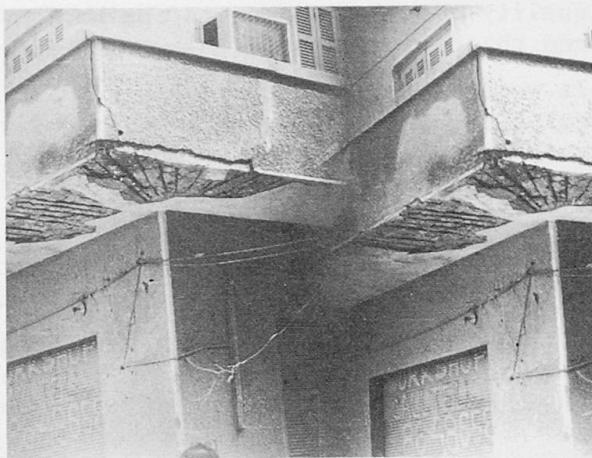
Fig. 6 Structure 2 showing concrete spalling due to rebar corrosion

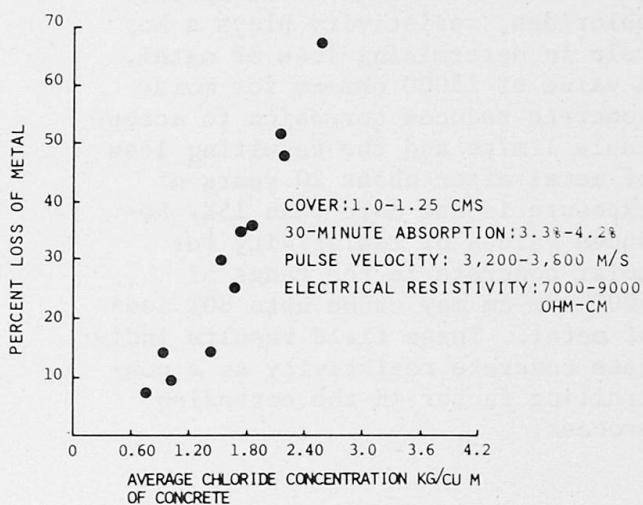
Fig.7: Relationship between Chloride content and metal loss.
