Zeitschrift: IABSE reports = Rapports AIPC = IVBH Berichte
Band: 46 (1983)

Rubrik: Session 2: Inspection and monitoring

SESSION 2

Inspection and Monitoring

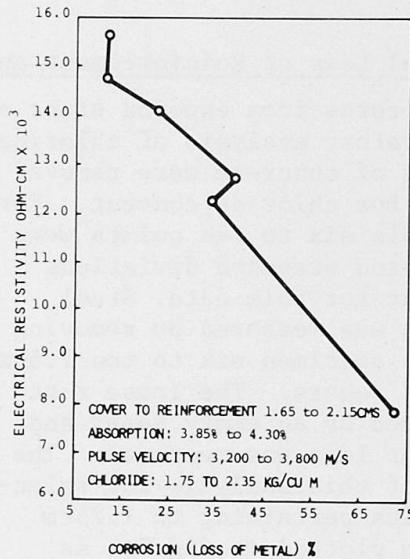
Fig.8: Relationship between electrical resistivity of concrete cored from field structures and metal loss.

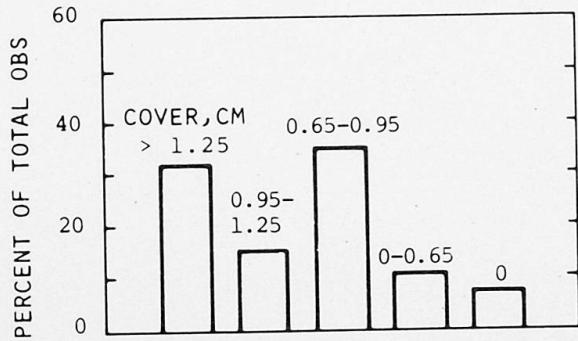
Fig.9: Distribution of concrete cover in spalled concrete

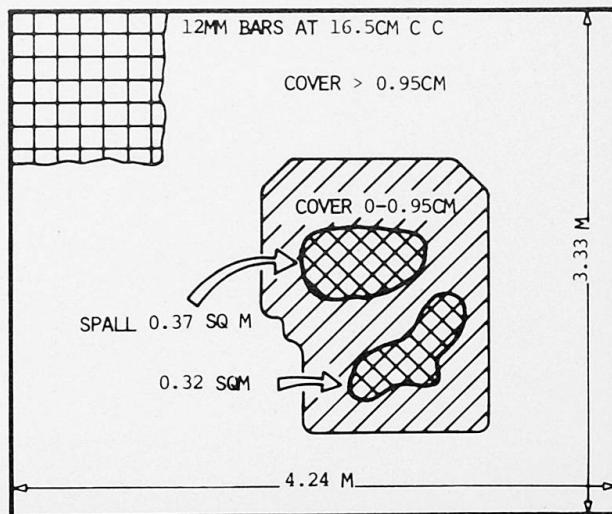
Fig.10: Concrete spalls related to inadequate cover.
