**Zeitschrift:** IABSE reports = Rapports AIPC = IVBH Berichte

**Band:** 46 (1983)

Rubrik: Session 2: Inspection and monitoring

# Appraisal - a Cyclical Process of Inspection and Calculation

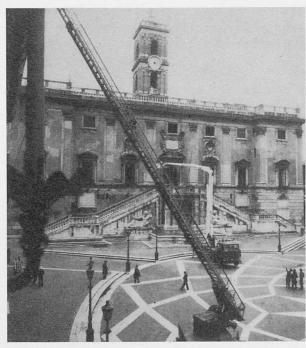
Fig. 1 - Facade looking on the Forum

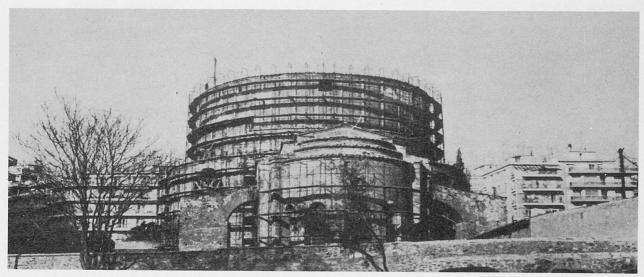
Fig.1 General view of Rotonda

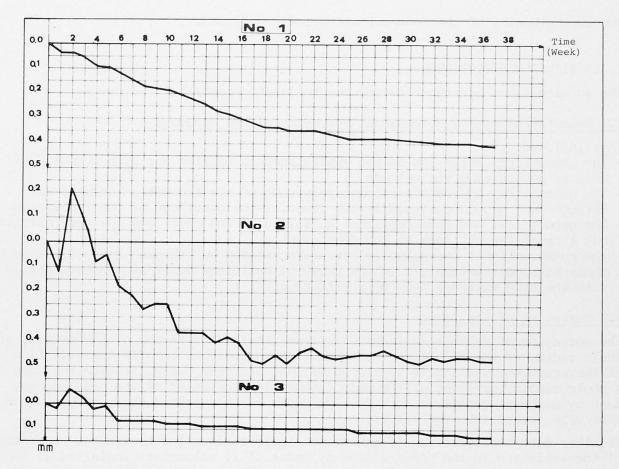
Fig.3 Variation of crack width with time

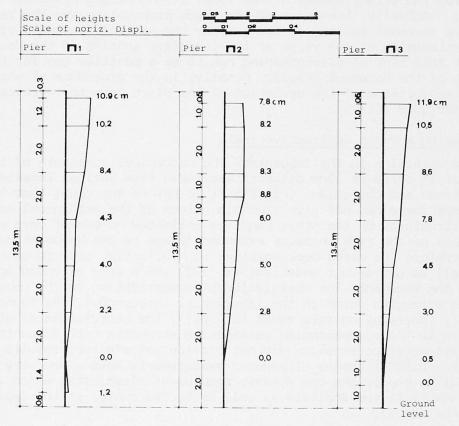
Fig.4 Horizontal displacements of the piers

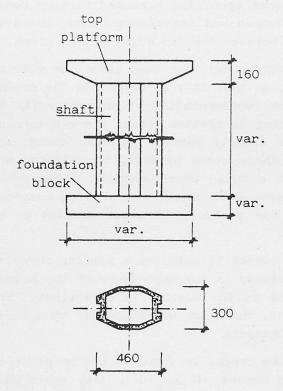
$\underline{\text{Fig. 1}}$  Schematic representation of the pier geometry.

$\frac{\text{Fig. 2}}{\text{tation of soil behaviour.}}$  Reference scheme for interpretation

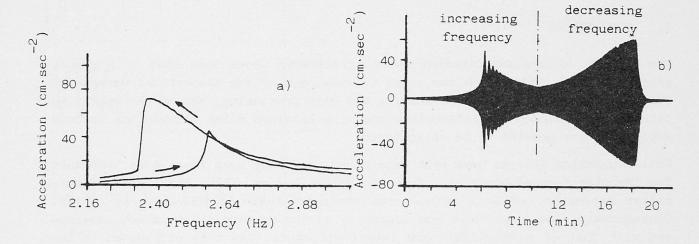
$\underline{\text{Fig. 3}}$  Acceleration values at top of the piers. a) Response curves for pier A; b) Time history for pier B. Tests with increasing and decreasing frequency.

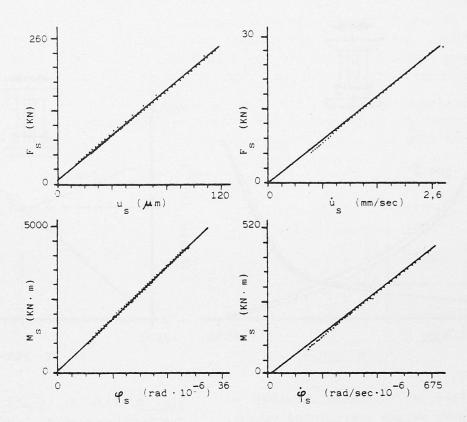
Fig. 4 Experimental correlation between applied loadings and foundation motions.

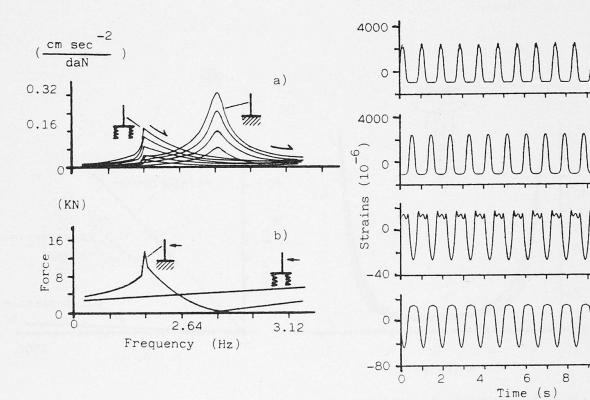
Fig. 5 Pier A: transfer functions (a) and exciting forces (b) for actual and "clamped" pier.

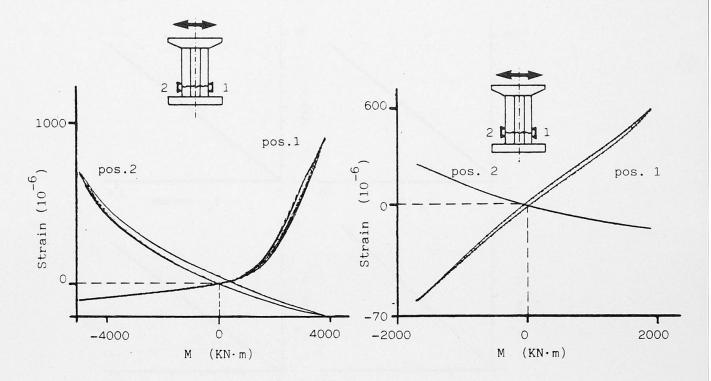
$\underline{\text{Fig. 7}}$  Pier B: strains measured across cracks versus overturning moment. The non symmetric behaviour of the crack openings is cleary shown.

$\underline{\text{Fig. 8}}$  Pier A: crack opening versus overturning moment. Position 1 shows mobilization of reinforcement in compression.

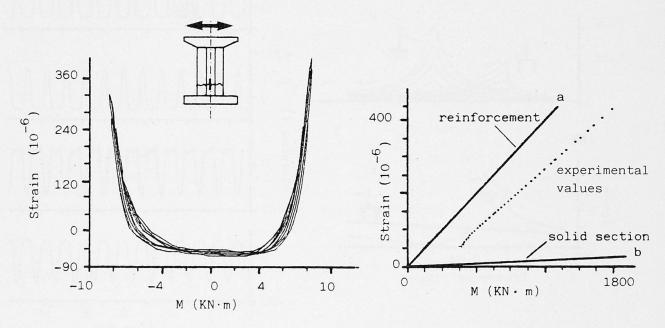
$\underline{\text{Fig. 9}}$  Pier B: strains measured versus overturning moment across a crack on the "neutral axis" of the shaft.

$\frac{\text{Fig. 10}}{\text{turning moment.}}$  Maximum strains versus over-

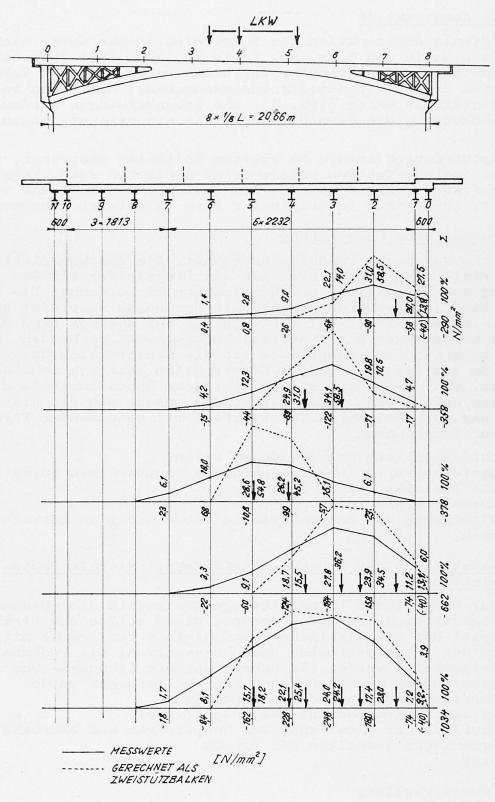
Abb. 2. Spannungen auf dem unteren Gurtblech der Bogenträgern in dem Viertelquerschnitt

Aus den Abbildungen ist es zu sehen, dass eine bedeutende Abweichung auf die sichere Seite zwischen den gerechneten und gemessenen Randfaser-Spannungen bei beiden Querschnitten sich befindet. Die Abweichung ist bei dem Mittelquerschnitt nur quantita-

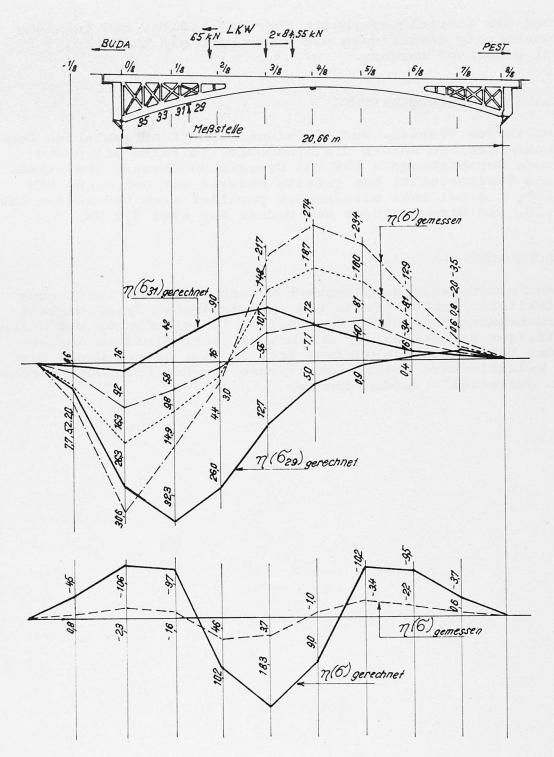
Abb. 4. Gerechnete und gemessene Lastenzug-Einflusslinie der Randfaser-Spannungen (N/mm²) in dem Viertelund Mittelquerschnitt der Bogenbrücke

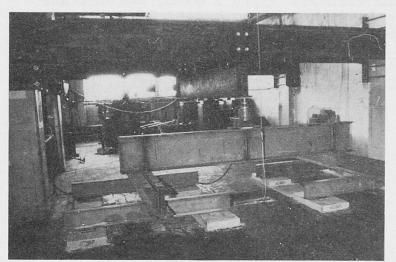
Mit einer eingebauten Kraftmeßdose konnte die jeweils wirkende Kraft in den einzelnen Laststufen genau bestimmt werden. Die Durchbiegungen wurden an 12 Punkten während der Probebelastung des Deckenfeldes und an 7 Punkten bei der Belastung des Nebenunterzuges gemessen. Weiterhin wurden folgende Meßdaten erfaßt:

Bild 3 Belastungsvorrichtung

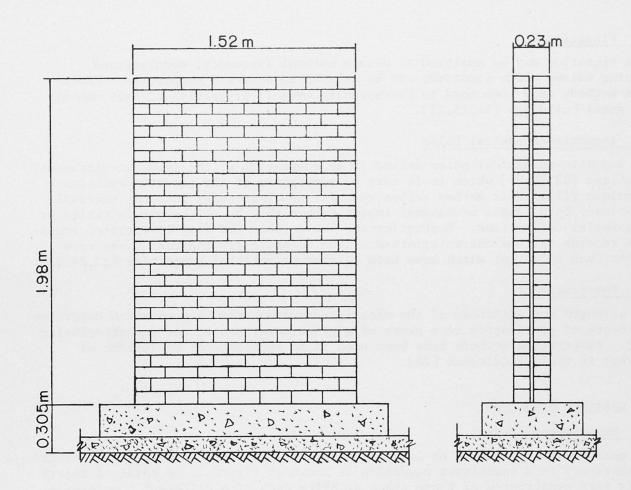
FIGURE I - BRICK MASONRY WALL SPECIMEN

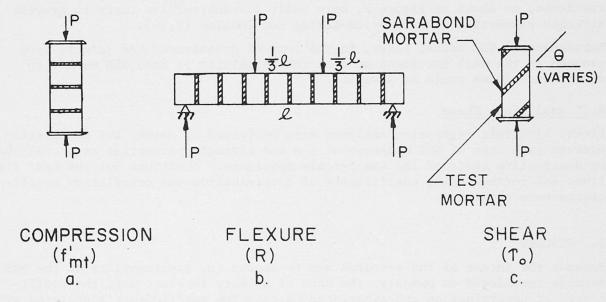
FIGURE 2-SMALL-SCALE SPECIMENS

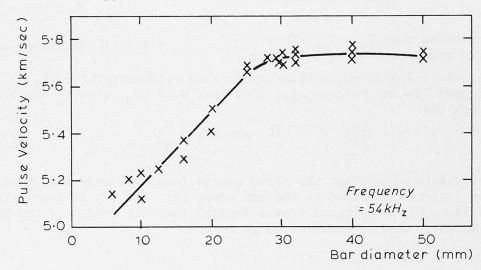
faces of the bars. These values are plotted in Fig. 3 for transducers with a frequency of 54 kHz which is the type most commonly used for insitu concrete investigations. Measured values using a frequency of 82 kHz were found to be approximately 2% higher.

Fig. 3 Results for bars in air

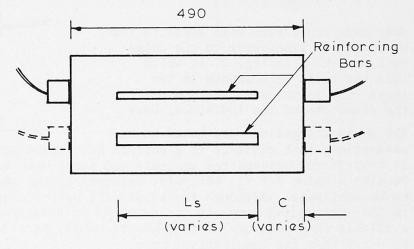
cover to the bars was between 85 mm and 130 mm and readings of pulse velocity were taken at increasing ages, commencing at 2 days, to obtain a range of concrete pulse velocities between 3.9 km/s and 4.5 km/s. These measurements were taken directly along the line of each bar, and also transversely across the block in line with each bar. Subsequently the ends of the blocks were sawn off to give end covers in the range 20-25 mm and the longitudinal

Fig. 4 Test block

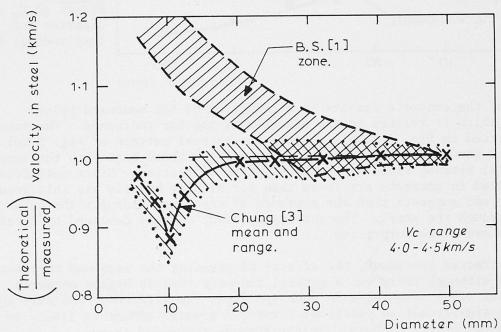
The effective velocity in each reinforcing bar has been calculated from the measured values by allowing for the concrete end cover and  $\gamma$  evaluated. Comparisons of the results with established theories are summarised in Fig. 5 which shows the ratio of theoretical/measured velocities in the steel for concrete pulse velocities between 4 km/s and 4.5 km/s. This covers the most commonly occurring range of concrete quality and indicates that the experimental values of  $V_{\rm S}$  generally agree with Chung's predictions for bars of 20 mm diameter or over. For smaller bars, Chung's theory underestimates the steel influence and his contention that bars of 10 mm or less may be ignored is not confirmed.

Fig. 5 Results for longitudinal bars

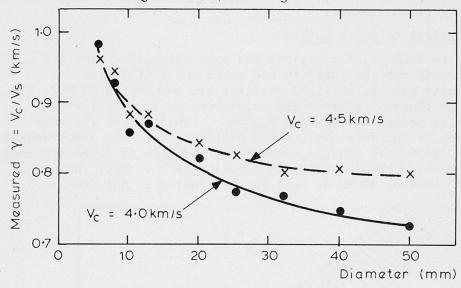
Measured values of  $\gamma$  are plotted in Fig. 6 for two levels of concrete pulse velocity, and may be used as the basis of a correction factor when used in conjunction with the expression given in section 2.1. The importance of bar diameter is clear, and it will be noted that for small diameter bars the velocity of pulses in the surrounding concrete is of reduced significance. It is also clear that bars of only 6 mm diameter may be detected although their effect is small, and the links of this size could not be identified in the tests on the beam when  $V_{\rm C}$  = 4.4 km/s and  $L_{\rm S} \simeq 0.67L$ .

$\frac{\text{Fig. 6}}{\text{Effect of V}_{\text{C}}}$  and diameter for longitudinal bars

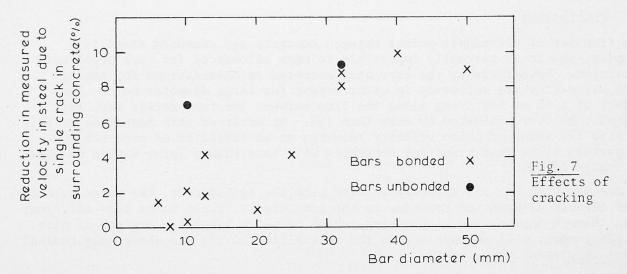
Cracking of the concrete results in a reduction of the measured pulse velocity, which is related to the diameter of the bar concerned. The results are summarised in Fig. 7. This follows the general pattern of Fig. 3 for bars in air, and shows that the effect is greatest for those bars with the largest differential between steel and concrete pulse velocities. Since velocities in bars embedded in concrete are lower than for similar bars in air this result is surprising and suggests that the presence of the crack disrupts the pulse passing through the steel. The increased effect on bars debonded by greasing is perhaps even more surprising.

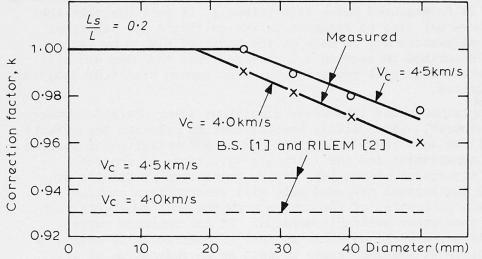
Calculated effective pulse velocities in the steel yield values of low accuracy due to the small path in steel. Consequently, these results have been presented directly in the form of the correction factor k required to convert measured pulse velocity to concrete pulse velocity. For ease of presentation, the values corresponding to  $L_{\rm S}/L$  = 0.2 have been computed from the measured readings and are plotted in Fig. 8 for two values of concrete pulse velocity.

Fig. 8
Correction
factors for
transverse bars

The inadequacy of existing recommended corrections is again obvious. The effect of reinforcement in this orientation is much smaller than longitudinally, but is nevertheless related to the bar diameter with bars of 20 mm or smaller scarcely detectable. Tests on the beam (section 3.4) showed no influence from the 12 mm main bars. Earlier tests by the Author [4] have indicated that a theoretical estimate of the effect of a transverse bar may be obtained by consideration of the bar as having an equivalent longitudinal length equal to the diameter, but with an effective diameter equal to one half of the true value. Use of the expression proposed by Chung [3] will then yield a value of  $V_{\rm S}$  and hence correction factor k. If this approach is applied to this series of tests, excellent agreement is obtained with the measured values.

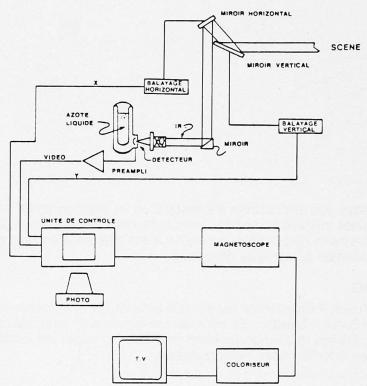
Ce dispositif permet après traitement des signaux électriques de restituer sur un écran cathodique une image thermique où les zones froides apparaissent en noir et les zones les plus chaudes en blanc avec, entre ces deux extrêmes les teintes de gris intermédiaires.

Fig. 1 Schéma de fonctionnement

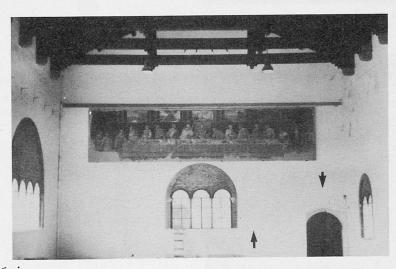
Fig. 2 Vue intérieure

La photo N°2 montre le mur Ouest de la Salle de Conseil. Sur cette photo sont repérés les emplacements des particularités relevés en infrarouge.

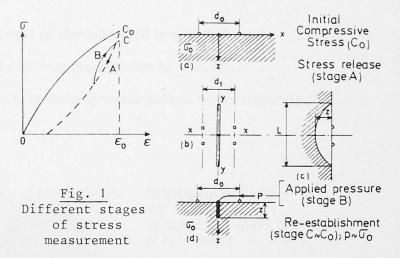
consists in a local elimination of stresses, followed by a controlled stress compensation (fig. 1). In practice, the displacement reference field is first determined; a slot is then cut in a plane normal to the desired direction of stress determination; finally, a very thin flat jack is introduced into the slot and used to restore the initial displacement field. The amount of cancelling pressure is an indication of the compressive stress in the direction normal to the slot.

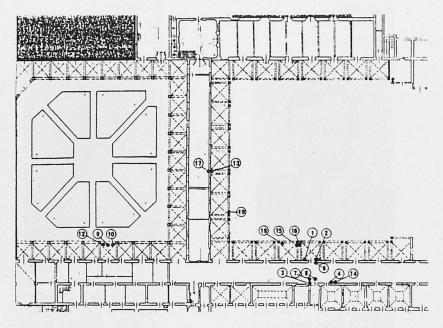
Fig. 1 Plan of the building.

As is known, the determination of geometrical features and their graphic display (Figs. 1, 2) together with an appropriate photographic campaign (Fig.3) are needed to supply a knowledge of the statical behaviour of the construction.

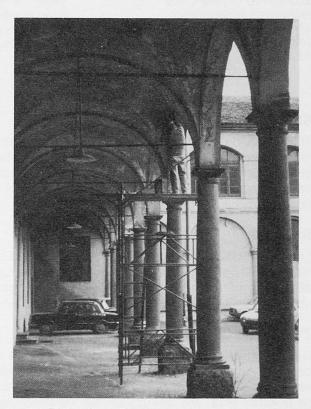
Fig. 3 Photographic survey.

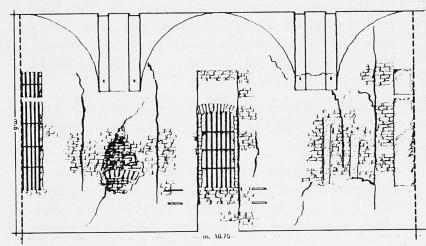
Crack pattern representation.

The photogrammetric survey and the crack pattern representation (Figs. 4, 5) may be quite useful: they aid in defining

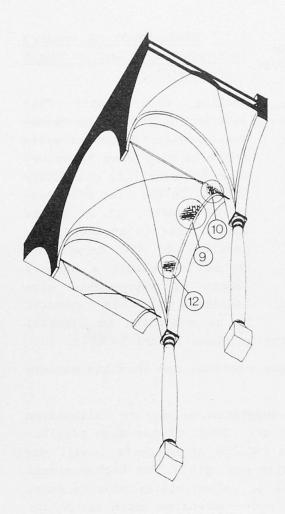
Fig. 7 Tests points on the cross vault.

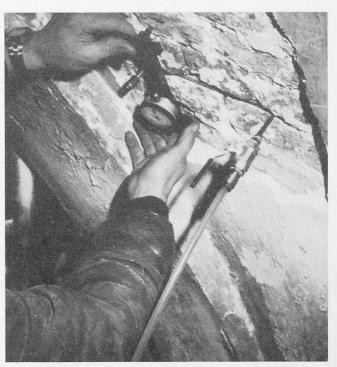
Fig. 8 Tests on the cross vault with a 24x12 cm flat jack.

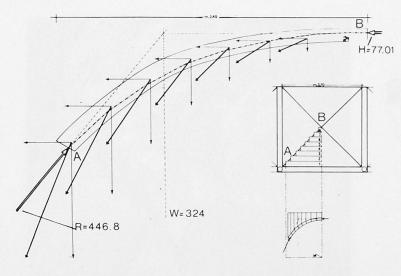
corresponding to a statically determined solution, suggested by the crack pattern, were computed. In particular, Fig. 9 shows the solution adopted for the cross vaults. The results are reported in the Table I.

Fig. 9 Static solution adopted for cross vault.

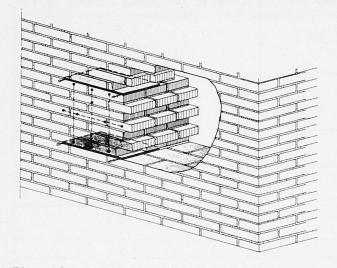
Fig. 10 Deformability test.

Ratio of deformability modulus  $E_d$ , computed in the load interval 0 - 0.5  $\sigma_R$  to ultimate stress  $\sigma_R$  is (Fig. 10):

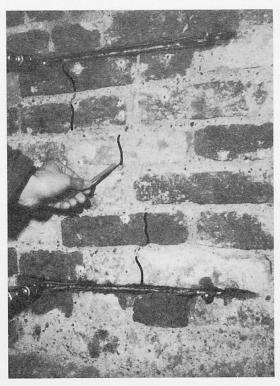
Fig. 12 Photo showing the appear ance of first cracks.

Fig. 11 shows stress-strain diagrams of the sample delimited by the two jacks. To estimate the strength limit, a test was carried out up to the appearance of the first cracks in the bricks (Fig. 12).

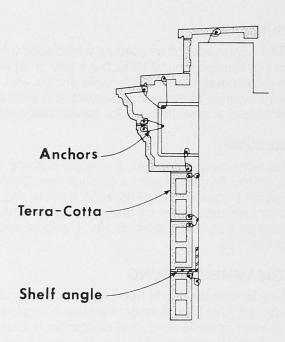
The terra-cotta was installed with solid joints of cement/lime mortar. Joints were narrow, often about 5 mm. The walls had no expansion joints either in the back-up or in the cladding and they had no internal flashings or weepholes.

Fig. 1: Terra-Cotta Anchors

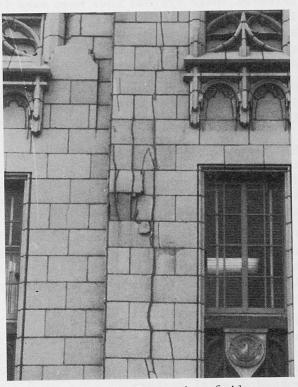
Fig. 2: Expansion failure

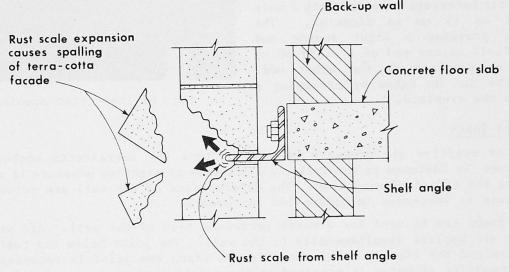
Spalling of the glaze and cracks caused by expansion allows water to enter the wall and results in further damage to the terracotta from freeze/thaw action. The moisture corrodes the anchors and the pressure from the volume expansion of the rust cracks the blocks, as seen in Figure 3.

Fig. 3: Terra-cotta spalling caused by corrosion of shelf angle.

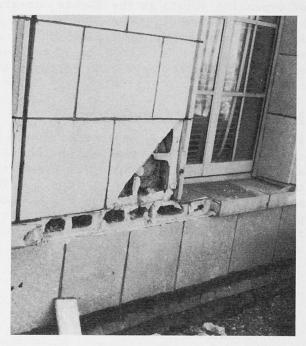
The inside of a wall can be examined using a fiberoptic borescope inserted into a hole as small as 15 mm in diameter. The borescope provides a light source and viewing field at one end of a rigid 40 cm rod and an eyepiece at the other end. Photographs can be taken by attaching a camera to the eyepiece.

Fig. 4: Inspection opening

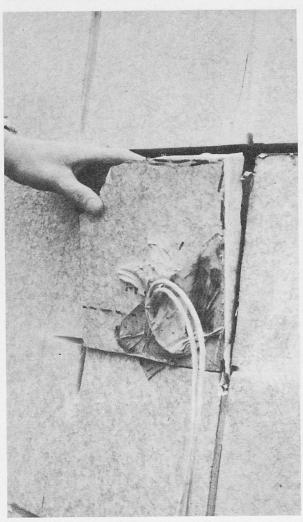
Electrical resistance strain gages are attached to the terra-cotta surface and the gages are read. Then the terra-cotta block, with the gages attached, is cut loose from the wall and the gages are read again, as seen in Figure 6. The change in gage reading is a measure of the strain in the block. The stress in the block is found by multiplying the measured strain difference by the modulus of elasticity, as determined by laboratory tests.

Fig. 6: Terra-cotta block, with strain gages attached, is cut loose.

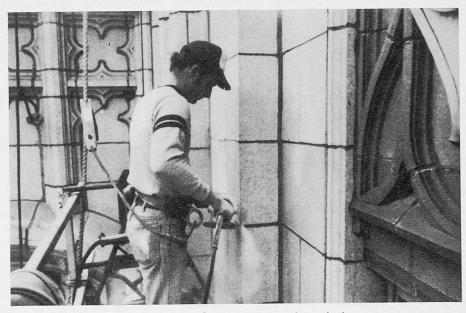
Vertical expansion joints are generally cut near corners and wall returns, while horizontal expansion joints are cut below reliveing angles, as seen in Figure 7. The joint location is determined from stress measurements of the terra-cotta. The joints are made watertight with elastomeric sealants. Cutting of expansion joints can disturb the fastening of the terra-cotta and will often require the installation of new anchors.

Fig. 7: Cutting of new expansion joints.

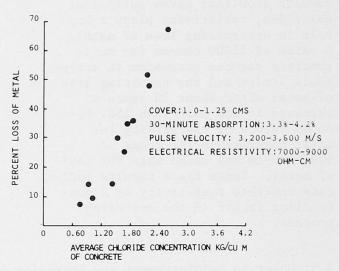
analyzed for chloride content. For each sample six to ten points were obtained and standard deviations worked out for this data. Steel corrosion was measured by removing from each specimen six to ten 7.5cm pieces of rebars. The loose rust was removed by an emery paper and the weight loss was measured. The results of this analysis for selected samples pertaining to 1.25cm cover are plotted in Fig.7. As concrete quality, cover, electrical conductance characteristics, and the soluble chloride content are the four supposedly dominant parameters affecting corrosion, samples were selected for the plot which enabled the first three variables to be held reasonably constant. Understandably, from among one hundred available observations only a few met the aforesaid criterion (Fig.7). Concrete

Fig.7: Relationship between Chloride content and metal loss.

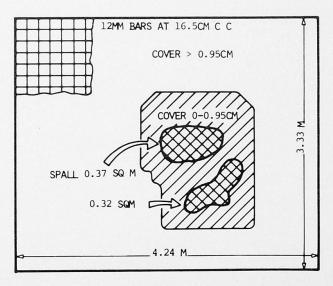
Fig.9: Distribution of concrete cover in spalled concrete

Fig.10: Concrete spalls related to inadequate cover.
