Zeitschrift: IABSE reports = Rapports AIPC = IVBH Berichte
Band: 46 (1983)

Rubrik: Session 2: Inspection and monitoring

SESSION 2

Inspection and Monitoring

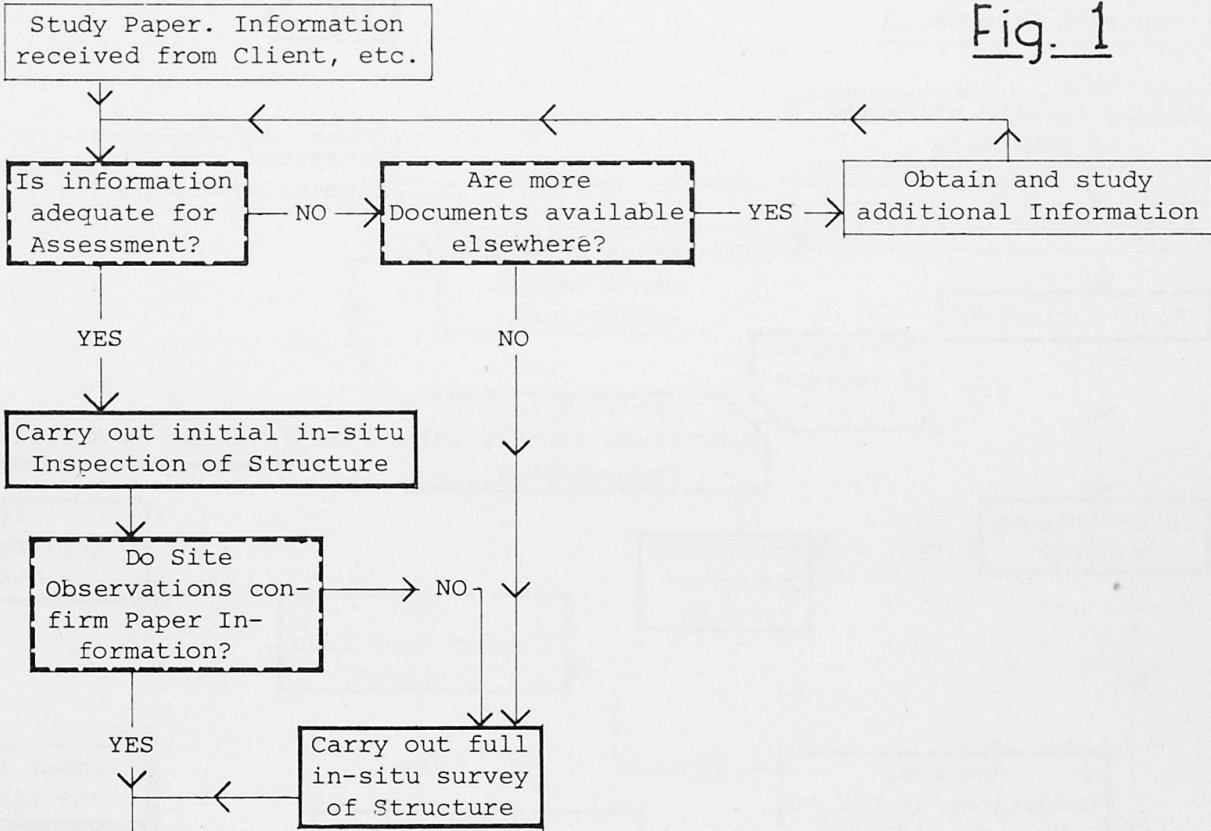
Fig. 1 illustrates the initial gathering of information. The first loop emphasises the need to obtain as much documentary evidence as possible: some effort at this stage may save a considerable amount of calculations and physical testing later. The other important operations are the site inspections: a) to make sure that the paper information is relevant to the actual building (and has not been superseded by a subsequent design alteration, lost in the meantime); b) to give the appraising engineer a first hand visual impression on how the structure performs in its present condition; this can be a very useful check on the validity of later calculations.

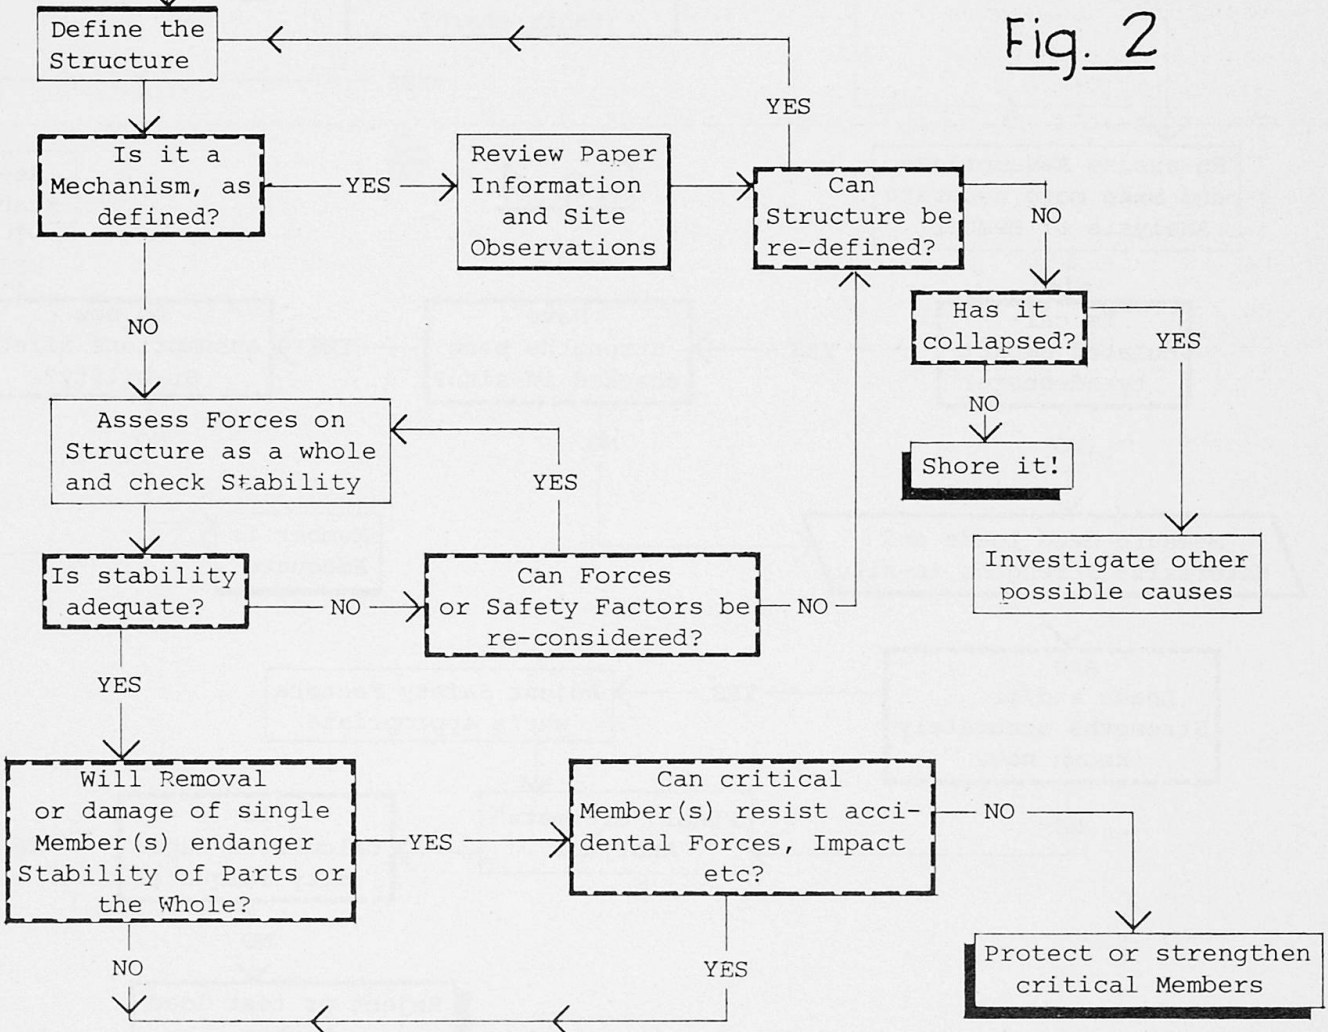
Fig. 2 shows the processes which may be involved in ensuring that the structure is a stable configuration and not liable to progressive collapse in case of relatively minor accidental damage. It is important here, as elsewhere in appraising, to choose a mathematical model which not only is easily understood, in terms of stability, but also takes advantage of such physical features, which in ordinary design might be ignored but which, in the actual building, contribute significantly to stability (eg. infill brickwork panels in a framed structure).

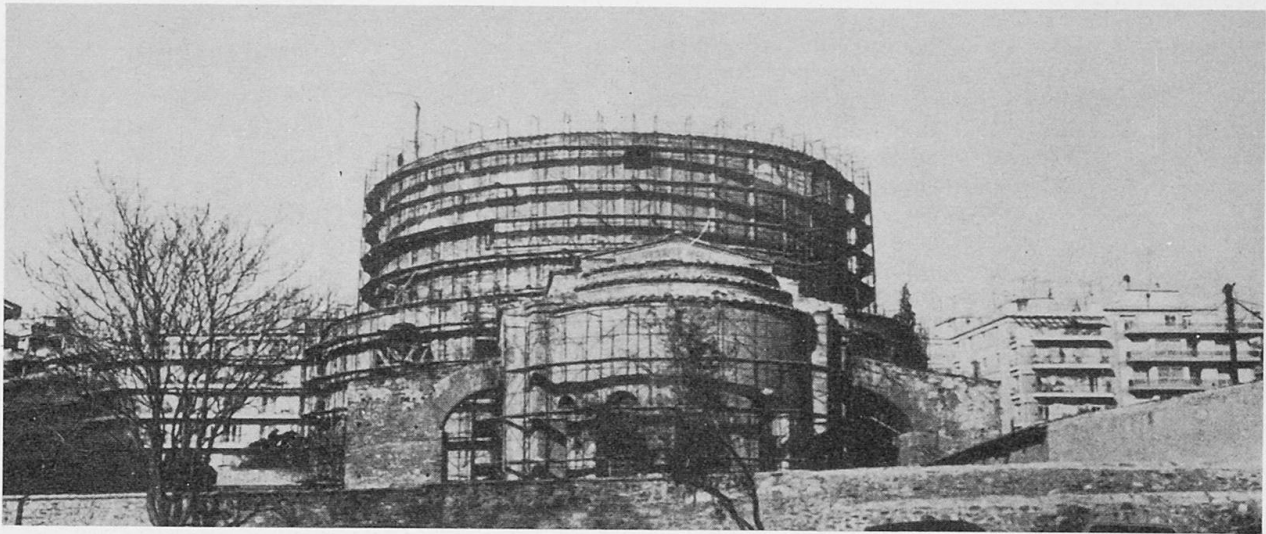
Fig.1 General view of Rotonda

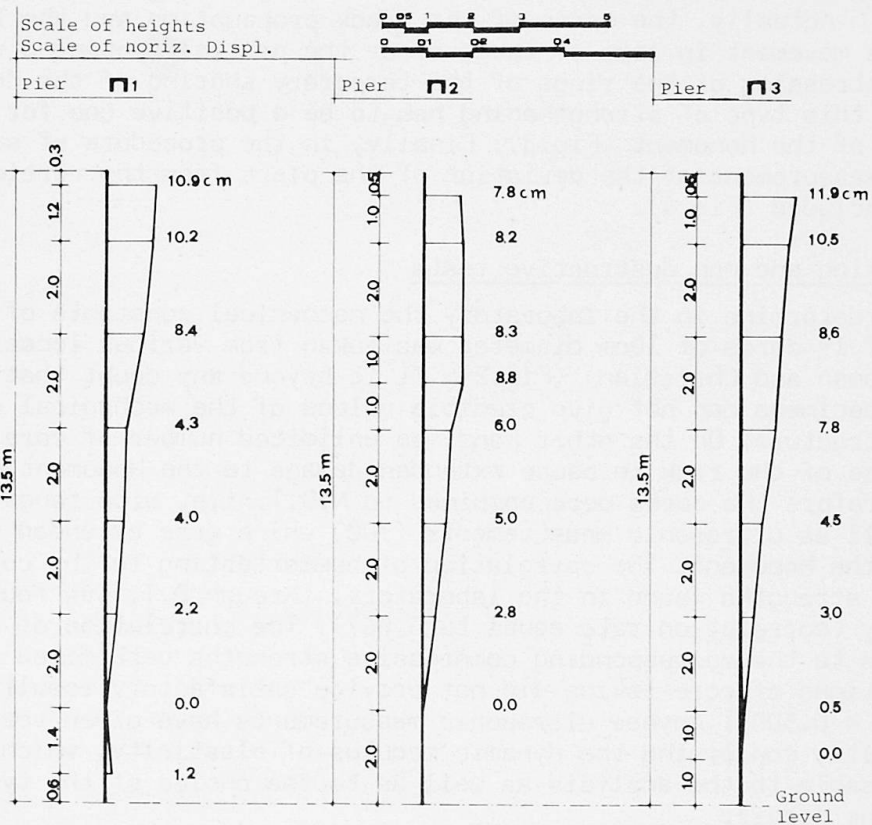
Fig.4 Horizontal displacements of the piers

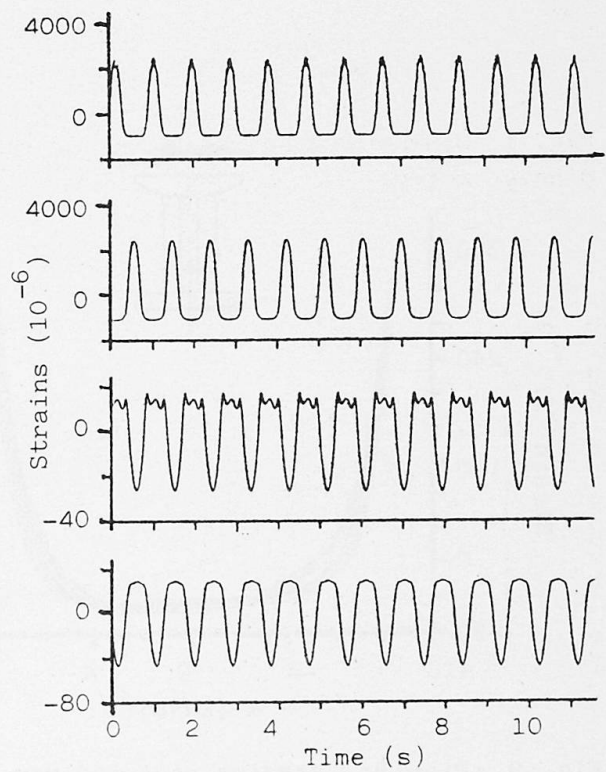
Fig. 6 Pier B: examples of strain behaviour showing contact of crack edges with shocks.

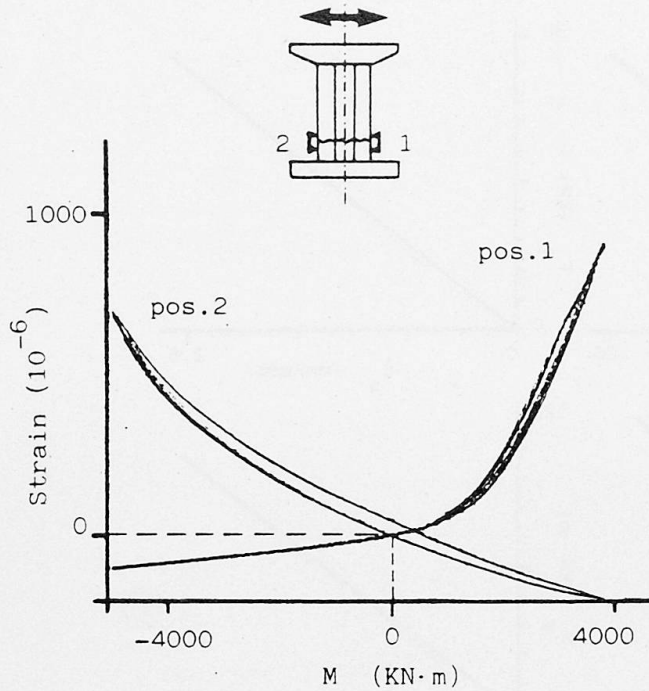
Fig. 7 Pier B: strains measured across cracks versus overturning moment. The non symmetric behaviour of the crack openings is clearly shown.

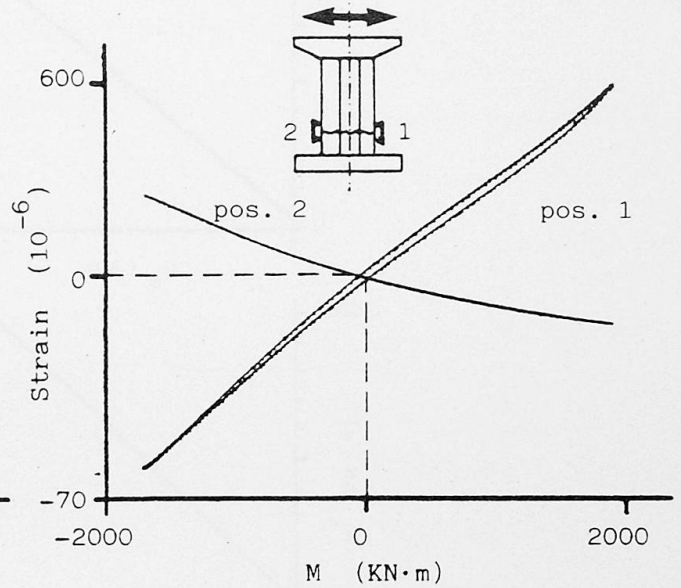
Fig. 8 Pier A: crack opening versus overturning moment. Position 1 shows mobilization of reinforcement in compression.

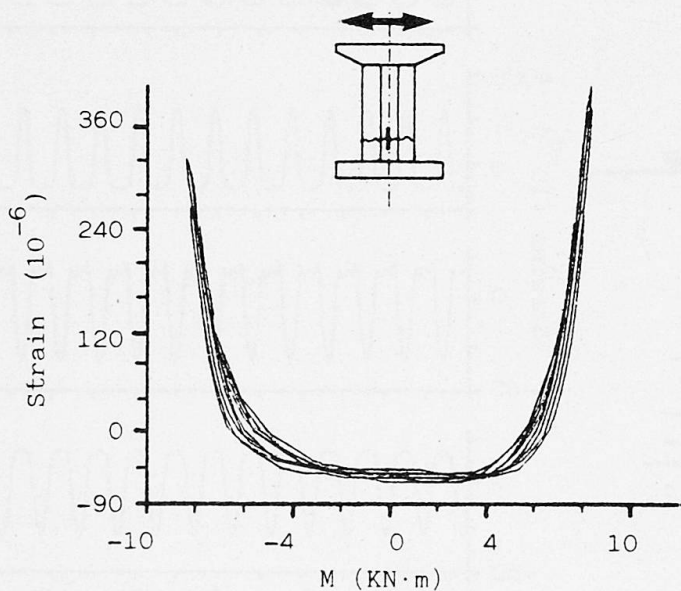
Fig. 9 Pier B: strains measured versus overturning moment across a crack on the "neutral axis" of the shaft.

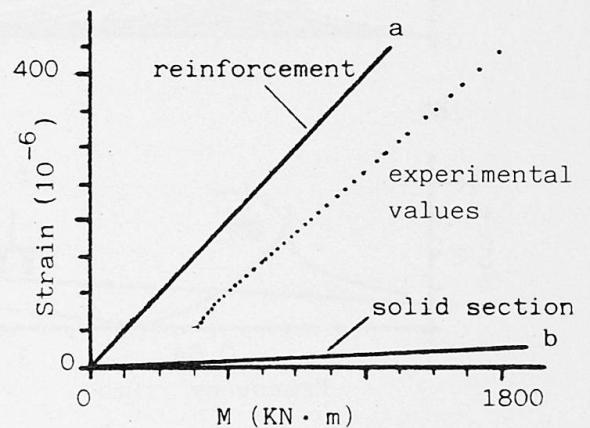
Fig. 10 Maximum strains versus overturning moment.

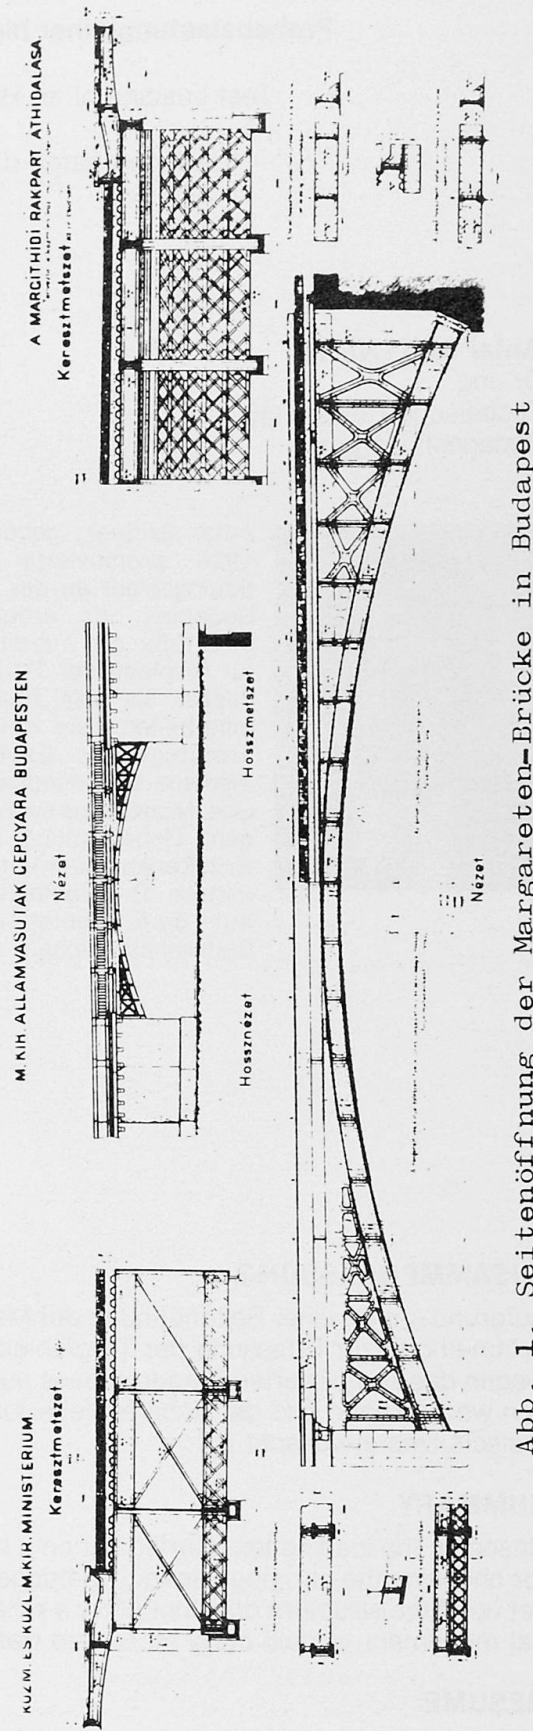
Abb. 1. Seitenöffnung der Margareten-Brücke in Budapest

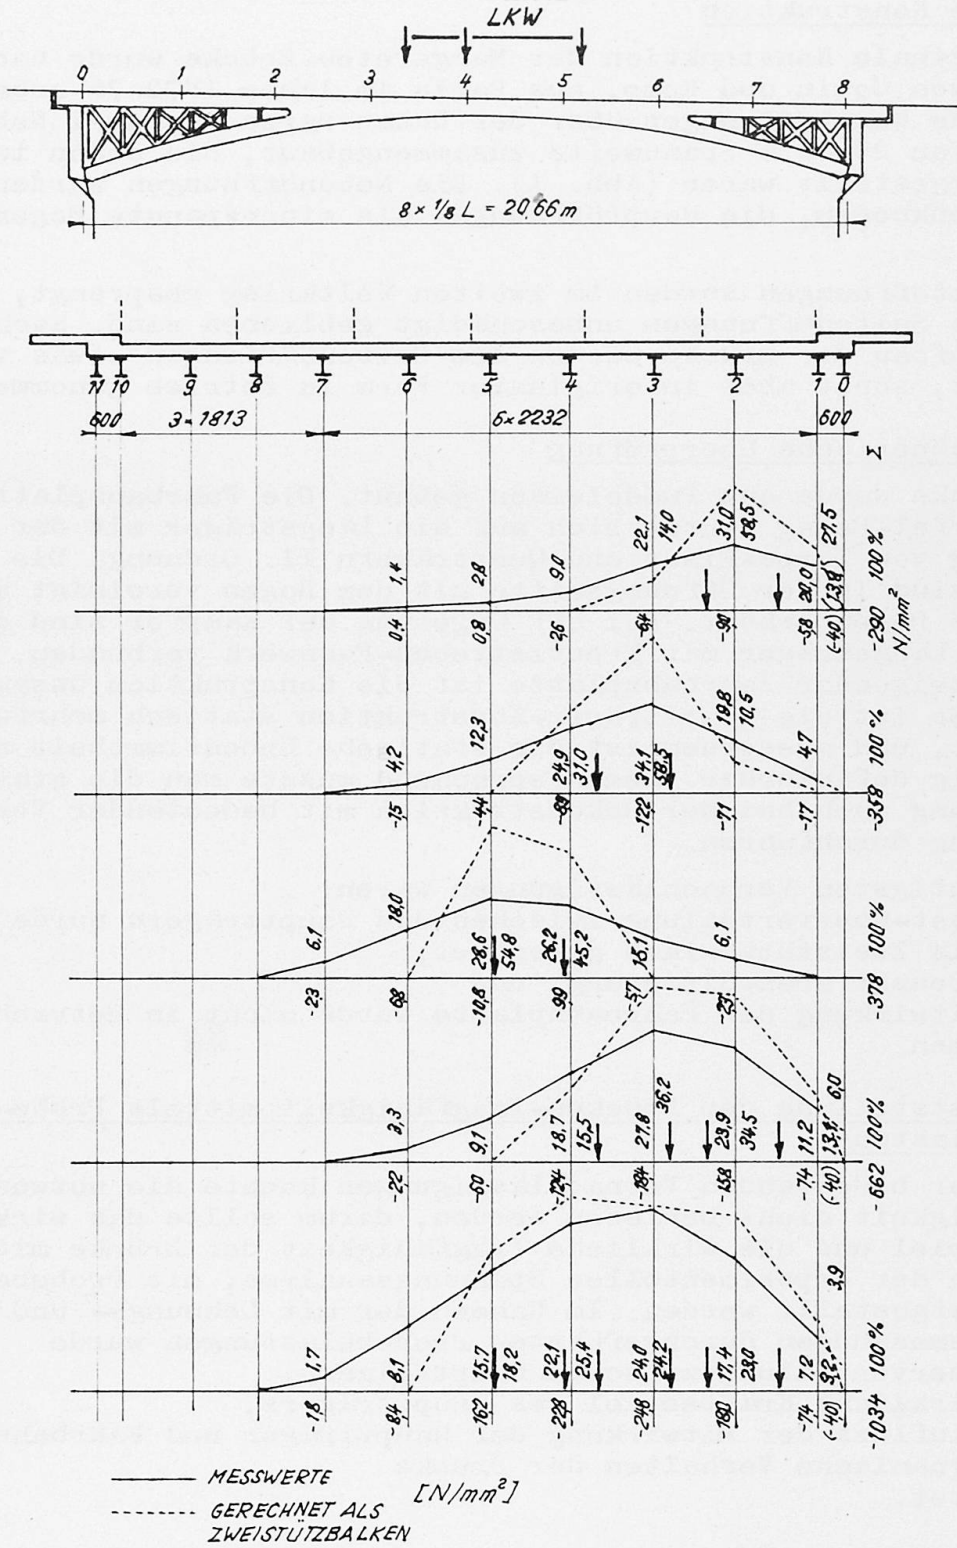
Abb. 2. Spannungen auf dem unteren Gurtblech der Bogenträger in dem Viertelquerschnitt

Die Untersuchung wurde mit in den Bogenvierteln auf den unteren Gurt aufgeklebten Dehnungsmess-Streifen durchgeführt. Die Position der in der Brückenhälfte stehenden LKW wurde in Querrichtung verändert. Dehnungen, bzw. Spannungen an den Hauptträgern deren Proportion die Erfassung der tatsächlichen Querverteilungsumständen ermöglichte, wurden inzwischen gemessen.

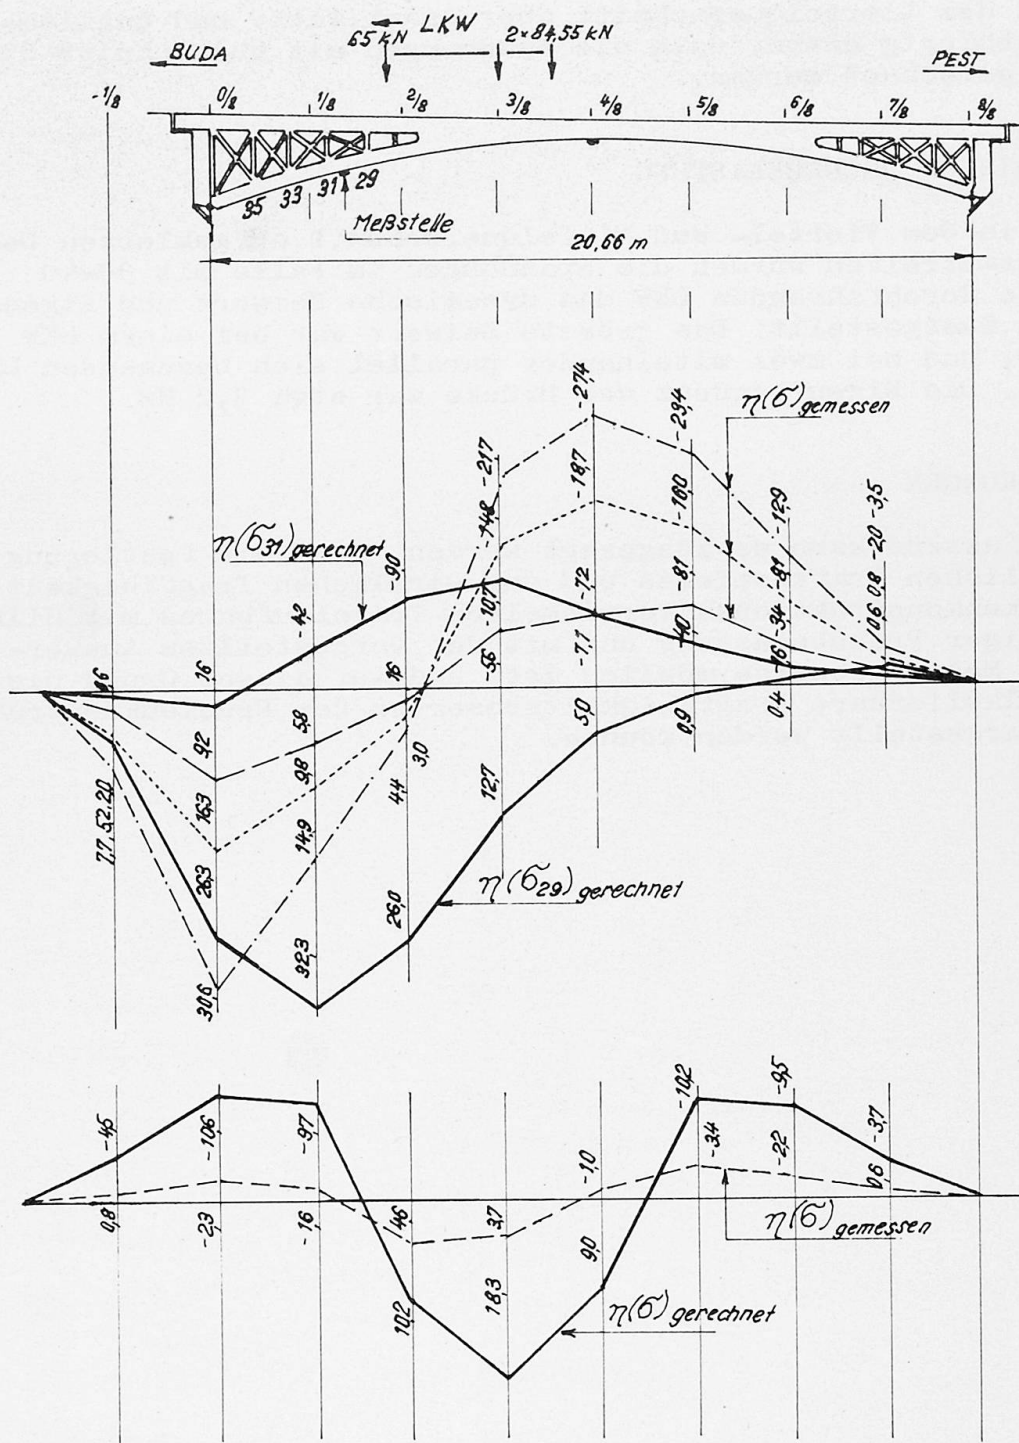
Abb. 4. Gerechnete und gemessene Lastenzug-Einflusslinie der Randfaser-Spannungen (N/mm²) in dem Viertel- und Mittelquerschnitt der Bogenbrücke

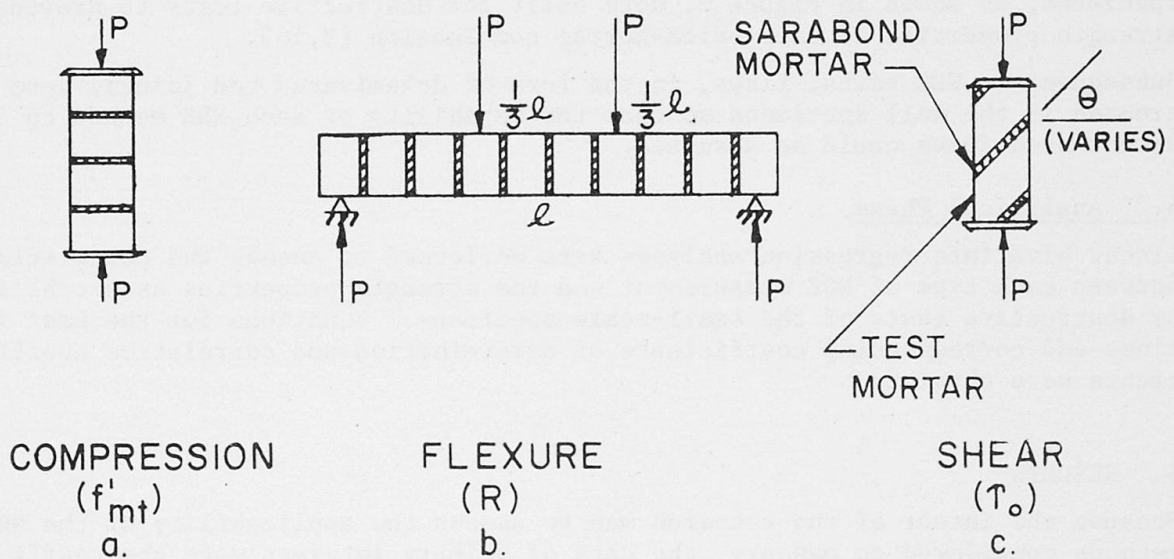
FIGURE 2 - SMALL-SCALE SPECIMENS

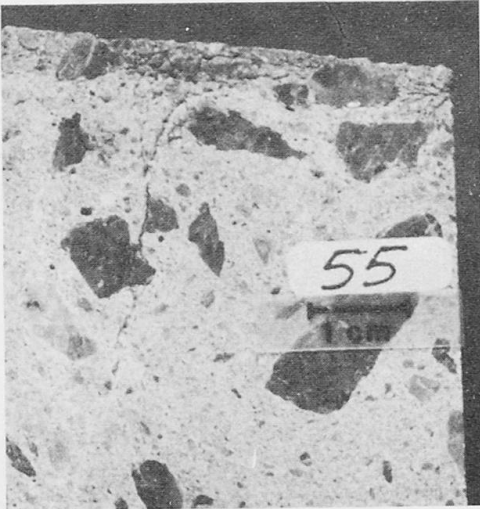
Fig. 1. Sawn cut of a concrete core with internal crack and low stone content.

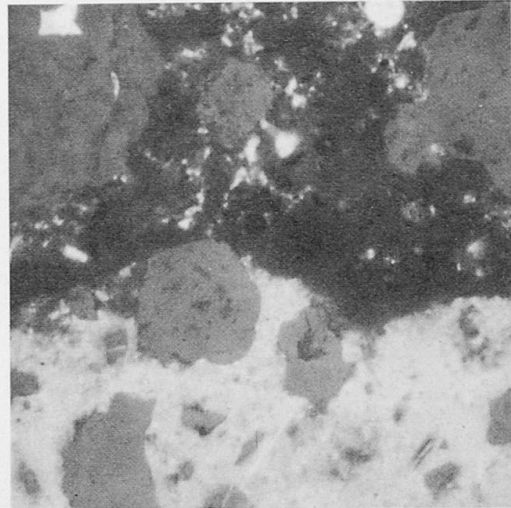
Fig. 10. Fluorescence. 65x.
Joint between old (porous) and new (dense) concrete.

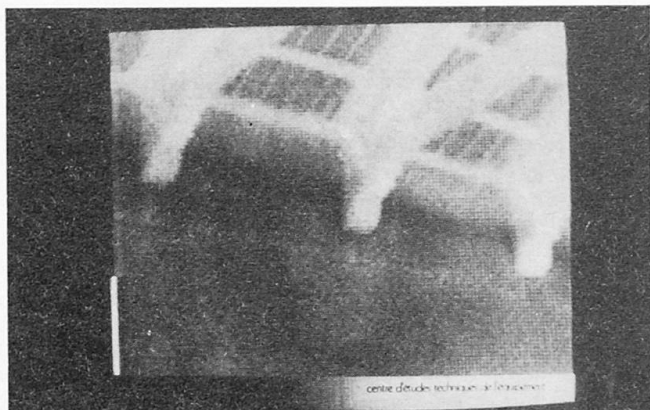
Fig. 6 Thermogramme du mur Nord

Les clichés infrarouge sur les mêmes parties de la structure révèlent la présence d'une trace rectiligne entre les corbeaux. Cette trace très bien délimitée fait penser à une poutre.

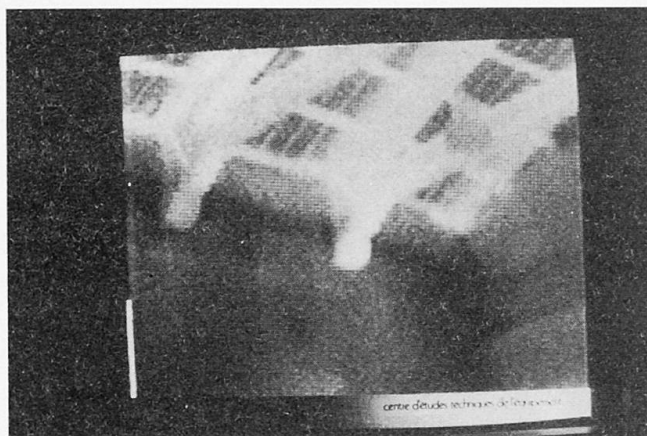
Fig.7 Extrémité du mur Nord

On note que la marque observée se prolonge jusqu'au mur Est. La présence d'une zone sombre dans l'angle de la pièce révèle que cet angle est pollué par l'humidité.

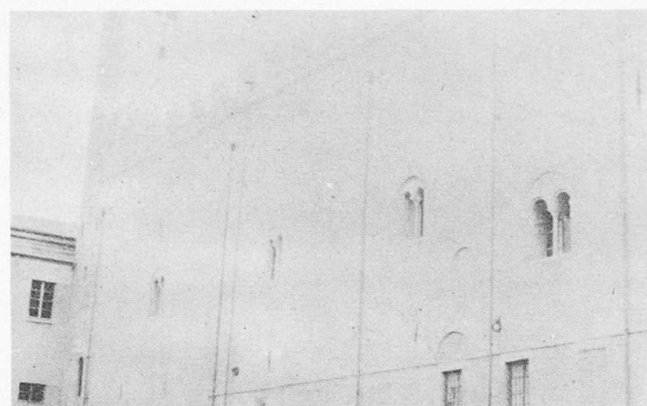
Fig. 8 Façade Nord

La photo ci-contre représente la façade Nord de l'édifice dont la Salle de Conseil occupe toute la partie supérieure. L'angle de la pièce montré sur l'image infrarouge précédente correspond à l'emplacement de la gouttière la plus à gauche.

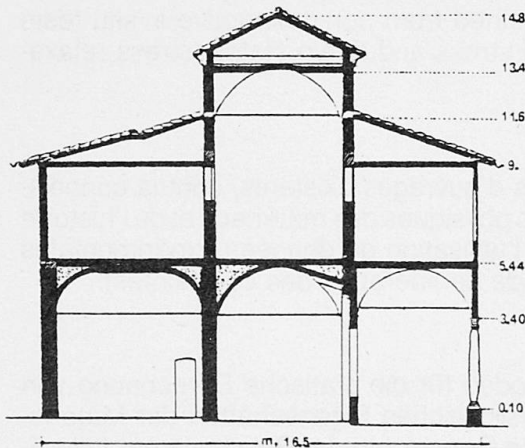
Fig. 2 Vertical section.

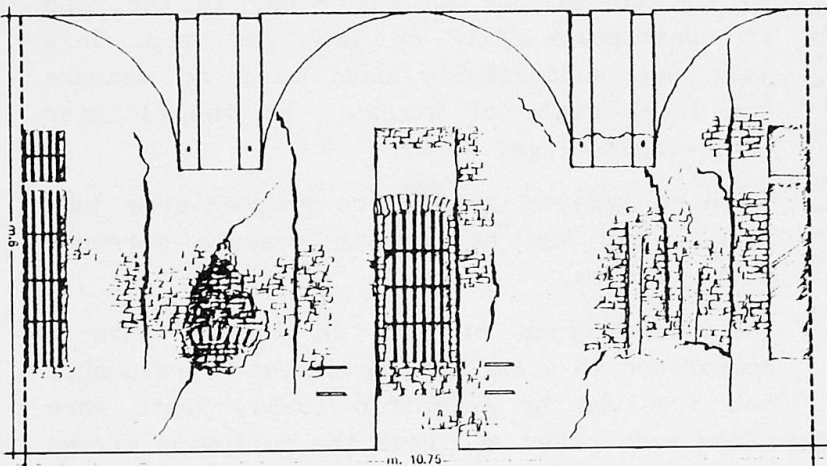
Fig. 5 Crack pattern representation.

The photogrammetric survey and the crack pattern representation (Figs. 4, 5) may be quite useful: they aid in defining

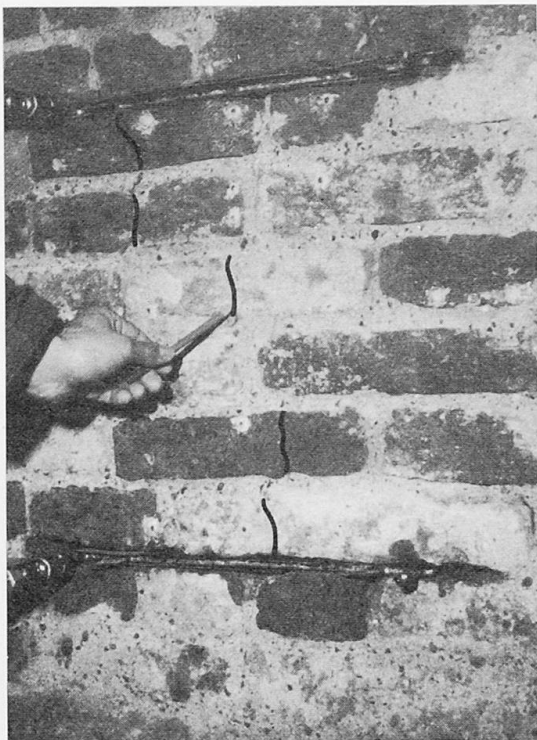
Fig. 12 Photo showing the appearance of first cracks.

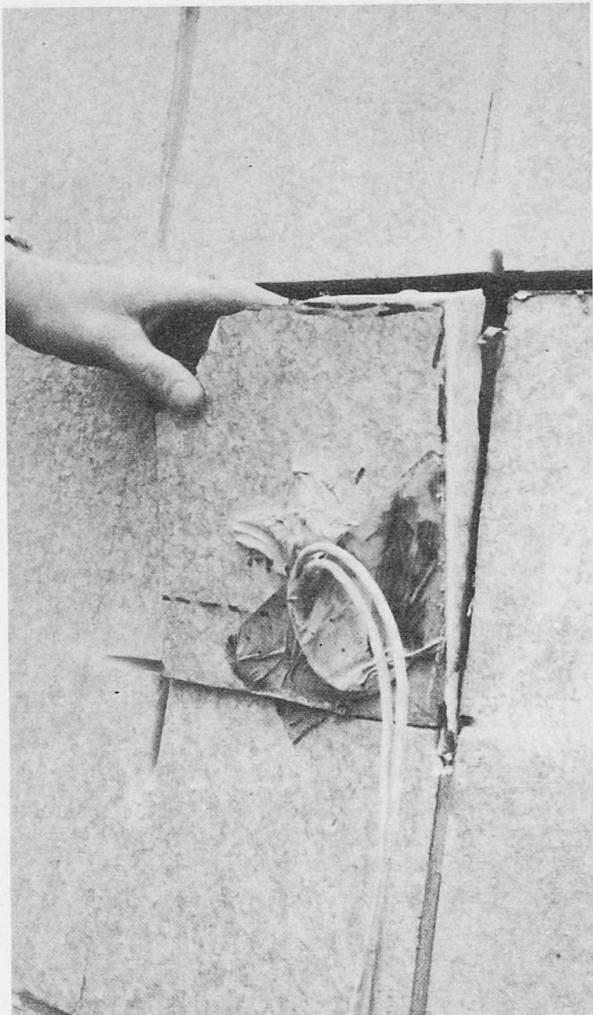
Fig. 6: Terra-cotta block, with strain gages attached, is cut loose.

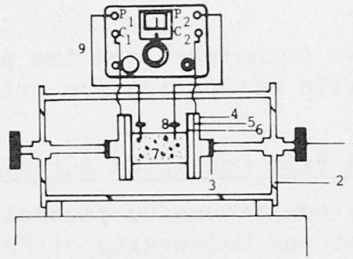
1. Screw for gripping the block
2. Steel frame
3. Insulator
4. Steel plate
5. Copper plate
6. Cloth pad
7. Concrete core
8. Copper pins inserted in concrete cores
9. Nilson 400 resistivity meter

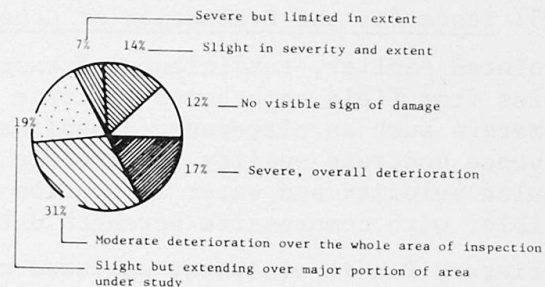
Fig.4: Classification of condition of 168 observations from concrete structures located in Eastern Saudi Arabia.

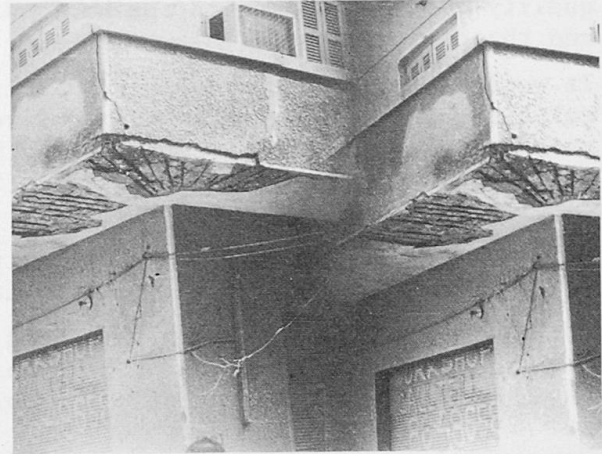
Fig. 6 Structure 2 showing concrete spalling due to rebar corrosion

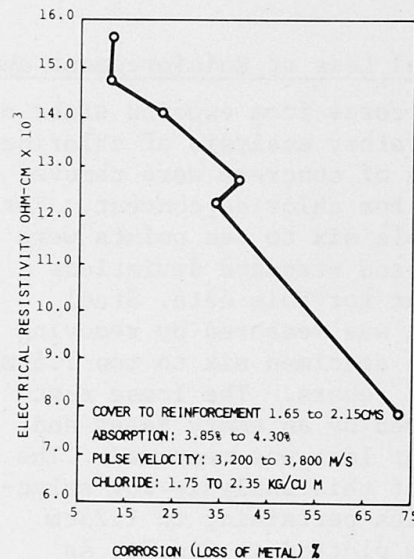
Fig.8: Relationship between electrical resistivity of concrete cored from field structures and metal loss.

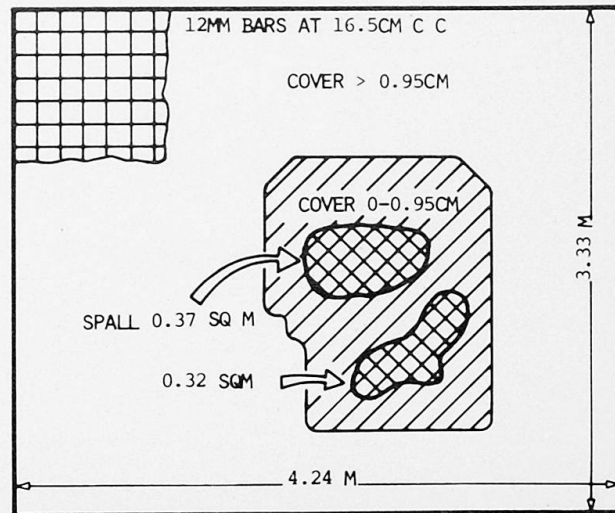
Fig.10: Concrete spalls related to inadequate cover.
