Artikel: Built up roofs - wind uplift resistance
Autor: Johansson, Germund
DOI: <https://doi.org/10.5169/seals-38321>

Built Up Roofs – Wind Uplift Resistance

Germund JOHANSSON

Chalmers Univ. of Technology
Göteborg, Sweden

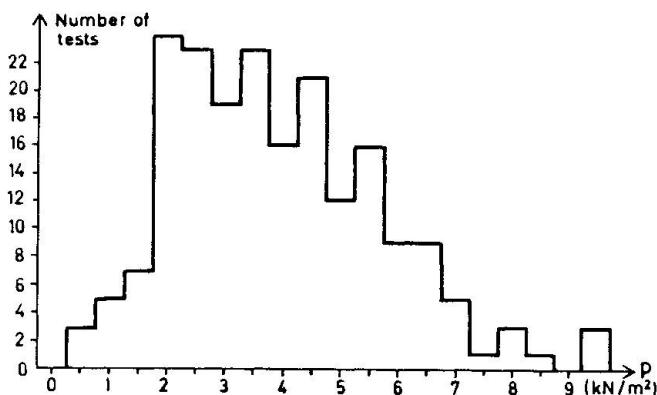
Fig.3 Measured strength of roofs with glass wool and mineral wool

In the middle of the 70's several roofs were tested with the equipment described. Twentyfive different roofs with insulation of fiber glass or mineral wool were tested with about ten specimens on each roof (200 in situ tests). The results showed a very large scatter, the maximum strength value obtained was more than twenty times the minimum value. The results are presented as a histogram in fig.3. The conclusion to be drawn is that the material quality and workmanship is not always what it ought to be. For instance, on one roof the lowest strength measured was 0.4 kN/m^2 and the highest 9.1 kN/m^2 , a difference as high as 8.7 kN/m^2 .

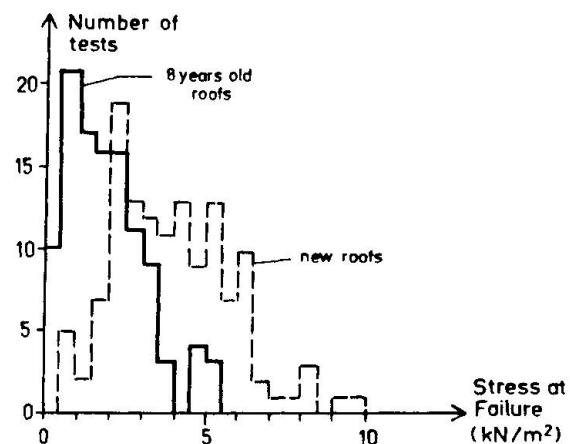
Fig.4 Measured strength of roofs with glass wool and mineral wool - comparison between old and new strength.

Eight years later, in the beginning of the 1980's, 13 of the roofs have been retested using the same equipment and the same technique. Some of the other roofs were "not available" for tests or they had blown off or they had been destroyed by fire. The results from the tests are a little bit frightening - there is a very large strength reduction. In table 1 some of the results are shown. After eight years the mean strength is reduced to about 50% of the original strength. The two histograms in fig.4 correspond to the measured strengths at all the roofs in table 1. The field tests show that for a new roof the fracture usually occur in the lower part of the insulation or between the insulation and the steel deck. Older roofs nearly always break in the upper part of the insulation just under the roofing felt.

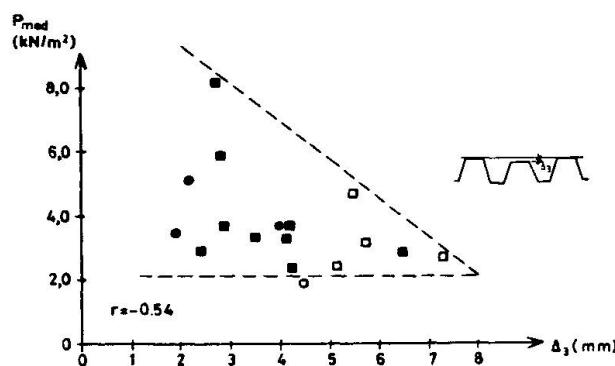
Fig.5 Relationship between measured strength (failure at sheeting – insulation interface) and measured flatness deviation Δ_3 for roofs insulated with mineral wool.

Unevenness of the sheeting surface has some effect on the strength. There does not seem to be a definite relationship, but approximate scatter range can be discerned. The relationship between strength and the measured deviation over three corrugations, Δ_3 , are plotted in fig.5 for 18 roofs. The conclusion which can be drawn from these figures is that a more even roof surface may increase the short-term strength, but need not necessarily do so.

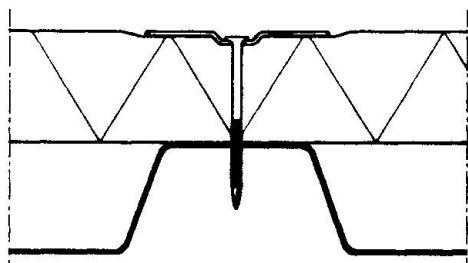
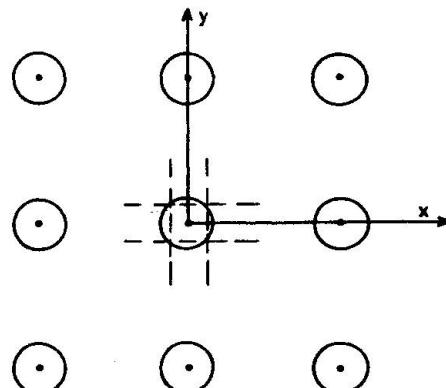
Fig. 7 Mechanical fasteners. Possible folding lines for the washers are indicated.

Storm damages due to the low strength have led to a new concept. Instead of using asphalt bonding most of the roofs nowadays have mechanical fasteners. This means that the requirements on the steel deck have been reduced and that the roof behaves in a different way. The use of mechanical fasteners on roofs have led to very few storm-damaged roofs. There are many different types but most of them consist of a screw and a washer. The fasteners are placed in a rectangular net, fig.7.

the boundary between the areas inclines 45° degrees to the attachment lines. The load on the screw, the total force, is the sum of all the loads on the different areas, I-IV, fig.8. The maximum load of the fastener occurs when the load on any of the perimeters I, II, III, IV reaches its maximum (fracture) level. If the exterior load is assumed to be carried the nearest way from the membrane to the fastener we get the influence areas shown in fig.9. When the external load q causes fracture in the fastener the load on perimeter II is

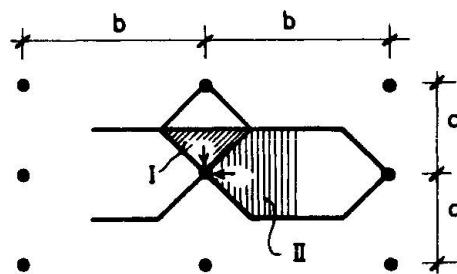
Fig. 9 Influence areas. Area I = $a^2/4$

$$P_{II} = q \cdot \frac{a}{2} (b - \frac{a}{2}) \quad (1)$$

The corresponding load at perimeter I is

$$P_I = \frac{a/2}{(b-a/2)} P_{II} \quad (2)$$

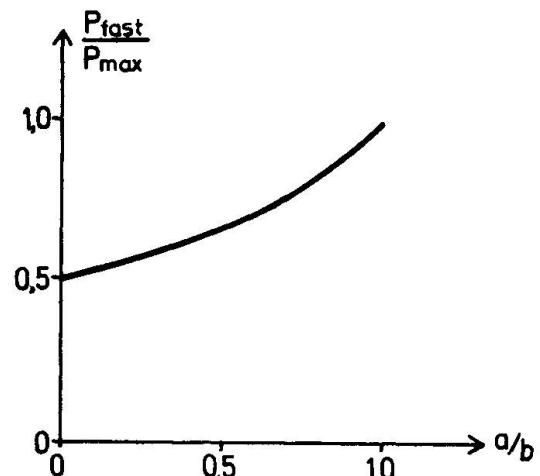
Fig. 10 Maximum load in the fastener as a function of a/b

The maximum load for the fastener is reached for $a = b$ and P_{max} is $4P_{II}$. The ratio a/b is governing the maximum load in the fastener and in fig.10 the ratio P_{fast}/P_{max} is shown.

$$P_{fast}/P_{max} = 0.5 + 0.5/(2 b/a - 1) \quad (4)$$

From eq (4) you will find that doubling the number of fasteners by changing from a quadratic net $a \times a$ to a rectangular net $\frac{a}{2} \times a$ will raise the external load by 33%. (P_{fast}/P_{max} decreases from 1 to 0.67) There have been conducted tests [2] on
