# Built up roofs - wind uplift resistance

Autor(en): **Johansson, Germund**

Zeitschrift: **IABSE reports = Rapports AIPC = IVBH Berichte**

Band (Jahr): **49 (1986)**

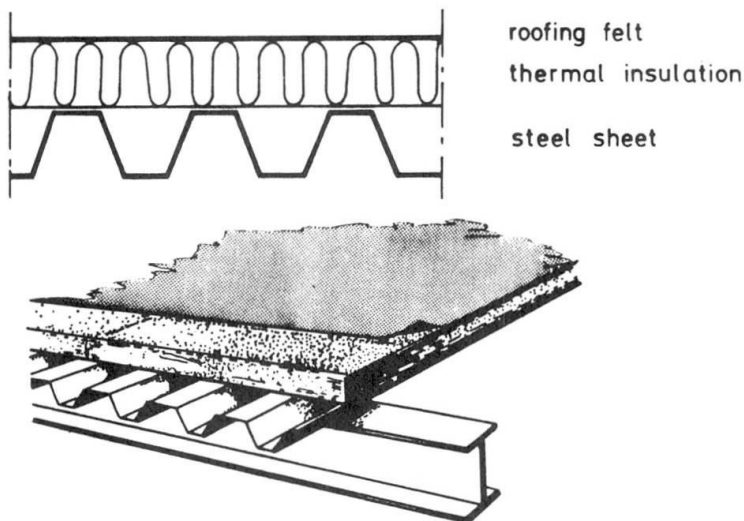
Fig.1 Built up roof

An externally insulated sheet metal roof consists of load-bearing trapezoidal metal sheet, thermal insulation and a covering surface. The insulation and the surface covering can be fixed to the sheet either by means of mechanical fasteners or by asphalt. Earlier the insulation were traditionally fixed to the sheet metal by bonding with warm asphalt. Nowadays often mechanical fasteners are used. In the case of mineral-wool insulated roofs the washers for these fixing devices are placed on the lower felt layer or, in certain cases, directly on the insulation.

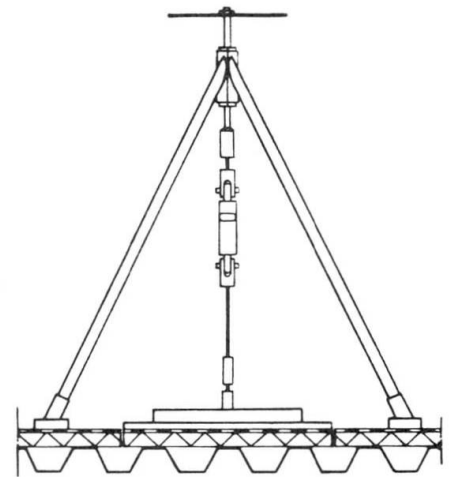
Fig.2 Test equipment for wind uplift testing

The test equipment used consists of three main parts - a stand with lift outfit, a frame to be attached to the specimen and a dynamometer between the stand and the frame, fig.2. The stand is made of aluminium and wood. The lifting force is achieved via screw in the top of the stand. A 22 mm thick slab of chipboard was bonded with hot asphalt to the surface of the roofing felt. The width of the chipboard slab is 500 mm and the length is governed by the pitch of the steel sheet. After having glued the board slab and screwed the frame to the slab, the insulation and the roofing felt were cut along the slab lines. The test method is easy to handle but it has some disadvantages - the test surface is disturbed by cutting and by gluing with hot asphalt. However, some test roofs which showed very low strength have later blown off during storms and the roofs with high values for the strength have not done so.

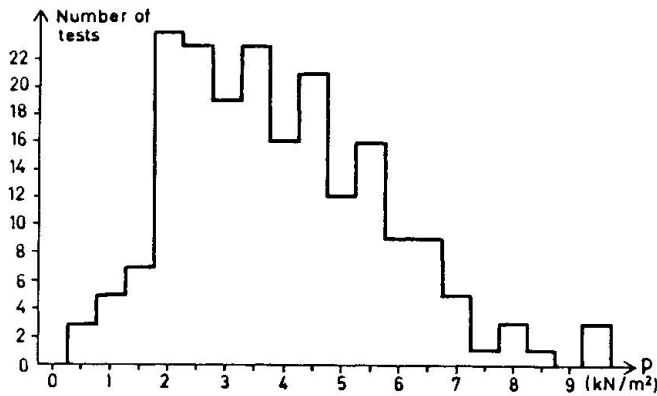
Fig.3 Measured strength of roofs with glass wool and mineral wool

In the middle of the 70's several roofs were tested with the equipment described. Twentyfive different roofs with insulation of fiber glass or mineral wool were tested with about ten specimens on each roof (200 in situ tests). The results showed a very large scatter, the maximum strength value obtained was more than twenty times the minimum value. The results are presented as a histogram in fig.3. The conclusion to be drawn is that the material quality and workmanship is not always what it ought to be. For instance, on one roof the lowest strength measured was 0.4 kN/m<sup>2</sup> and the highest 9.1 kN/m<sup>2</sup>, a difference as high as 8.7 kN/m<sup>2</sup>.

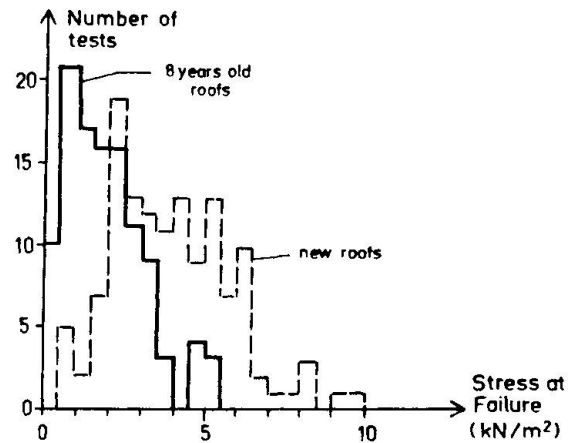
Fig.4 Measured strength of roofs with glass wool and mineral wool - comparison between old and new strength,

Eight years later, in the beginning of the 1980's, 13 of the roofs have been re-tested using the same equipment and the same technique. Some of the other roofs were "not available" for tests or they had blown off or they had been destroyed by fire. The results from the tests are a little bit frightening - there is a very large strength reduction. In table 1 some of the results are shown. After eight years the mean strength is reduced to about 50% of the original strength. The two histograms in fig.4 correspond to the measured strengths at all the roofs in table 1. The field tests show that for a new roof the fracture usually occur in the lower part of the insulation or between the insulation and the steel deck. Older roofs nearly always break in the upper part of the insulation just under the roofing felt.

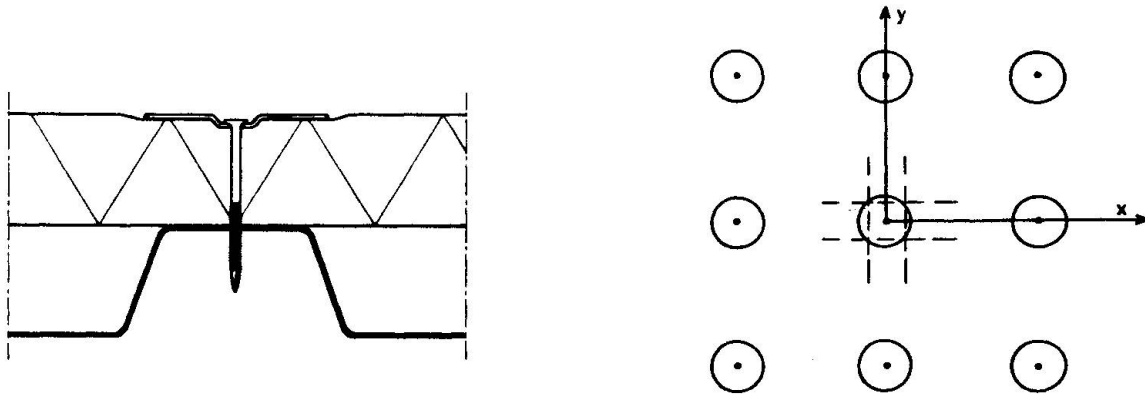
Fig. 7 Mechanical fasteners. Possible folding lines for the washers are indicated.

Storm damages due to the low strength have led to a new concept. Instead of using asphalt bonding most of the roofs nowadays have mechanical fasteners. This means that the requirements on the steel deck have been reduced and that the roof behaves in a different way. The use of mechanical fasteners on roofs have led to very few storm-damaged roofs. There are many different types but most of them consist of a screw and a washer. The fasteners are placed in a rectangular net, fig.7.

"Full scale tests" with suction box have shown that there is not linear relationship between the limit load and the number of screws  $\text{mer m}^2$  if fracture occurs in the attachment between the water proofing membrane and the fastener. Usually fracture appears to be a combination of bending in the washer and punching of the membrane. The washer and its perimeter can be divided in four different parts where

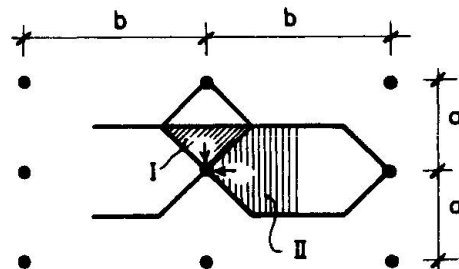
Fig. 9 Influence areas. Area I =  $a^2/4$

the boundary between the areas inclines 45° degrees to the attachment lines. The load on the screw, the total force, is the sum of all the loads on the different areas, I-IV, fig. 8. The maximum load of the fastener occurs when the load on any of the perimeters I, II, III, IV reaches its maximum (fracture) level. If the exterior load is assumed to be carried the nearest way from the membrane to the fastener we get the influence areas shown in fig. 9. When the external load  $q$  causes fracture in the fastener the load on perimeter II is

$$P_{II} = q \cdot \frac{a}{2} \left( b - \frac{a}{2} \right) \tag{1}$$

The corresponding load at perimeter I is

$$P_I = \frac{a/2}{(b-a/2)} P_{II} \tag{2}$$

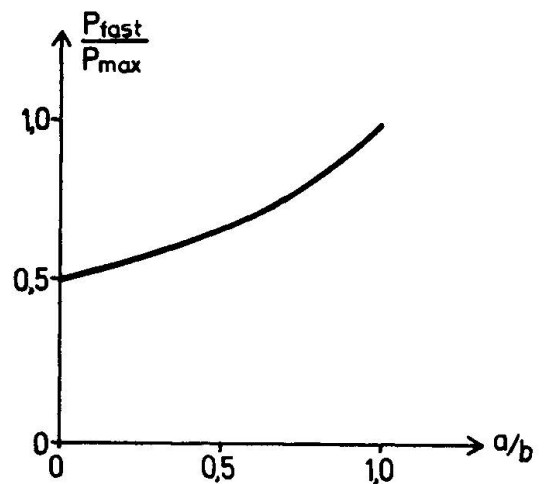
Fig.10 Maximum load in the fastener as a function of  $a/b$

The maximum load for the fastener is reached for  $a = b$  and  $P_{max}$  is  $4P_{II}$ . The ratio  $a/b$  is governing the maximum load in the fastener and in fig. 10 the ratio  $P_{fast}/P_{max}$  is shown.

$$P_{fast}/P_{max} = 0.5 + 0.5/(2 b/a - 1) \tag{4}$$

From eq (4) you will find that doubling the number of fasteners by changing from a quadratic net  $a \times a$  to a rectangular net  $\frac{a}{2} \times a$  will raise the external load by 33%. ( $P_{fast}/P_{max}$  decreases from 1 to 0.67) There have been conducted tests [2] on
