Built Up Roofs – Wind Uplift Resistance

Germund JOHANSSON

Assist. Prof.
Chalmers Univ. of Technology
Göteborg, Sweden

Results from laboratory and in situ tests with glued fasteners (steel deck – insulation – roofing felt) are presented. It is shown how to predict the «strength on the roof» from the laboratory test results. The roofs tested have been retested 8 years later with the same equipment and these results show that the strength has been reduced – in some cases to a very low level. The paper includes a theoretical analysis of the behaviour of mechanical fasteners and a comparison with tests.

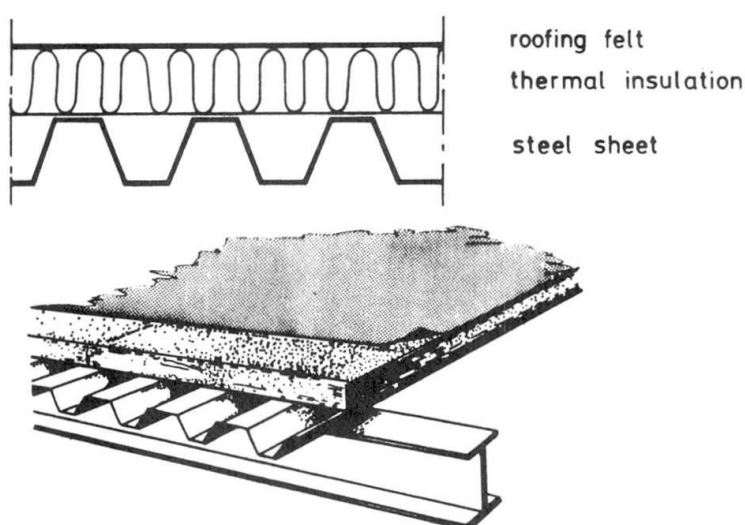
Fig.1 Built up roof

An externally insulated sheet metal roof consists of load-bearing trapezoidal metal sheet, thermal insulation and a covering surface. The insulation and the surface covering can be fixed to the sheet either by means of mechanical fasteners or by asphalt. Earlier the insulation were traditionally fixed to the sheet metal by bonding with warm asphalt. Nowadays often mechanical fasteners are used. In the case of mineral-wool insulated roofs the washers for these fixing devices are placed on the lower felt layer or, in certain cases, directly on the insulation.

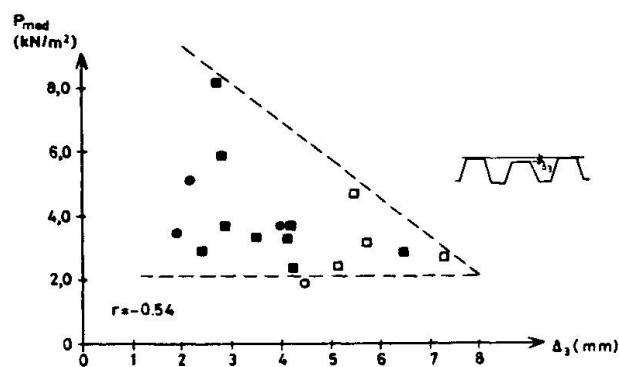
Fig.5 Relationship between measured strength (failure at sheeting - insulation interface) and measured flatness deviation Δ_3 for roofs insulated with mineral wool.

Unevenness of the sheeting surface has some effect on the strength. There does not seem to be a definite relationship, but approximate scatter range can be discerned. The relationship between strength and the measured deviation over three corrugations, Δ_3 , are plotted in fig.5 for 18 roofs. The conclusion which can be drawn from these figures is that a more even roof surface may increase the short-term strength, but need not necessarily do so.

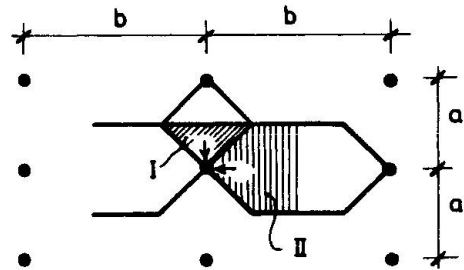
Fig.9 Influence areas. Area I = $a^2/4$

the boundary between the areas inclines 45° degrees to the attachment lines. The load on the screw, the total force, is the sum of all the loads on the different areas, I-IV, fig.8. The maximum load of the fastener occurs when the load on any of the perimeters I, II, III, IV reaches its maximum (fracture) level. If the exterior load is assumed to be carried the nearest way from the membrane to the fastener we get the influence areas shown in fig.9. When the external load q causes fracture in the fastener the load on perimeter II is

$$P_{II} = q \cdot \frac{a}{2} (b - \frac{a}{2}) \quad (1)$$

The corresponding load at perimeter I is

$$P_I = \frac{a/2}{(b-a/2)} P_{II} \quad (2)$$
