Artikel: Built up roofs - wind uplift resistance
Autor: Johansson, Germund
DOI: <https://doi.org/10.5169/seals-38321>

Built Up Roofs – Wind Uplift Resistance

Germund JOHANSSON

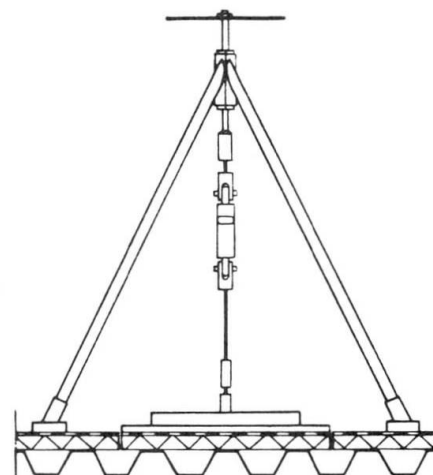
Fig.2 Test equipment for wind uplift testing

The test equipment used consists of three main parts – a stand with lift outfit, a frame to be attached to the specimen and a dynamometer between the stand and the frame, fig.2. The stand is made of aluminium and wood. The lifting force is achieved via screw in the top of the stand. A 22 mm thick slab of chipboard was bonded with hot asphalt to the surface of the roofing felt. The width of the chipboard slab is 500 mm and the length is governed by the pitch of the steel sheet. After having glued the board slab and screwed the frame to the slab, the insulation and the roofing felt were cut along the slab lines. The test method is easy to handle but it has some disadvantages – the test surface is disturbed by cutting and by gluing with hot asphalt. However, some test roofs which showed very low strength have later blown off during storms and the roofs with high values for the strength have not done so.

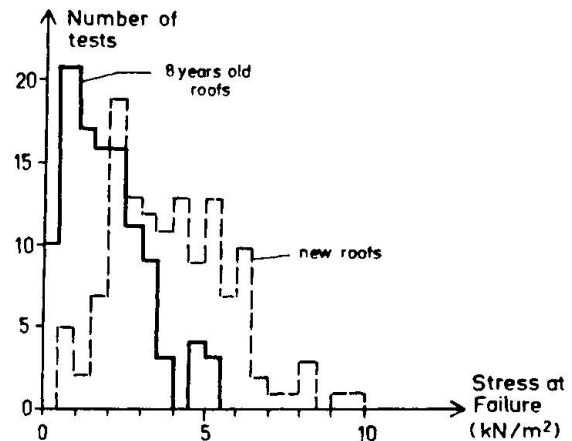
Fig.4 Measured strength of roofs with glass wool and mineral wool - comparison between old and new strength.

Eight years later, in the beginning of the 1980's, 13 of the roofs have been re-tested using the same equipment and the same technique. Some of the other roofs were "not available" for tests or they had blown off or they had been destroyed by fire. The results from the tests are a little bit frightening - there is a very large strength reduction. In table 1 some of the results are shown. After eight years the mean strength is reduced to about 50% of the original strength. The two histograms in fig.4 correspond to the measured strengths at all the roofs in table 1. The field tests show that for a new roof the fracture usually occur in the lower part of the insulation or between the insulation and the steel deck. Older roofs nearly always break in the upper part of the insulation just under the roofing felt.

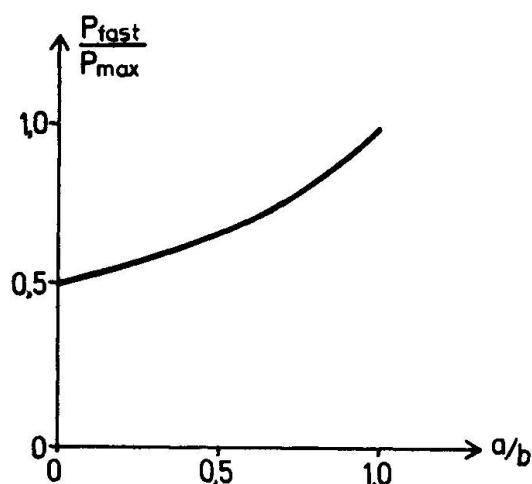
Fig.10 Maximum load in the fastener as a function of a/b

The maximum load for the fastener is reached for $a = b$ and P_{max} is $4P_{II}$. The ratio a/b is governing the maximum load in the fastener and in fig.10 the ratio P_{fast}/P_{max} is shown.

$$P_{fast}/P_{max} = 0.5 + 0.5/(2 b/a - 1) \quad (4)$$

From eq (4) you will find that doubling the number of fasteners by changing from a quadratic net $a \times a$ to a rectangular net $\frac{a}{2} \times a$ will raise the external load by 33%. (P_{fast}/P_{max} decreases from 1 to 0.67) There have been conducted tests [2] on
