Quality Assurance and Safety in Highway Construction

Otto M. VOGLER

Consulting Engineer
Vienna, Austria

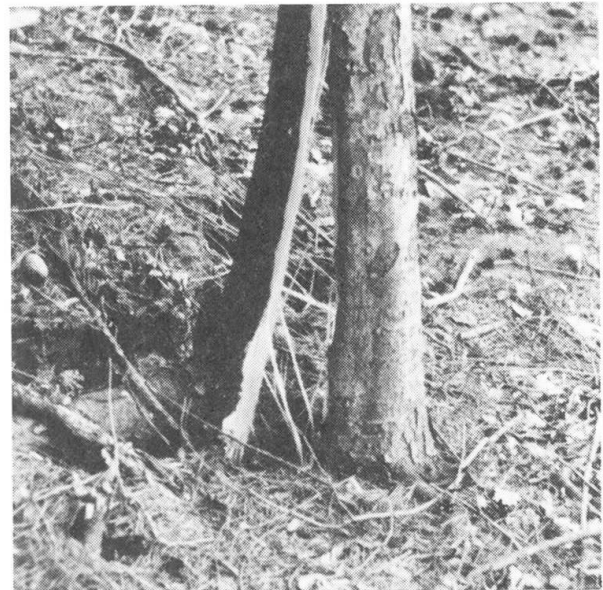
Fig. 6: Crack Above Slope.
Width of Crack: 20 cm,
Distance to Road: 70 m

Accordingly, slope movement became apparent in many of the cuttings during excavation. In many locations, cracks (width: several decimeters) occurred at a distance of 200 m from the road. In other places, the movement could be detected only with the help of careful slope-indicator measurements. Slope indicators can also be used to determine the depth of the gliding layers and the speed of the gliding movement. In one location, 29,000 m³ of material moved towards the road level, more or less suddenly, after the slopes had remained in balance for two months and after landscaping had begun.

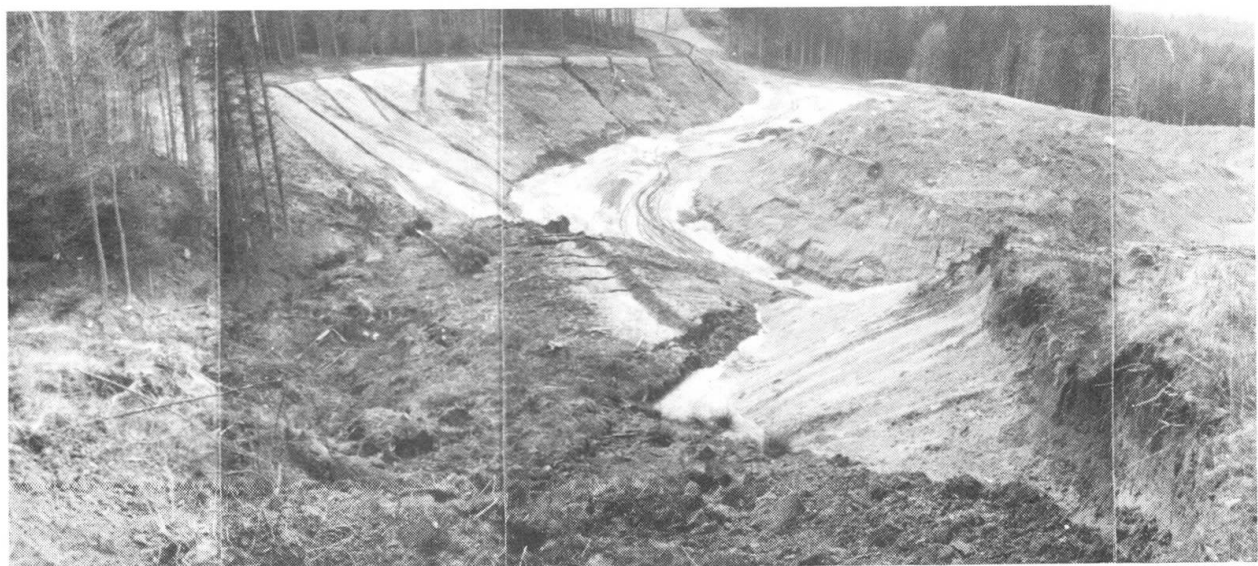
Figure 7 A Rock Mass of 29,000 m³ Glides Off.
