Quality Assurance and Safety in Highway Construction

Otto M. VOGLER

Consulting Engineer
Vienna, Austria

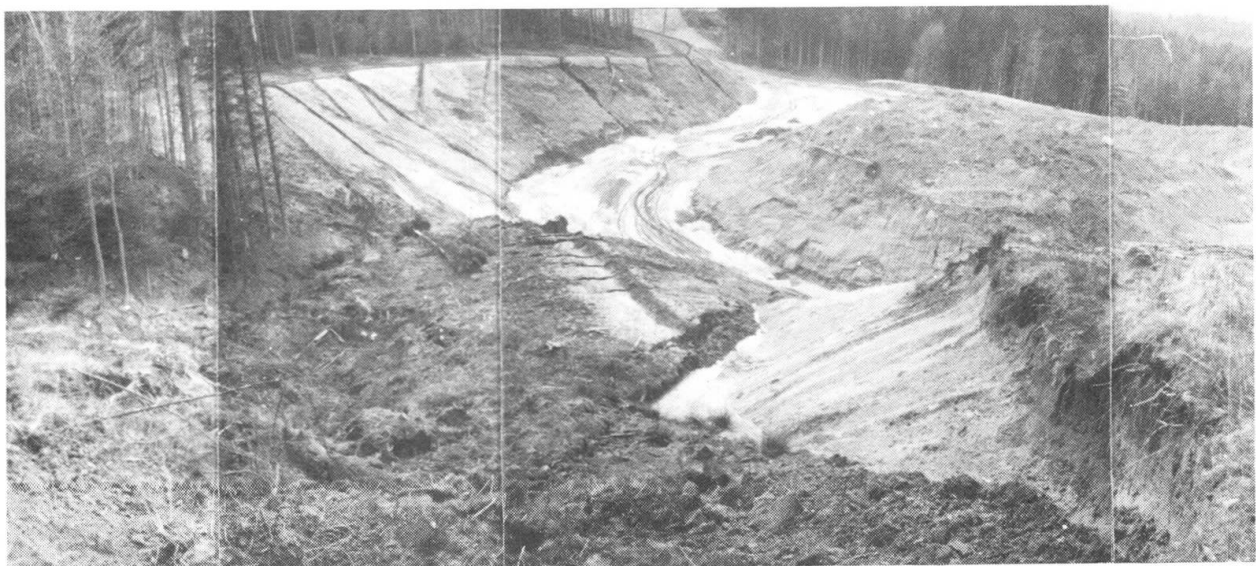
Figure 7 A Rock Mass of 29,000 m³ Glides Off.
