**Artikel:** Quality assurance and safety in highway construction  
**Autor:** Vogler, Otto M.  
**DOI:** <https://doi.org/10.5169/seals-39595>

## Quality Assurance and Safety in Highway Construction

**Otto M. VOGLER**  
Consulting Engineer  
Vienna, Austria

The paper discusses the organisational and human aspects encountered in project management and on-site project supervision. Examples taken from five tunnel projects, with a total length of 6 km, and a highway-construction project (approximate length 30 km) demonstrate how continually changing geological and soil-mechanical conditions can be met in optimum form, in order to produce, with economies, safe and high-quality structures.

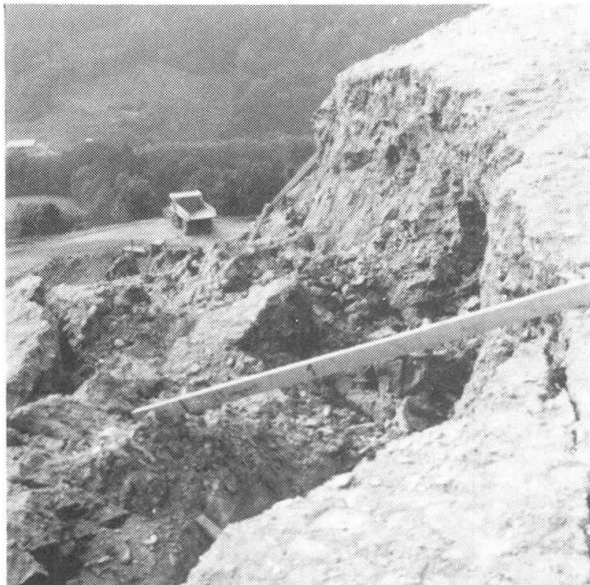
**Fig. 5:** Loosened Rock Masses  
Gliding Off.  
Height of Slope: 50 m

Accordingly, slope movement became apparent in many of the cuttings during excavation. In many locations, cracks (width: several decimeters) occurred at a distance of 200 m from the road. In other places, the movement could be detected only with the help of careful slope-indicator measurements. Slope indicators can also be used to determine the depth of the gliding layers and the speed of the gliding movement. In one location, 29,000 m<sup>3</sup> of material moved towards the road level, more or less suddenly, after the slopes had remained in balance for two months and after landscaping had begun.

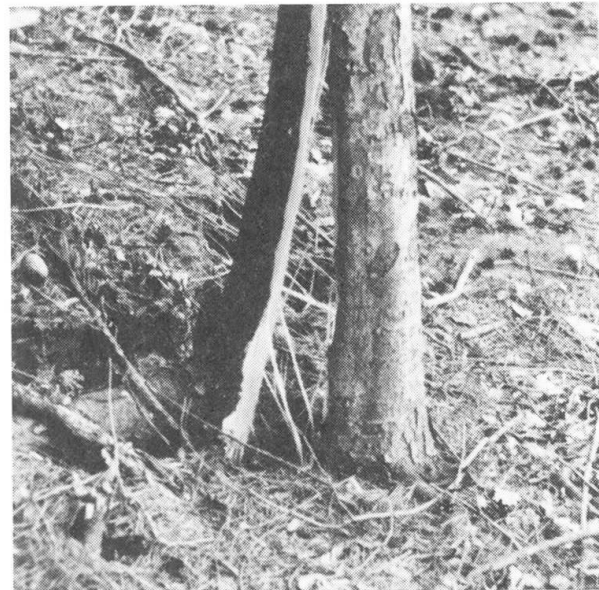
**Fig. 6:** Crack Above Slope.  
Width of Crack: 20 cm,  
Distance to Road: 70 m

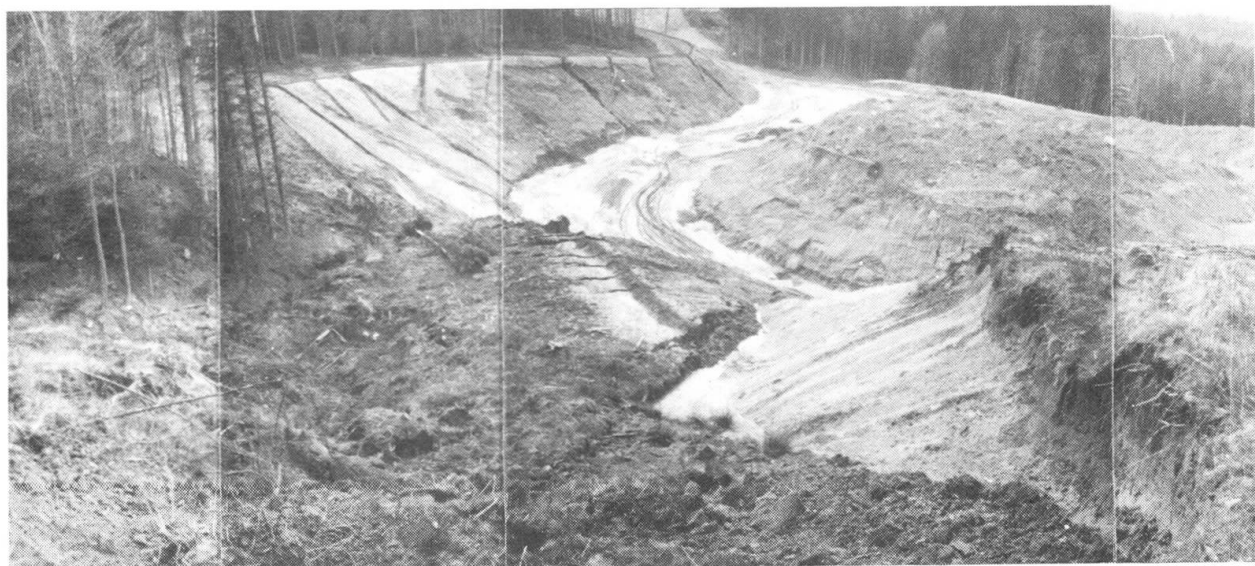
**Figure 7** A Rock Mass of 29,000 m<sup>3</sup> Glides Off.
