Quality Assurance and Safety in Highway Construction

Otto M. VOGLER

Consulting Engineer
Vienna, Austria

The paper discusses the organisational and human aspects encountered in project management and on-site project supervision. Examples taken from five tunnel projects, with a total length of 6 km, and a highway-construction project (approximate length 30 km) demonstrate how continually changing geological and soil-mechanical conditions can be met in optimum form, in order to produce, with economies, safe and high-quality structures.

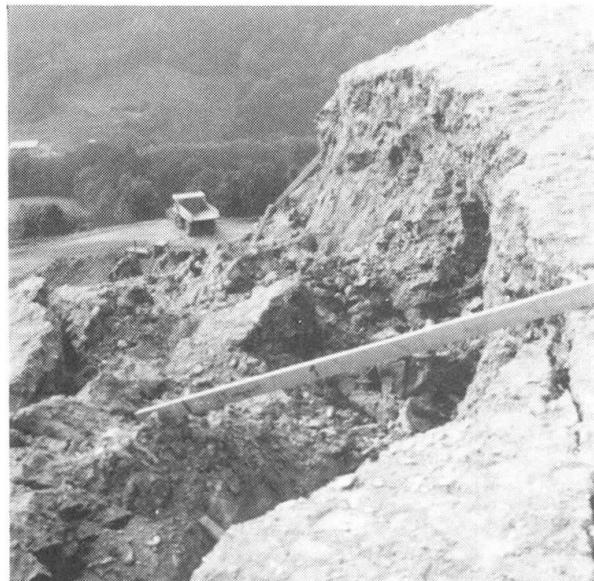
Fig. 5: Loosened Rock Masses
Gliding Off.
Height of Slope: 50 m

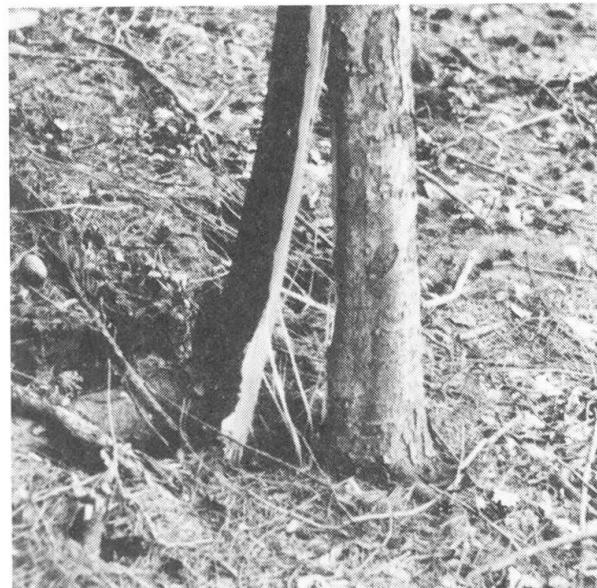
Fig. 6: Crack Above Slope.
Width of Crack: 20 cm,
Distance to Road: 70 m

Accordingly, slope movement became apparent in many of the cuttings during excavation. In many locations, cracks (width: several decimeters) occurred at a distance of 200 m from the road. In other places, the movement could be detected only with the help of careful slope-indicator measurements. Slope indicators can also be used to determine the depth of the gliding layers and the speed of the gliding movement. In one location, 29,000 m³ of material moved towards the road level, more or less suddenly, after the slopes had remained in balance for two months and after landscaping had begun.

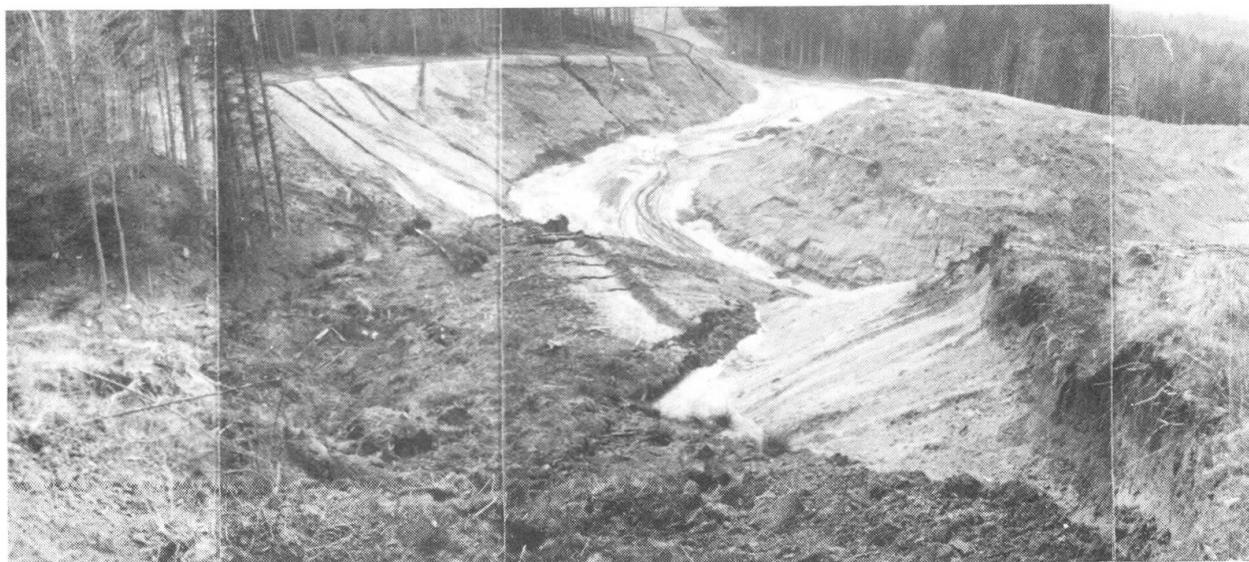
Figure 7 A Rock Mass of 29,000 m³ Glides Off.
