Zeitschrift: IABSE reports = Rapports AIPC = IVBH Berichte
Band: 52 (1986)
Rubrik: Poster sessions

POSTER SESSIONS

TSING YI SOUTH BRIDGE
ASSESSMENT AND REPAIRS
1986

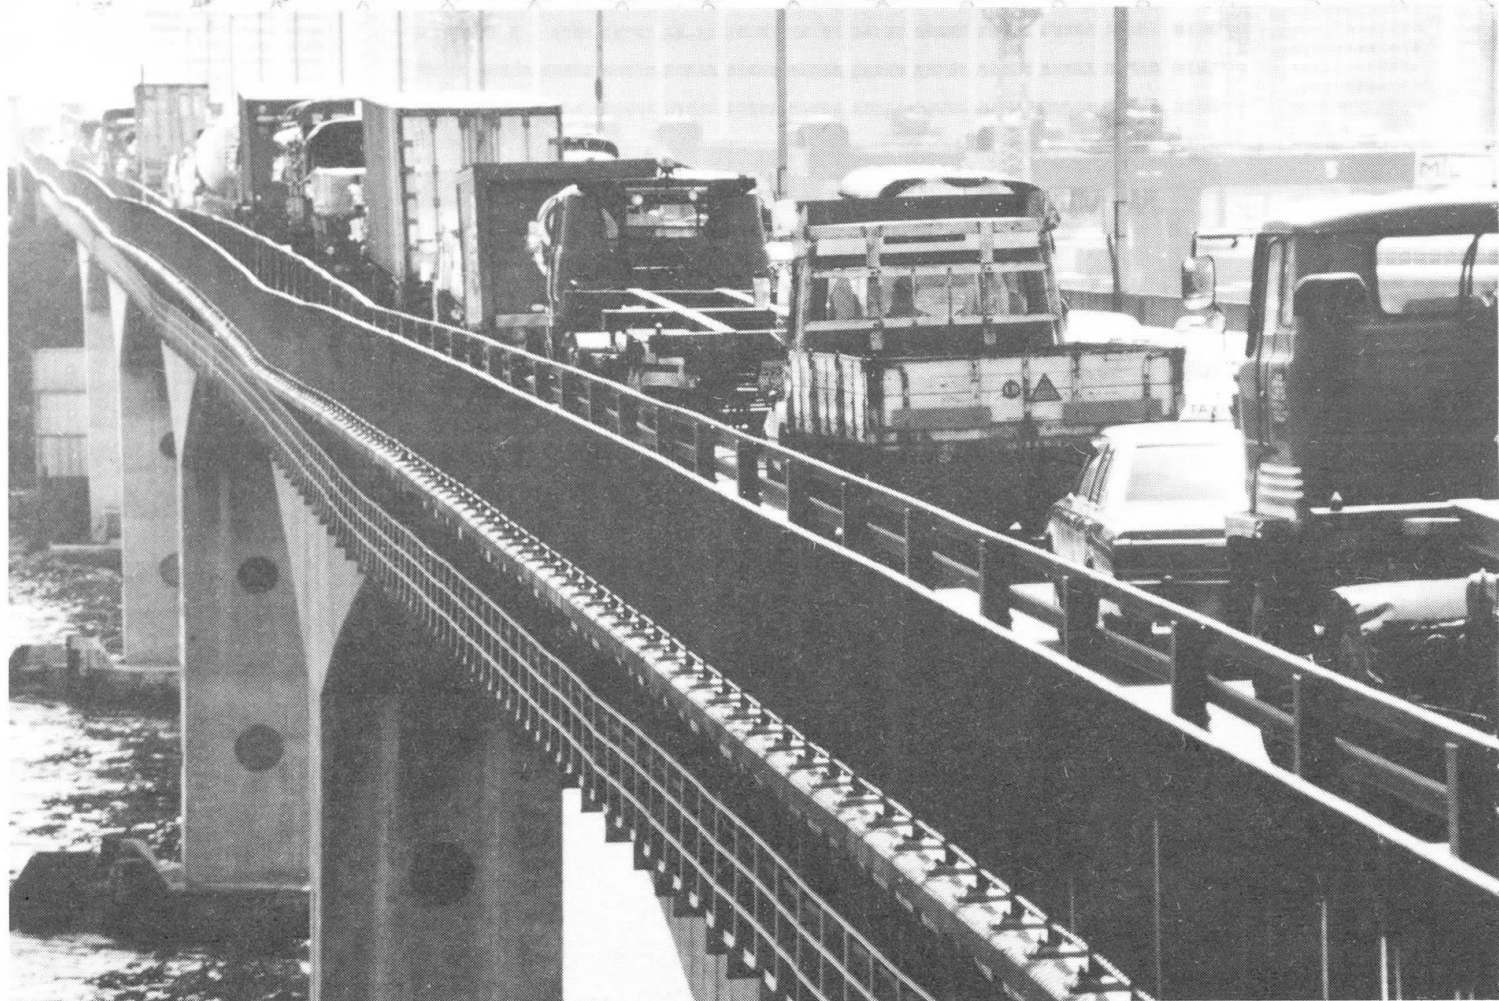
Figure 1

Opened to traffic in 1974, Tsing Yi South Bridge currently provides the only means of access from the mainland to the island of Tsing Yi. It was constructed by a private consortium, principally to provide access to a power station and to carry six 132 kV circuits from it to Kowloon, and upon completion was handed over to Government to operate. Since the bridge was completed, extensive development has occurred on the island, including a rapidly expanding new town. The bridge, which was built by the balanced cantilever method, is made up of five structurally independent prestressed concrete 'T' units, resulting in four main spans of 122 metres and two side spans of 61 metres, see Figure 1.

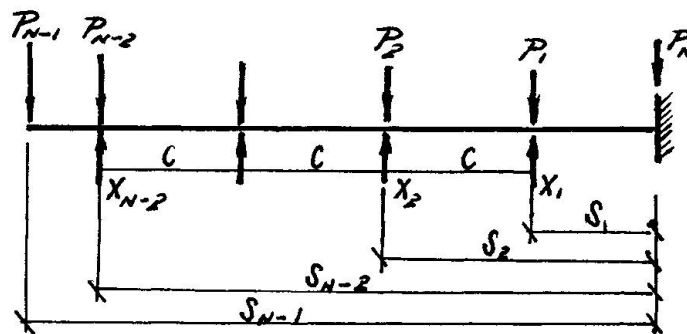
Fig. 1 The sketch of a pile-foundation

A pile-foundation shown in Fig. 1 can be properly simulated by a Winkle-type model. The corresponding simultaneous equations in the contracted form can be written as

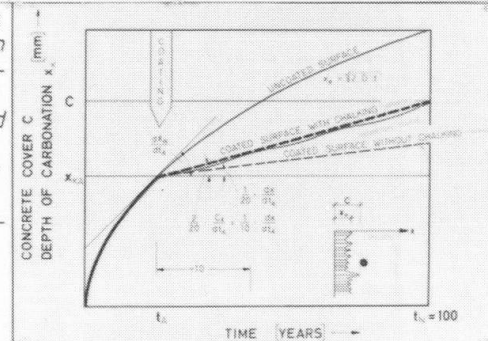
Parabola - straight line-function for process of carbonation of a concrete surface coated at t_A

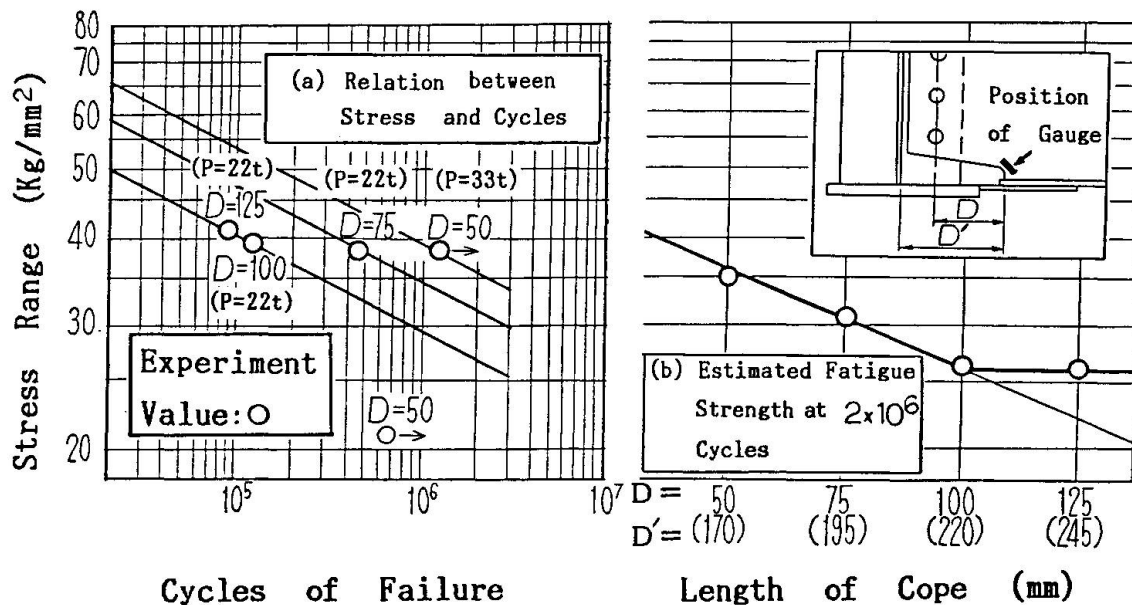
Fig. II Fatigue Strength of Coped Portion of Floor Beam

of the copes were varied, were tested under repeated loading and developed the same kind of crack as seen in the actual bridges. Both the FEM analysis and the model test revealed that the local tensile stress along the periphery of the cope became greater and consequently the fatigue strength decreased, as the cope length increased, as shown in Fig. II.

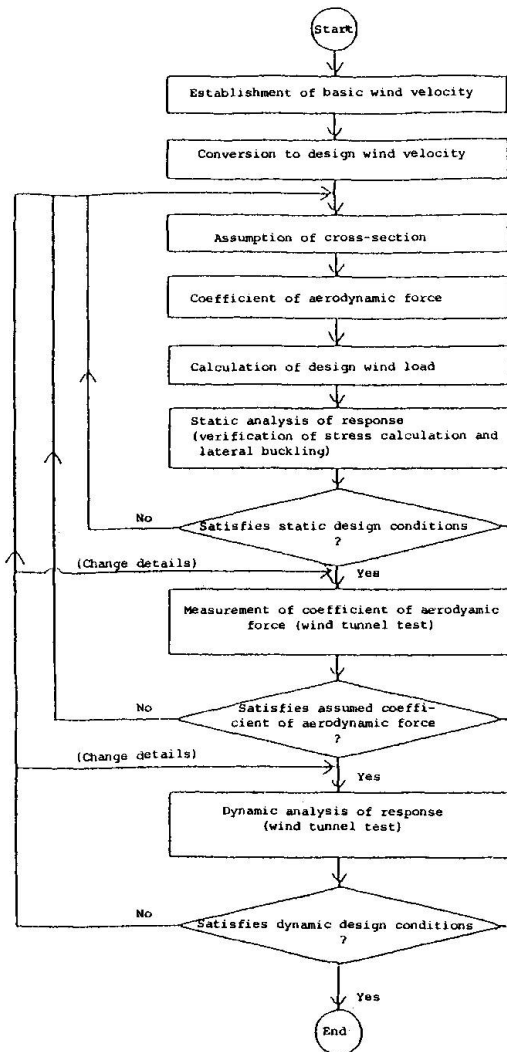
Fig-2 Flowchart of Windproof Design of Ohnaruto Bridge

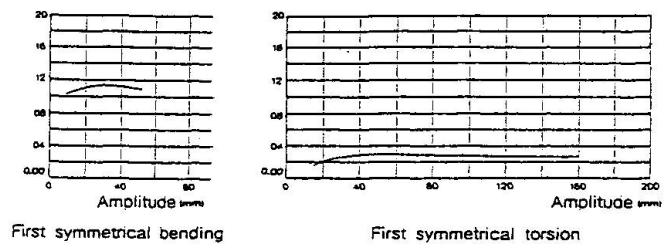
Fig.-4 Logarithmic decrement

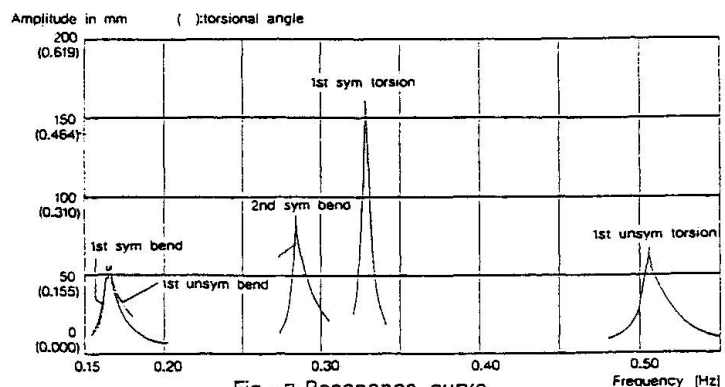
Fig.-7 Resonance curve

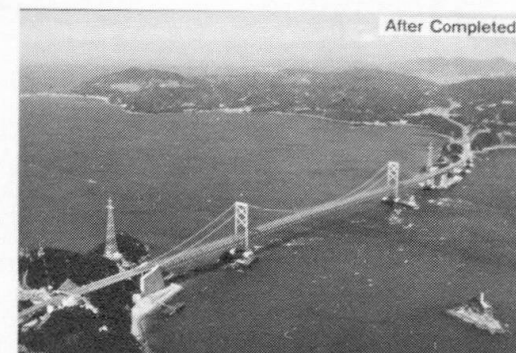
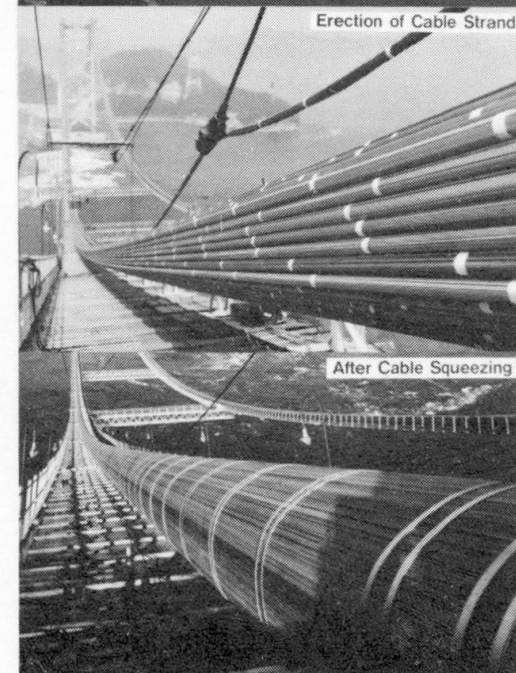
Arrangement of Cable Strand

Gulfvanized Wire	Diameter	5.37mm
	Tensile Strength	180~185kg/mm ²
	Amount of Wires Consisting Strand	PWS 127
Strand	Unit Weight	22.525kg/m
	Length	1722m
	Weight of Strand	39.0t
Cable	Amount of Strands Consisting Cable	154
	Diameter	840mm
	Amount of Wires Consisting Cable	19,558
	Total weight	11,062t

For all cables of the suspension bridges parallel wires of about 5 mm in diameter were used. The quality required of this wire is specified in the Honshu-Shikoku Bridge Standards. In strength of wire testing methods for each item and criteria for judgement, etc. are provided. The breaking strength is required to be in the range of 160 kg/mm^2 - 180 kg/mm^2 . Each wire is galvanized to keep it from corrosion. The diameters of the wires vary depending on the bridge, which is in the range of 5.10 mm to 5.37 mm. In the PWS method, strands consisting of 127 wires are fabricated in the shop. The length of the strand is controlled using a gage wire prefabricated to the required length which is marked and placed at one corner of a regular hexagon. Colored wires are placed on the other corners facilitating inspection of twists in the strand at the site.

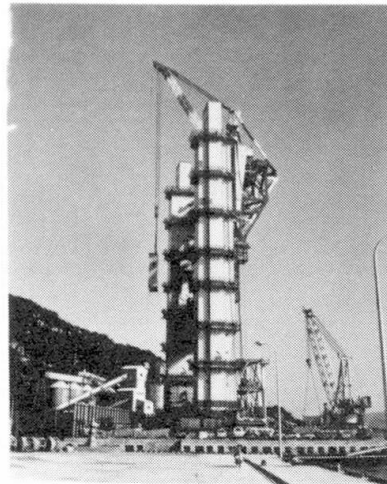
Erection of tower

To assure this design policy, end surface of three blocks of tower shaft was finished by facing machine. At the erection site the ratio of metal contacts was inspected using gap gauge, and the ratio was confirmed at inspected points.

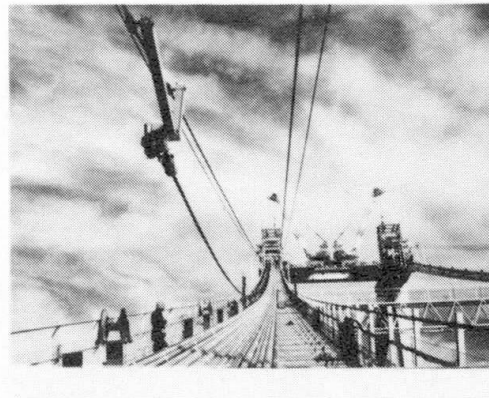
Erection of cable

The height of other strands were adjusted to this standard strand. These adjustment should be done at around midnight when the temperature of each strand were uniform. The void ratio of main cables, which indicates how the wires were compacted, are within 20% as specified.

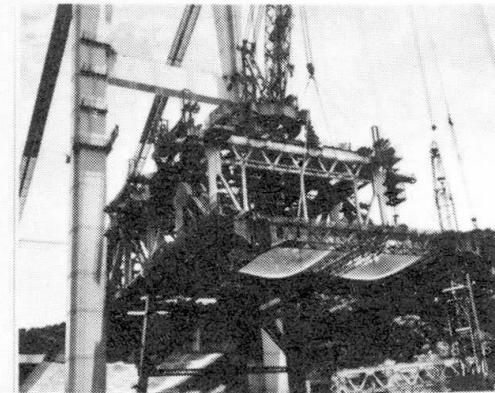
Erection of stiffening truss

To erect the stiffening truss, the panel members which is assembled at the shop are connected tightly each other so as to keep stiffness of erected truss. When the stiffening truss is connected to the suspended ropes, oil jacks are set at three panel points for each side of truss in order to distribute the tensile force of suspended ropes. At several steps during erection, the height, torsional deflection, and others will be measured to confirm the accuracy comparing measurement and calculation.

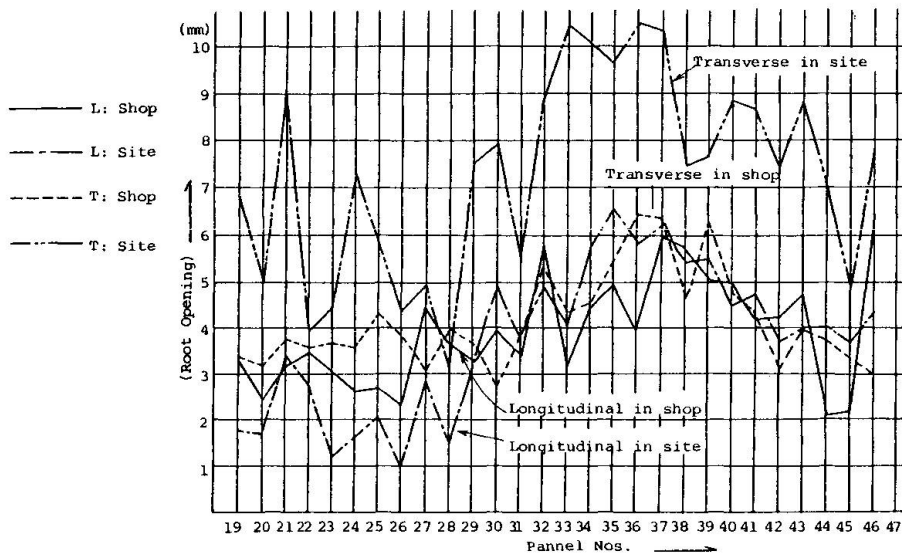
Fig. 1 Root Opening Difference between Shop Assembly and Construction Site

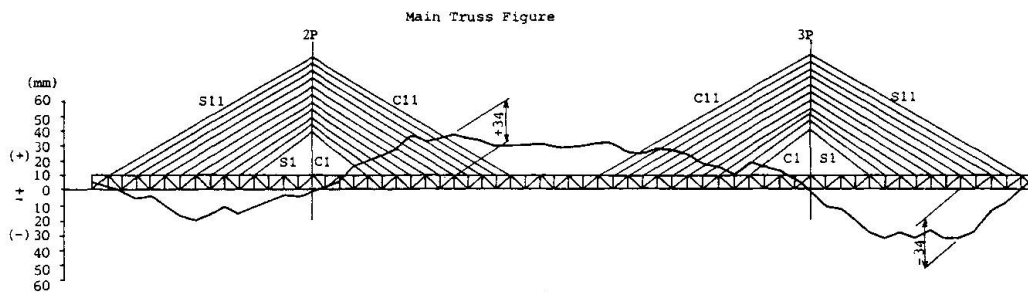
Fig.-2 Vertical error

Fig-2 shows errors between the planned values and the measured values at the time of closure of the girder. In the figure, the planned values were calculated according to the loading at the time. The error at the center of the central span is + 34 mm and that on the side spans is - 34 mm, and the tolerance on the central span being 118 mm and 59 mm on the side spans, respectively. These prove that the accuracy is satisfactory.

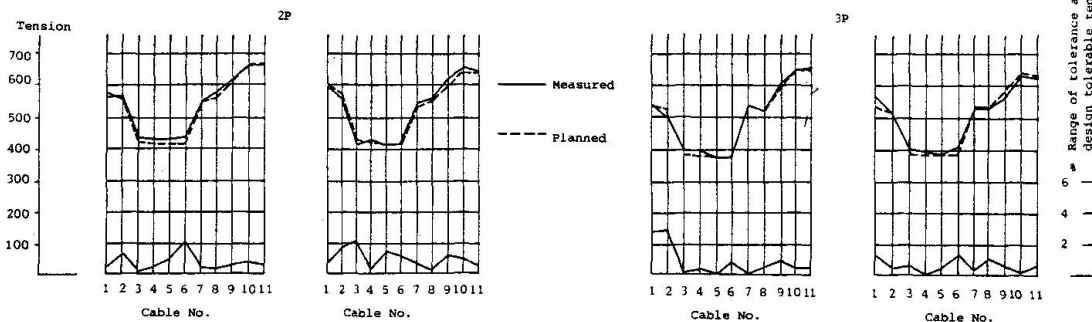
Fig. -3 Cable Tensions

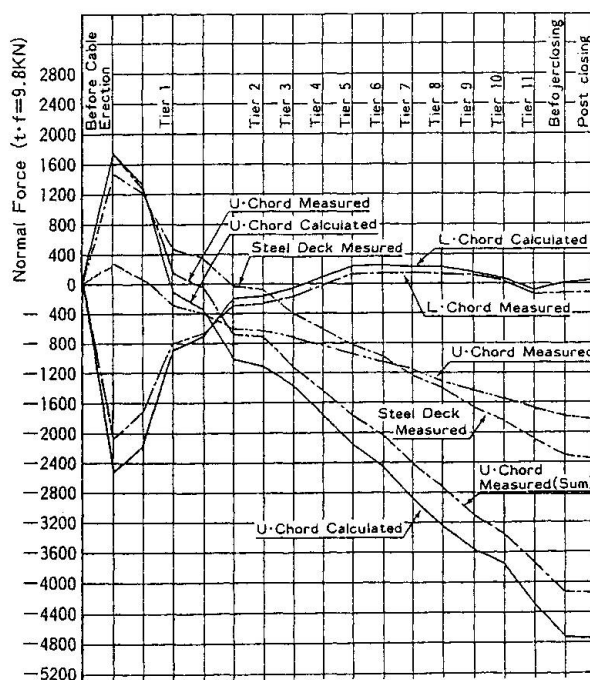
Fig-4 Transition of Main Truss Stress

It is judged that the contraction caused by field welding was thoroughly released by arranging the welding sequence and by releasing the stress by removing the drift pins and temporary bolts etc. In addition, thanks to the bolt hole control method, which aims at the reproduction of the shop assembling accuracy at the site, a high erection accuracy was obtained without having to adjust the cable shim and the camber during erection.

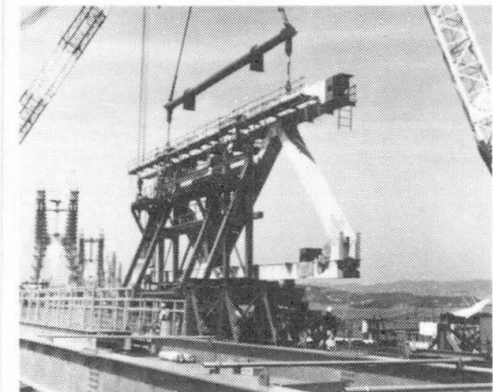
Temporary support

Other members were erected by balanced cantilever method. These methods were adopted considering topographic condition and limitation of carrying capacity of floating crane.

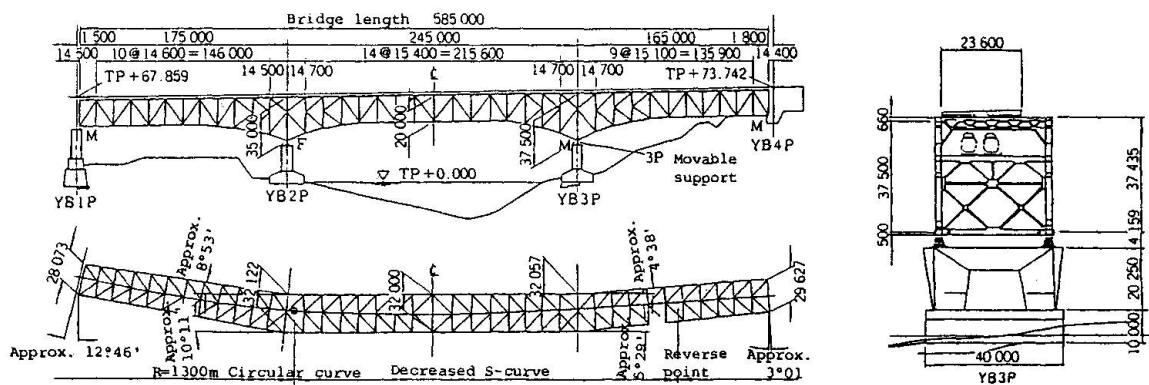
Fig. 1

The Yoshima Bridge (cf. Fig.1) is a continuous 3-span truss bridge with a total length of 585 m (175 m + 245 m + 165 m) for combined highway and railroad use, forming part of the Honshu-Shikoku Bridge Project. Due to the route alignment, an S-shaped transition curve is included in the bridge, which connects with suspension and cable-stayed bridges at both ends. This makes the design, fabrication and erection of this bridge particularly complicated because the main trusses should be knuckled at the intermediate piers and the main trusses of the side spans are not arranged parallel to the central span.

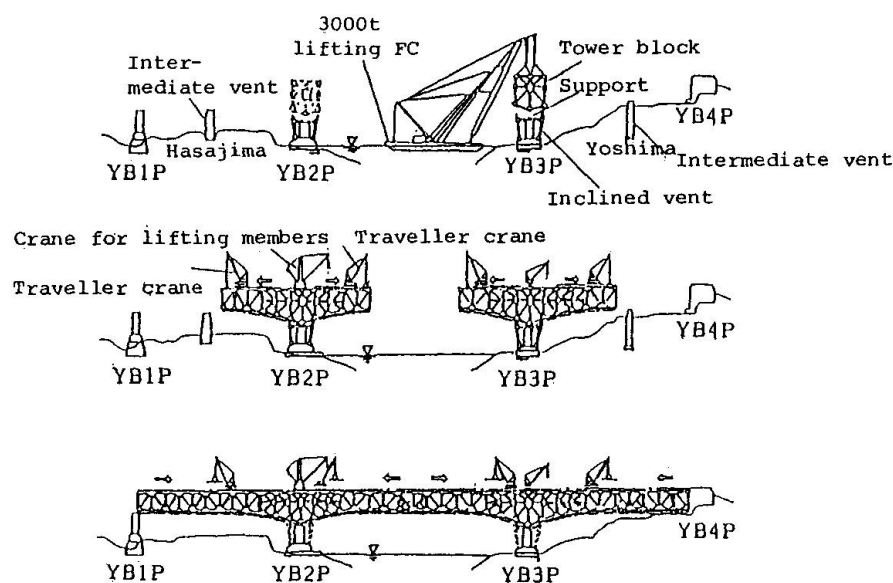
Fig. 2

The erection of the bridge was carried out by the procedure shown in Fig. 2.

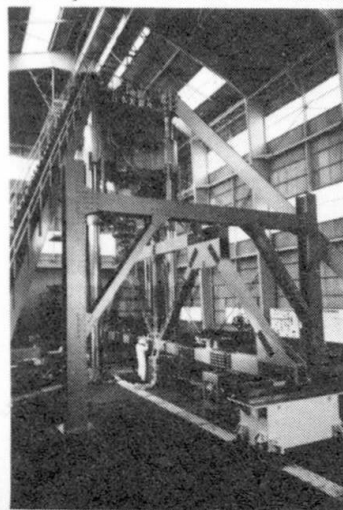
Photo 1 Large Scale Fatigue TEST

The Honshu-Shikoku Bridges include many long, large bridges for combination road/railway use that use a great deal of quenched and tempered high-strength steel which was previously not often used in railway bridges. Also, in the particular case of stiffening girders of suspension bridges, since the ratio of the live load stress was greater, close examinations were carefully conducted as to the fatigue due to repeated loading of trains. As one of such examinations, a large-scale fatigue test was carried out on approximately one-third models of the truss panel (Photo 1). As a result, it was found that the fatigue strength would be reduced by reason of the micro welding defects, such as blowholes in the corner joints of box-section members.

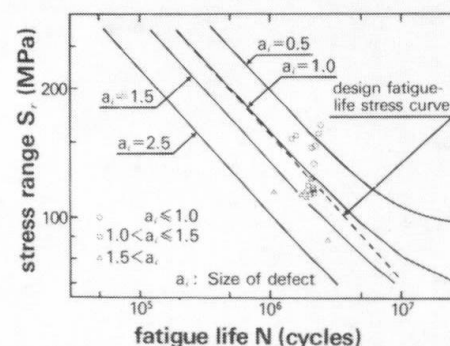
Fig. 1. Predicted S_r-N_p Curves and Test Results

Following the aforementioned a relationship between the blowhole dimensions and the fatigue life was found, based on the test results and calculation by fracture mechanics (see Fig. 1). By comparing the results with the design fatigue-life curves allowable dimensions for blowholes has now been determined, considering the working stress (Table 1).

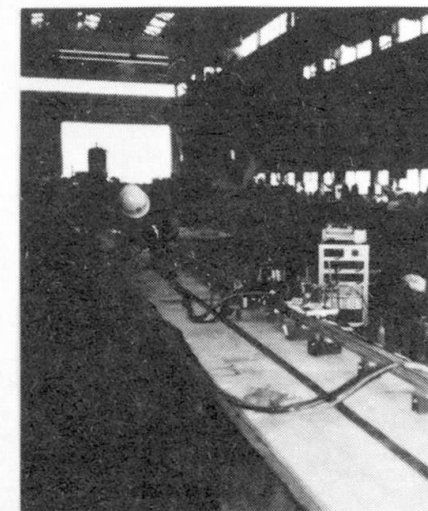
Photo 2 Nondestructive Examination

During fabrication, all possible occurrence of welding defects has been avoided, by carrying out severe control in welding condition, root gap, cleanliness of the groove face, and so on. Moreover, the suitability of fabricating conditions has been efficiently confirmed, by making actual-sized pilot members prior to the fabrication of the members. At the same time, a nondestructive examination was performed by means of automatic ultrasonic equipment (Photo 2), and when any defects of greater dimensions than the allowable ones were detected, they were soon repaired.

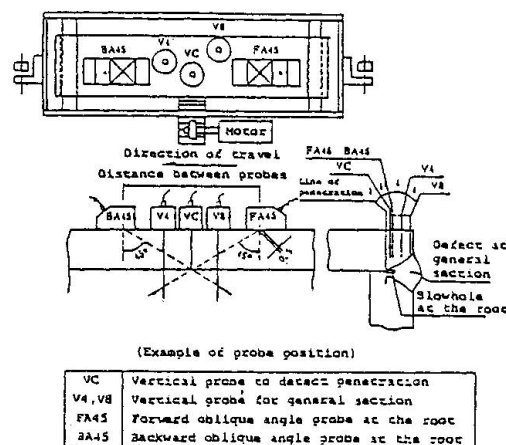
Fig-1 Example of probe position

Fig-1 shows an example of probe position.

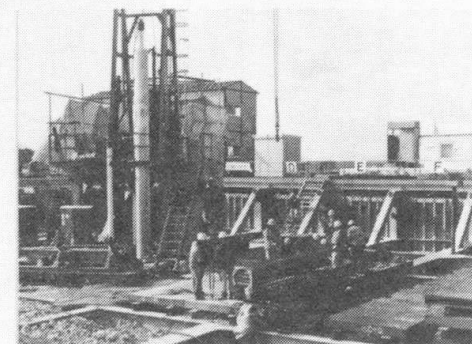
Core sampling

- (3) Core sampling : After mortar was poured into completely, the cores with 45cm dia. from the base to the top of pier were taken, and these cores (without any material separation phenomeon) could be completely collected at each 5m pre-cut. Moreover, the average compressive strength of age 91 day's was 200kgf/cm².

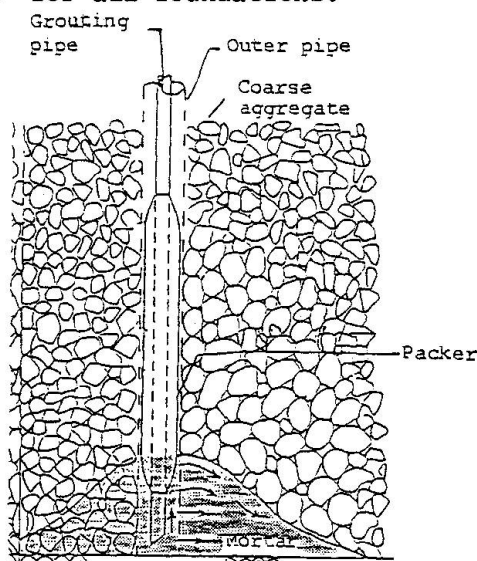
Fig-1 Grouting pipe

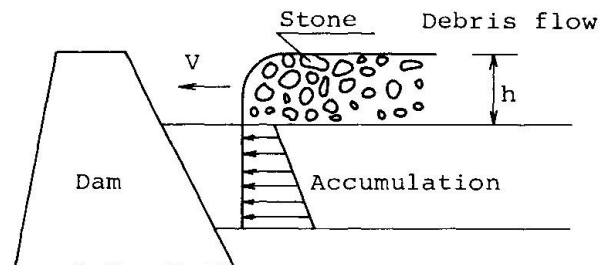
Fig.1 Debris flow

(3) Impact forces of stones: Huge stones are contained at the head of the debris flow as shown in Fig.1. The stones collide with the grid members of the dam and impact forces act on the member.

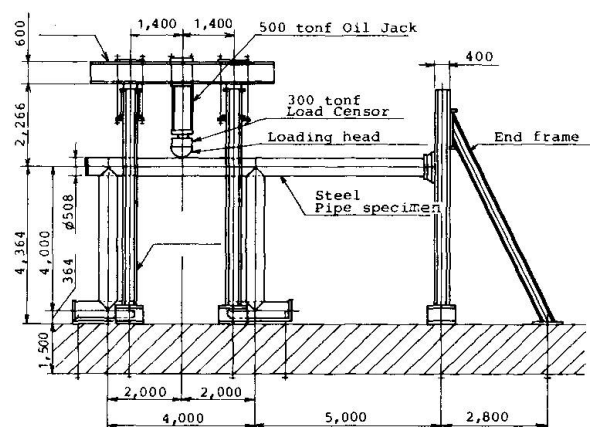
Fig.2 Loading test apparatus

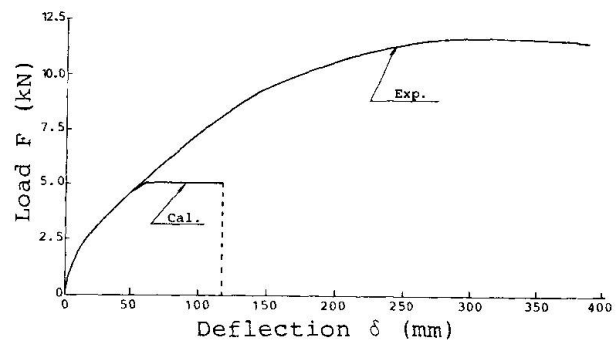
Fig.3 Load-deflection curve
Loading at the midpoint of joints

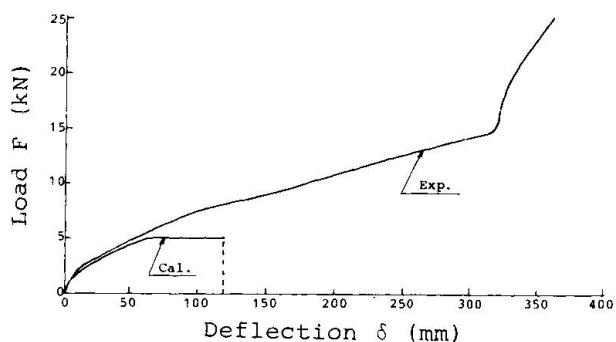
Fig.4 Load-deflection curve
Loading at a joint

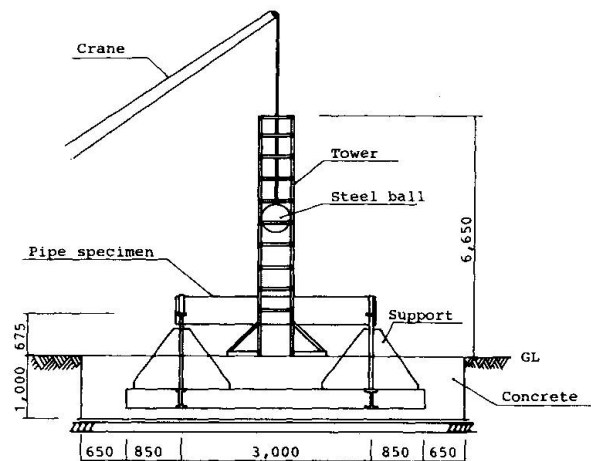
Fig.5 General view of impact tests

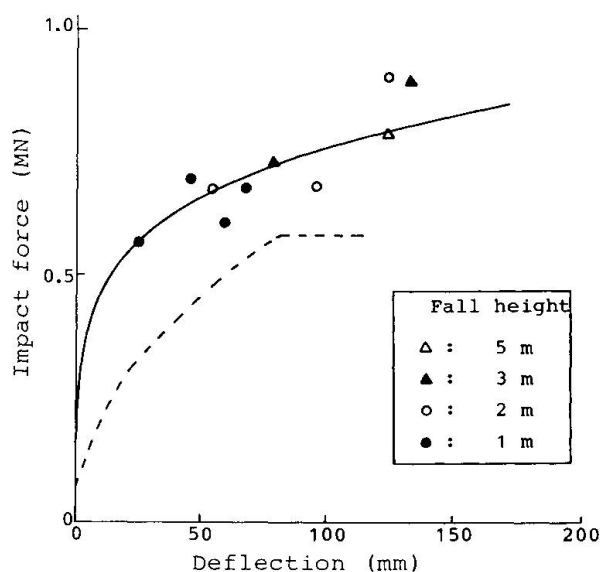
Fig. 6 Impact force-deflection relation

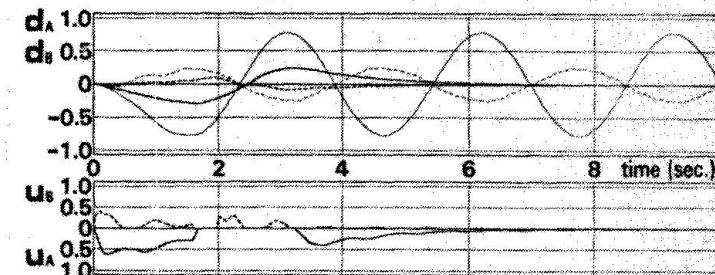
Fig. 2 Control of Bending Vibration Caused by Force Type 1.

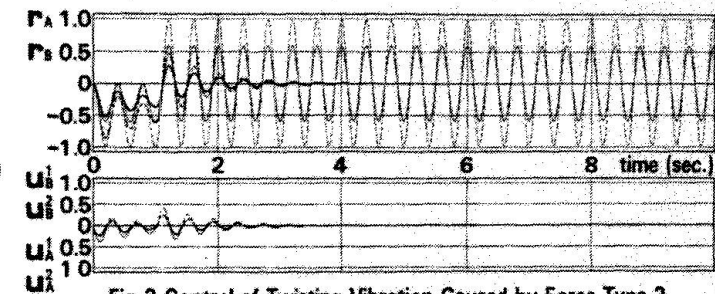
Fig. 3 Control of Twisting Vibration Caused by Force Type 2.

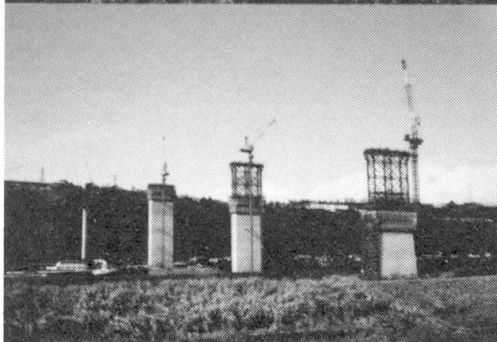
▲ 3. CONSTRUCTION OF HIGH PIERS

High piers were constructed by tower cranes and self-climbing forms. The highest pier is 69.4m. Seismic shaking test was conducted after the completion of piers.

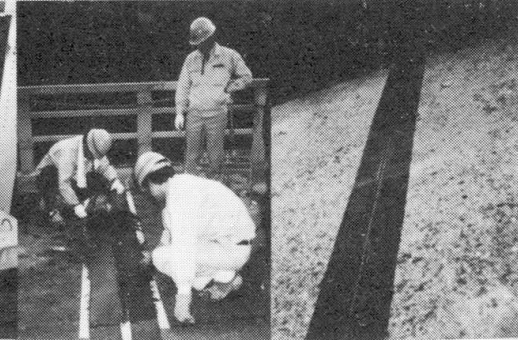
Impact strength test

The mixture ratio of the epoxy resin and the rubber gives an influence on the dynamic characteristics, the time of hardening and the workability.

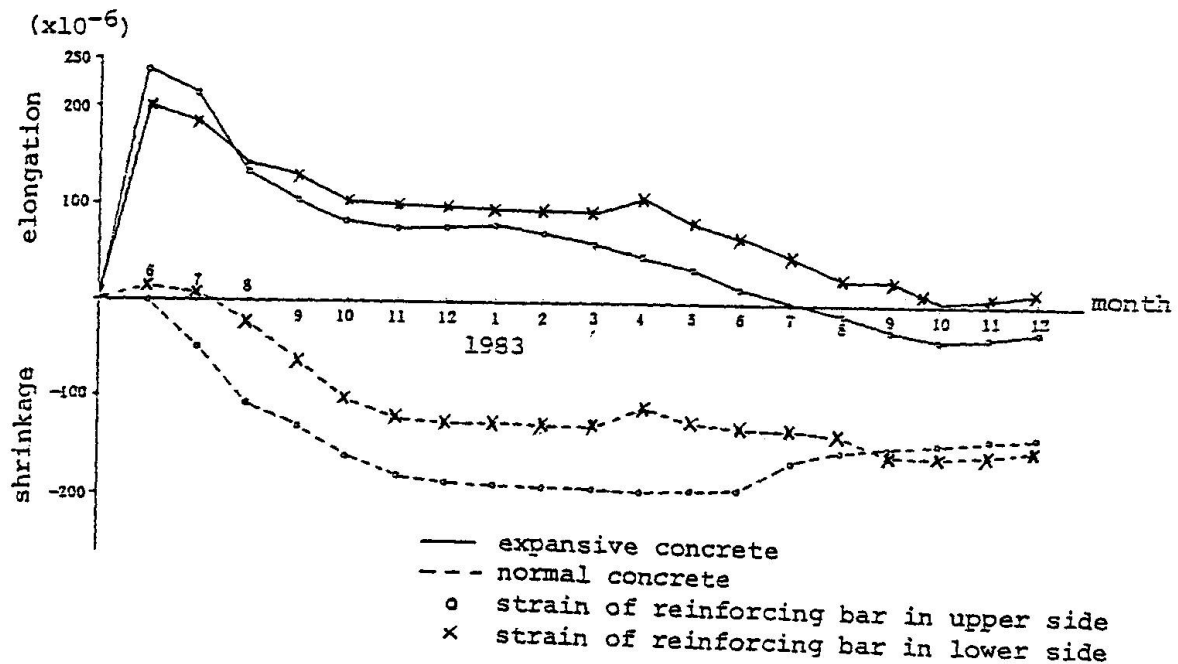
Fig-1 Time-dependent strain variation of reinforcing bar of deck slab in transverse direction.

It was clarified that amount of expansion differs by the direction and the type of bridges.
