Zeitschrift: IABSE reports = Rapports AIPC = IVBH Berichte
Band: 52 (1986)

Rubrik: Poster sessions

POSTER SESSIONS

- 1. Assessment of Existing Structures**
- 2. Honshu-Shikoku Bridge Project**
- 3. Technical Solutions**

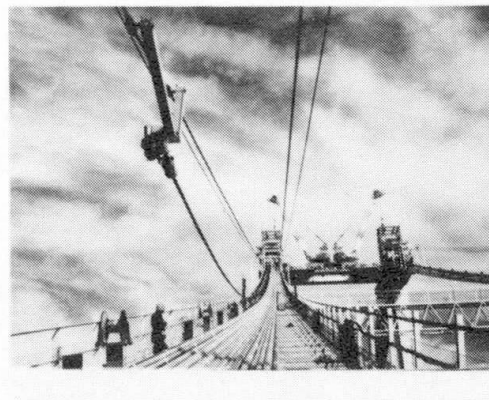
The height of other strands were adjusted to this standard strand. These adjustments should be done at around midnight when the temperature of each strand was uniform. The void ratio of main cables, which indicates how the wires were compacted, are within 20% as specified.

Erection of cable
