Artikel: Construction of cable-stayed bridges in Honshu-Shikoku bridges project

Outline of Iwakurojima
Cable-stayed Bridge
Weight (Tower) 8,340ton
(Cable) 2,230
(Girder) 24,530
Total 35,100

CONSTRUCTION OF CABLE-STAYED BRIDGE

Construction of Cable Stayed Bridges in Honshu-Shikoku Bridges Project

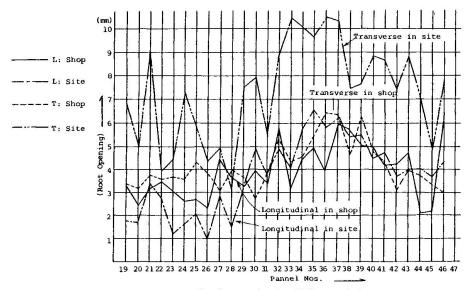
Fig. 1 Root Opening Difference between Shop Assembly and Construction Site

Fig-1 shows the root opening in the shop and on site.

Apparently the transverse root opening in the site bridge axis is larger than that in the shop. This is a result of the welding contruction, because the drift pins and the temporary bolts at the bolt joints between the main girder and the steel deckplate were removed, releasing the residual stress caused by welding. Therefore the main girder camber was not greatly affected by the contraction due to the welding.

The longitudinal root opening tends to be smaller at site than in the shop, although the difference is small.

Also the longitudinal root opening did not appear to have any effect on the width of the main girder because stress releasing was performed as in the case of the transverse opening, with the floor truss keeping the width of the main truss.

(2) Quality of welds (Fig-1)

33 - 46 show larger root openings than 19 - 32. This is due to the fact that the standard values of the root opening differ depending on the method of welding (Submerged arc welding- CO_2 gas automatic arc welding).

The transverse root openings in the direction at right angles to the bridge axis were larger at the site, but the results of X-ray tests show that the quality of welding was satisfactory, presenting no problems.

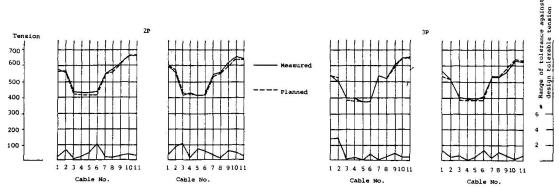
Fig. -3 Cable Tensions

Fig-3 shows cable tensions at each tier at the time of closure. The difference between the planned value and measured value according to the loading condition at the time was smaller than 5%, showing that the erection was performed with an extremely high accuracy.

However, as the allowed designed erection error was $\pm 5\%$ of the allowable design tension at the time of completion, it is judged that the range of errors at this stage was to be made $\pm 2.8\%$ of the allowable tension, taking into account the errors in the measurement. Therefore, shim plate adjustment was performed only on the cables at the 6th tier of the left side span, and at the 2nd tier and 1st tier on the right side of the center span.

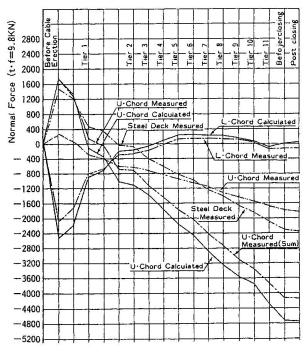
Fig-4 Trasition of Main Truss Stress

At each point of measurement a strain gauge was attached and the stresses at each erection stage were measured. The axial forces were calculated from these values and the planned values were compared. Fig-4 shows the condition of the axial force acting near the tower column on the 2P side. The axial force of the upper chord member of the composite steel deck plate is the resultant force of the axial force of the chord member alone and the axial force of the steel deck, but the difference in calculation between the planned value and the measured value is deemed to have resulted from the fact that the stress in the steel deck-plate includes the bending stress of the direct loading of erection machines, etc. However, since the values for the lower chord member match with the planned values, the erection can be judged to have been completed with a satisfactory accuracy.
