**Artikel:** Construction of cable-stayed bridges in Honshu-Shikoku bridges project  
**Autor:** Matsuzaki, M. / Ohnmachi, T. / Yasuda, M.  
**DOI:** <https://doi.org/10.5169/seals-40347>

Outline of Iwakurojima  
Cable-stayed Bridge  
Weight (Tower) 8,340ton  
(Cable) 2,230  
(Girder) 24,530  
Total 35,100

# CONSTRUCTION OF CABLE-STAYED BRIDGE

## Construction of Cable Stayed Bridges in Honshu-Shikoku Bridges Project

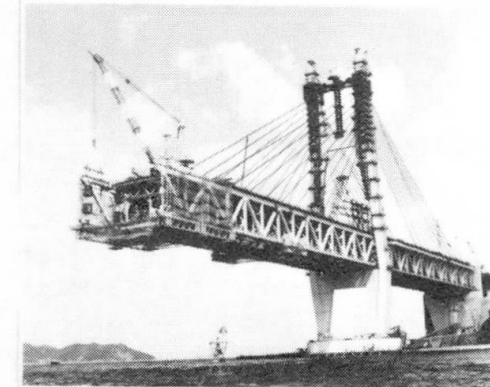
Erection of main truss

Regarding bolted joints, the pilot holes into which drift pins are driven during shop assembly are used in erection of main truss at the site to reproduce the figures in shop.

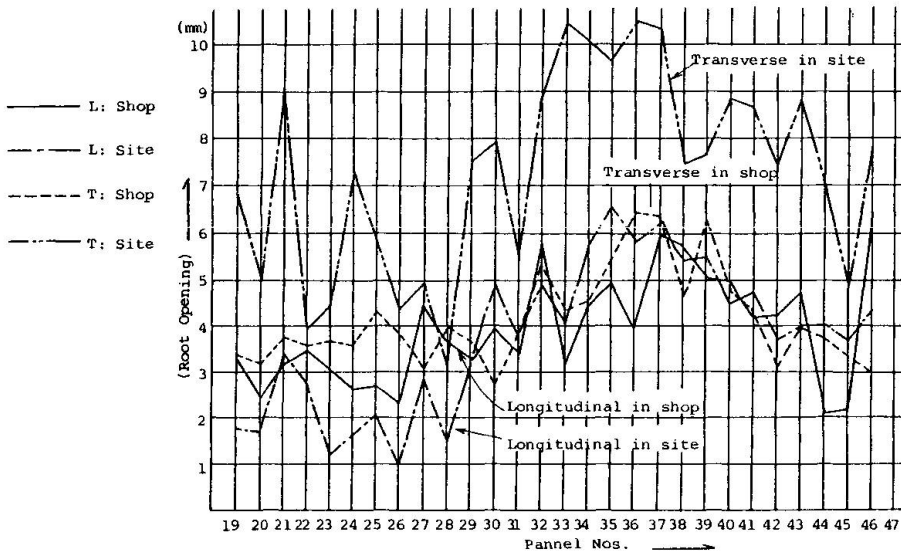
Fig. 1 Root Opening Difference between Shop Assembly and Construction Site

Fig-1 shows the root opening in the shop and on site.

Apparently the transverse root opening in the site bridge axis is larger than that in the shop. This is a result of the welding construction, because the drift pins and the temporary bolts at the bolt joints between the main girder and the steel deckplate were removed, releasing the residual stress caused by welding. Therefore the main girder camber was not greatly affected by the contraction due to the welding.

The longitudinal root opening tends to be smaller at site than in the shop, although the difference is small.

Also the longitudinal root opening did not appear to have any effect on the width of the main girder because stress releasing was performed as in the case of the transverse opening, with the floor truss keeping the width of the main truss.

- (2) Quality of welds (Fig-1)

33 - 46 show larger root openings than 19 - 32. This is due to the fact that the standard values of the root opening differ depending on the method of welding (Submerged arc welding-CO<sub>2</sub> gas automatic arc welding).

The transverse root openings in the direction at right angles to the bridge axis were larger at the site, but the results of X-ray tests show that the quality of welding was satisfactory, presenting no problems.

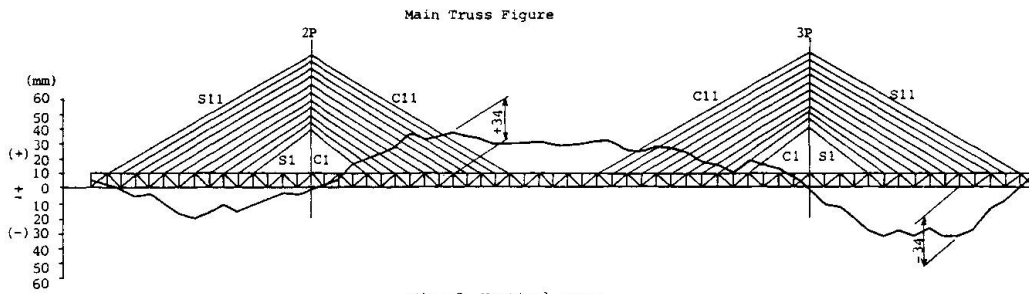
Fig.-2 Vertical error

Fig-2 shows errors between the planned values and the measured values at the time of closure of the girder. In the figure, the planned values were calculated according to the loading at the time. The error at the center of the central span is + 34 mm and that on the side spans is - 34 mm, and the tolerance on the central span being 118 mm and 59 mm on the side spans, respectively. These prove that the accuracy is satisfactory.

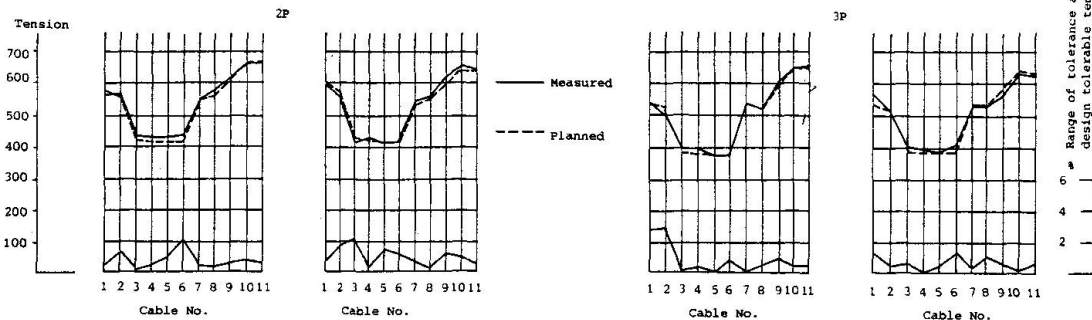
Fig. -3 Cable Tensions

Fig-3 shows cable tensions at each tier at the time of closure. The difference between the planned value and measured value according to the loading condition at the time was smaller than 5%, showing that the erection was performed with an extremely high accuracy.

However, as the allowed designed erection error was +5% of the allowable design tension at the time of completion, it is judged that the range of errors at this stage was to be made +2,8% of the allowable tension, taking into account the errors in the measurement. Therefore, shim plate adjustment was performed only on the cables at the 6th tier of the left side span, and at the 2nd tier and 1st tier on the right side of the center span.

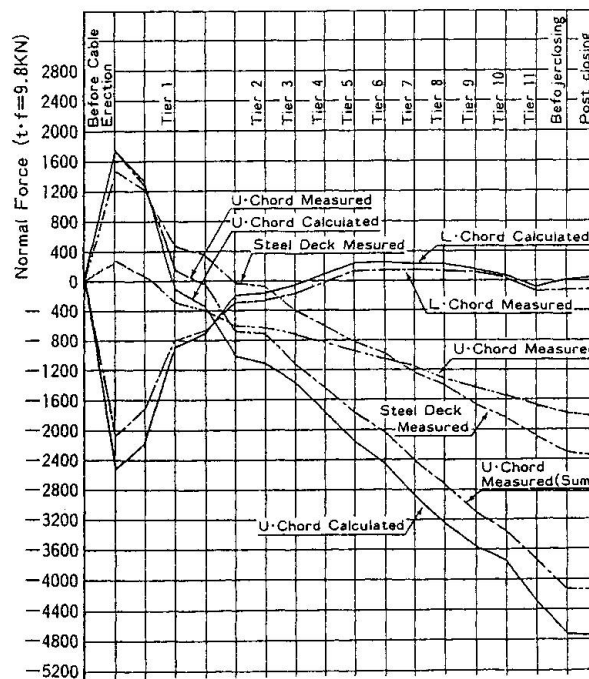
Fig-4 Transition of Main Truss Stress

At each point of measurement a strain gauge was attached and the stresses at each erection stage were measured. The axial forces were calculated from these values and the planned values were compared. Fig-4 shows the condition of the axial force acting near the tower column on the 2P side. The axial force of the upper chord member of the composite steel deck plate is the resultant force of the axial force of the chord member alone and the axial force of the steel deck, but the difference in calculation between the planned value and the measured value is deemed to have resulted from the fact that the stress in the steel deck-plate includes the bending stress of the direct loading of erection machines, etc. However, since the values for the lower chord member match with the planned values, the erection can be judged to have been completed with a satisfactory accuracy.
