**Artikel:** Construction of cable-stayed bridges in Honshu-Shikoku bridges project  
**Autor:** Matsuzaki, M. / Ohnmachi, T. / Yasuda, M.  
**DOI:** <https://doi.org/10.5169/seals-40347>

Outline of Iwakurojima  
Cable-stayed Bridge  
Weight (Tower) 8,340ton  
(Cable) 2,230  
(Girder) 24,530  
Total 35,100

# CONSTRUCTION OF CABLE-STAYED BRIDGE

## Construction of Cable Stayed Bridges in Honshu-Shikoku Bridges Project

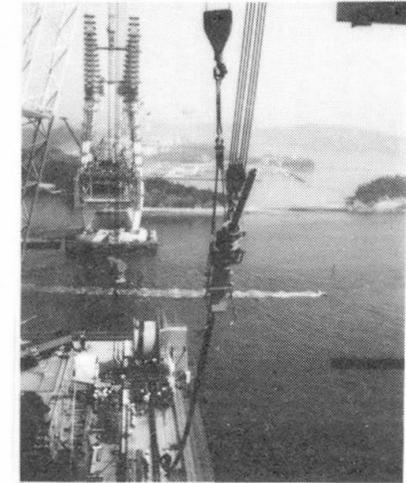
Erection of cable

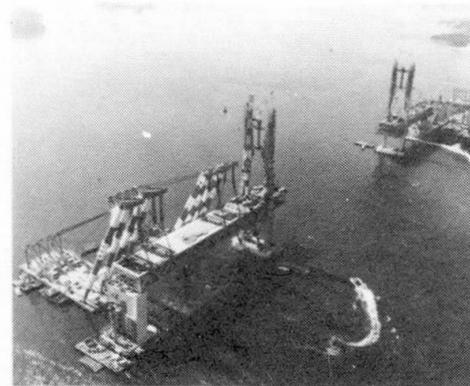
Erection of large block

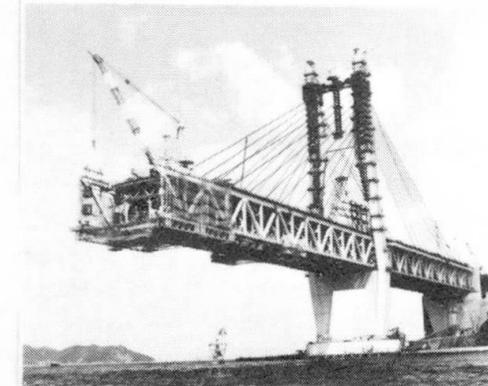
Erection of main truss

Regarding bolted joints, the pilot holes into which drift pins are driven during shop assembly are used in erection of main truss at the site to reproduce the figures in shop.

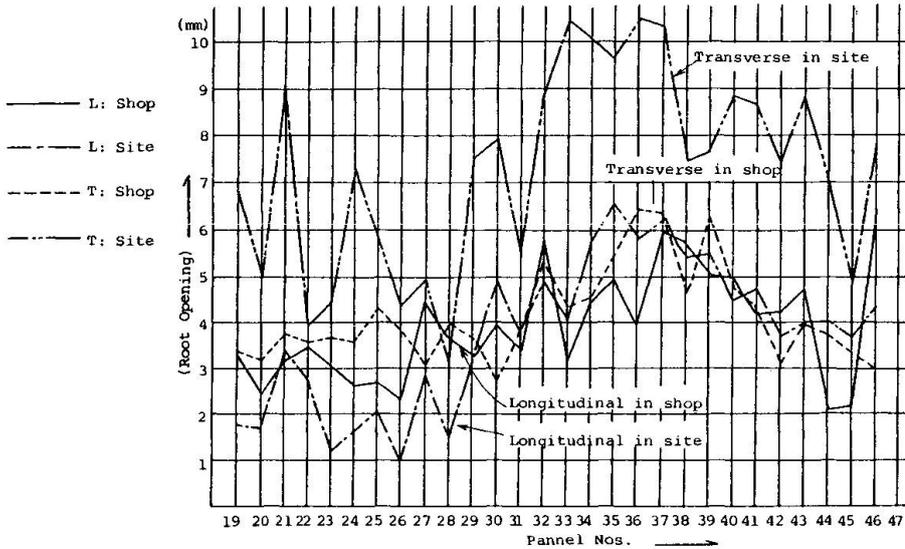
Fig. 1 Root Opening Difference between Shop Assembly and Construction Site

Fig-1 shows the root opening in the shop and on site.

Apparently the transverse root opening in the site bridge axis is larger than that in the shop. This is a result of the welding construction, because the drift pins and the temporary bolts at the bolt joints between the main girder and the steel deckplate were removed, releasing the residual stress caused by welding. Therefore the main girder camber was not greatly affected by the contraction due to the welding.

The longitudinal root opening tends to be smaller at site than in the shop, although the difference is small.

Also the longitudinal root opening did not appear to have any effect on the width of the main girder because stress releasing was performed as in the case of the transverse opening, with the floor truss keeping the width of the main truss.

- (2) Quality of welds (Fig-1)

33 - 46 show larger root openings than 19 - 32. This is due to the fact that the standard values of the root opening differ depending on the method of welding (Submerged arc welding-CO<sub>2</sub> gas automatic arc welding).

The transverse root openings in the direction at right angles to the bridge axis were larger at the site, but the results of X-ray tests show that the quality of welding was satisfactory, presenting no problems.

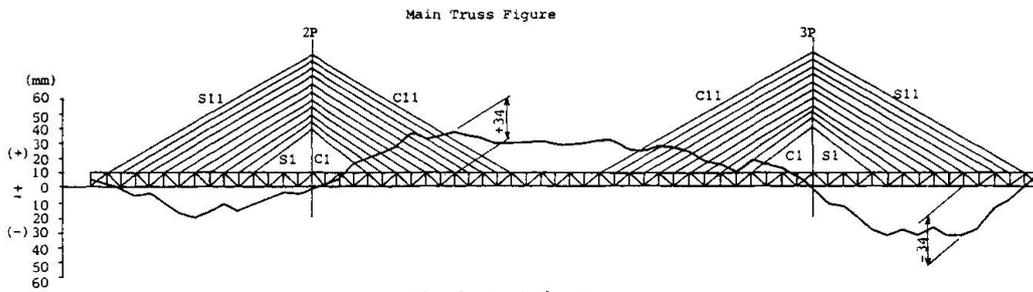
Fig.-2 Vertical error

Fig-2 shows errors between the planned values and the measured values at the time of closure of the girder. In the figure, the planned values were calculated according to the loading at the time. The error at the center of the central span is + 34 mm and that on the side spans is - 34 mm, and the tolerance on the central span being 118 mm and 59 mm on the side spans, respectively. These prove that the accuracy is satisfactory.

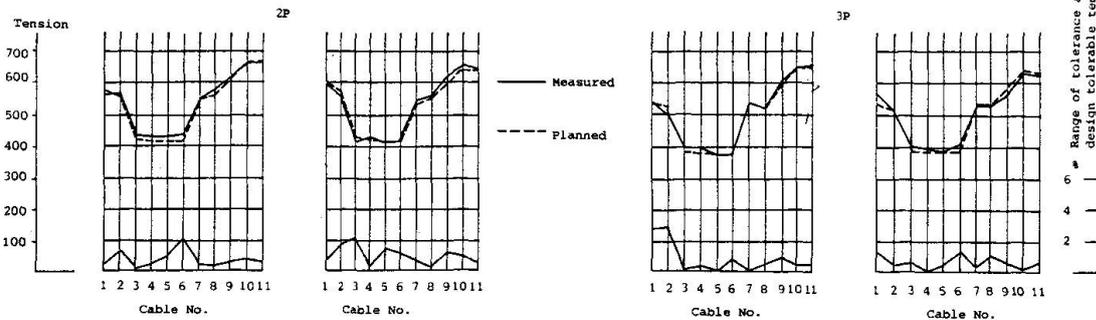
Fig. -3 Cable Tensions

Fig-3 shows cable tensions at each tier at the time of closure. The difference between the planned value and measured value according to the loading condition at the time was smaller than 5%, showing that the erection was performed with an extremely high accuracy.

However, as the allowed designed erection error was +5% of the allowable design tension at the time of completion, it is judged that the range of errors at this stage was to be made +2,8% of the allowable tension, taking into account the errors in the measurement. Therefore, shim plate adjustment was performed only on the cables at the 6th tier of the left side span, and at the 2nd tier and 1st tier on the right side of the center span.

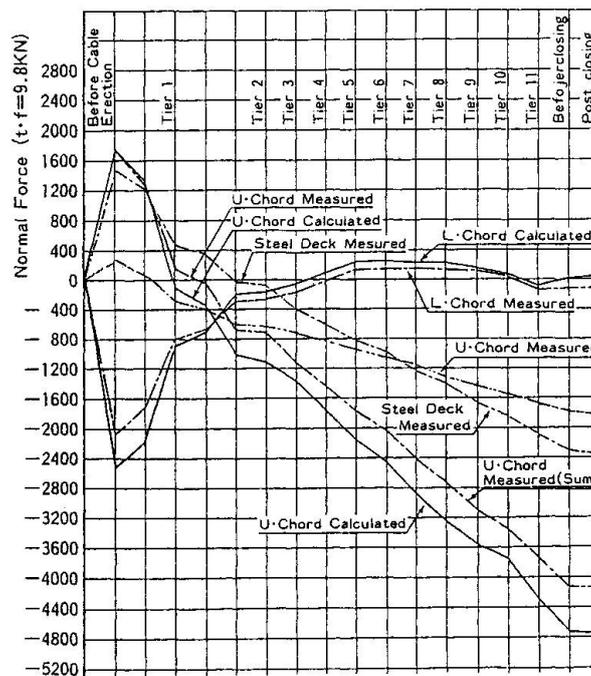
Fig-4 Transition of Main Truss Stress

At each point of measurement a strain gauge was attached and the stresses at each erection stage were measured. The axial forces were calculated from these values and the planned values were compared. Fig-4 shows the condition of the axial force acting near the tower column on the 2P side. The axial force of the upper chord member of the composite steel deck plate is the resultant force of the axial force of the chord member alone and the axial force of the steel deck, but the difference in calculation between the planned value and the measured value is deemed to have resulted from the fact that the stress in the steel deck-plate includes the bending stress of the direct loading of erection machines, etc. However, since the values for the lower chord member match with the planned values, the erection can be judged to have been completed with a satisfactory accuracy.
