Artikel: Construction of cable-stayed bridges in Honshu-Shikoku bridges project
Autor: Matsuzaki, M. / Ohnmachi, T. / Yasuda, M.
DOI: <https://doi.org/10.5169/seals-40347>

Outline of Iwakurojima
Cable-stayed Bridge
Weight (Tower) 8,340ton
(Cable) 2,230
(Girder) 24,530
Total 35,100

CONSTRUCTION OF CABLE-STAYED BRIDGE

Construction of Cable Stayed Bridges in Honshu-Shikoku Bridges Project

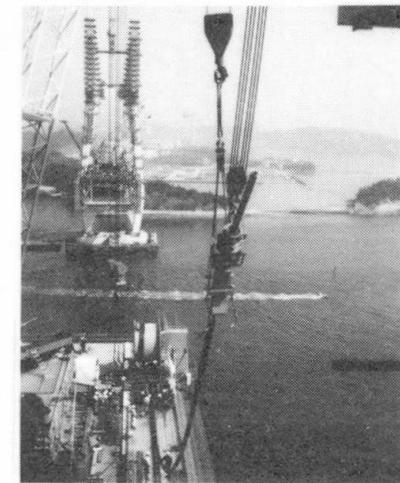
Erection of cable

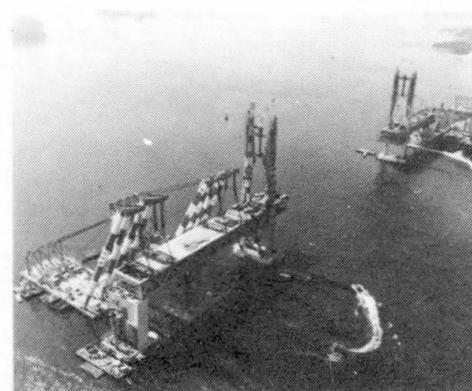
Erection of large block

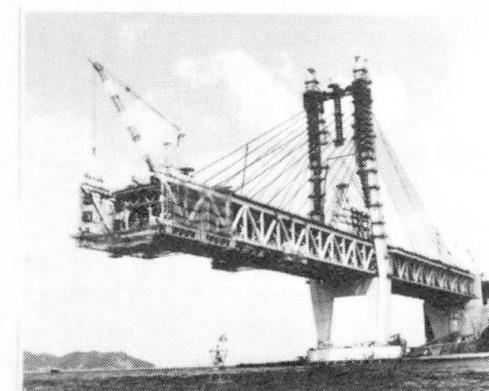
Erection of main truss

Regarding bolted joints, the pilot holes into which drift pins are driven during shop assembly are used in erection of main truss at the site to reproduce the figures in shop.

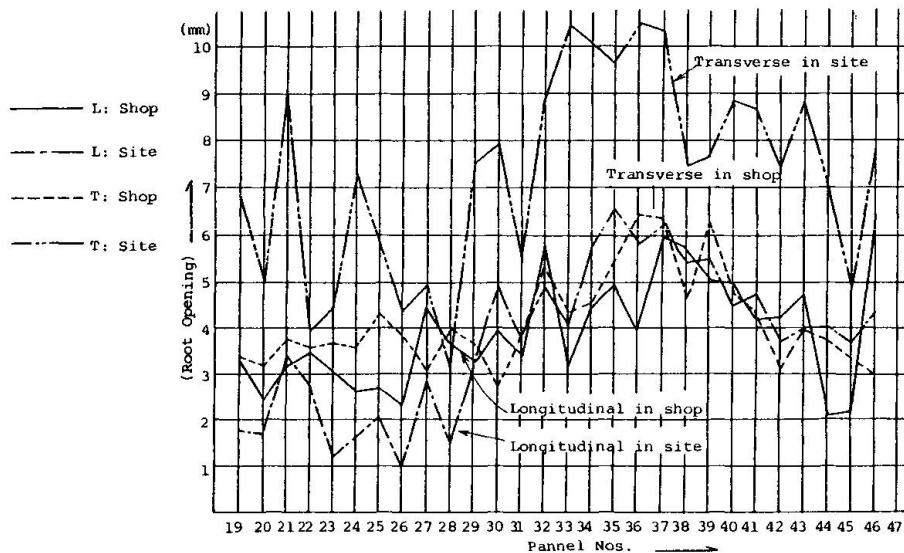
Fig-1 shows the root opening in the shop and on site.

Apparently the transverse root opening in the site bridge axis is larger than that in the shop. This is a result of the welding contraction, because the drift pins and the temporary bolts at the bolt joints between the main girder and the steel deckplate were removed, releasing the residual stress caused by welding. Therefore the main girder camber was not greatly affected by the contraction due to the welding.

The longitudinal root opening tends to be smaller at site than in the shop, although the difference is small.

Fig. 1 Root Opening Difference between
Shop Assembly and Construction Site

Also the longitudinal root opening did not appear to have any effect on the width of the main girder because stress releasing was performed as in the case of the transverse opening, with the floor truss keeping the width of the main truss.

(2) Quality of welds (Fig-1)

33 - 46 show larger root openings than 19 - 32. This is due to the fact that the standard values of the root opening differ depending on the method of welding (Submerged arc welding-CO₂ gas automatic arc welding).

The transverse root openings in the direction at right angles to the bridge axis were larger at the site, but the results of X-ray tests show that the quality of welding was satisfactory, presenting no problems.

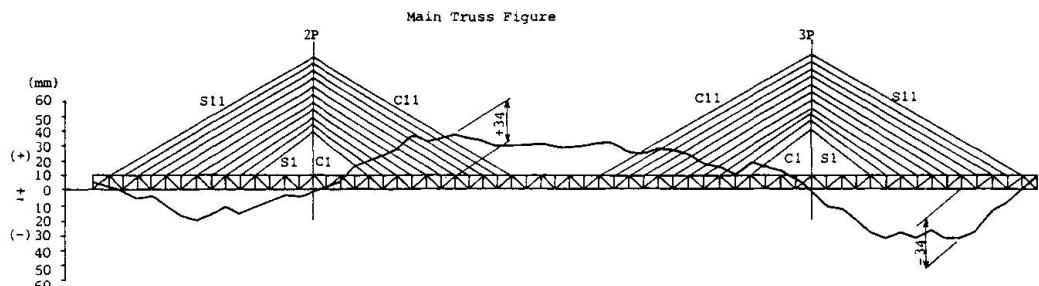
Fig-2 shows errors between the planned values and the measured values at the time of closure of the girder. In the figure, the planned values were calculated according to the loading at the time. The error at the center of the central span is + 34 mm and that on the side spans is - 34 mm, and the tolerance on the central span being 118 mm and 59 mm on the side spans, respectively. These prove that the accuracy is satisfactory.

Fig. 2 Vertical error

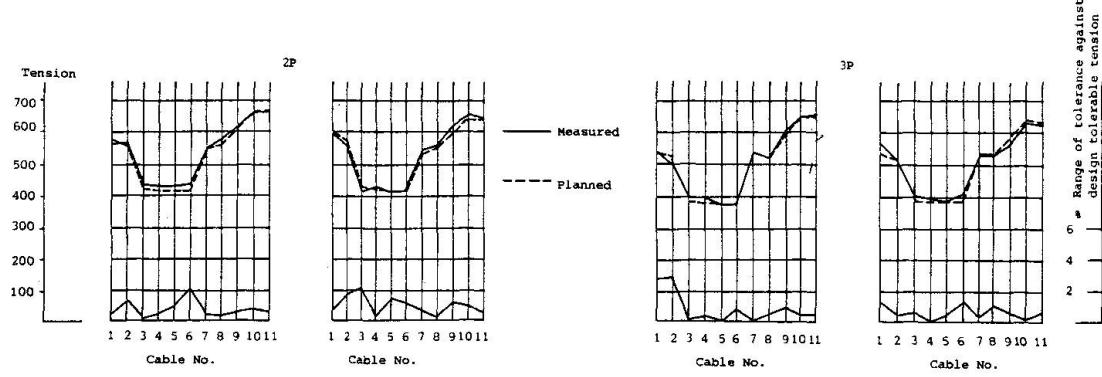
Fig. 3 Cable Tensions

Fig-3 shows cable tensions at each tier at the time of closure. The difference between the planned value and measured value according to the loading condition at the time was smaller than 5%, showing that the erection was performed with an extremely high accuracy.

However, as the allowed designed erection error was $\pm 5\%$ of the allowable design tension at the time of completion, it is judged that the range of errors at this stage was to be made $\pm 2.8\%$ of the allowable tension, taking into account the errors in the measurement. Therefore, shim plate adjustment was performed only on the cables at the 6th tier of the left side span, and at the 2nd tier and 1st tier on the right side of the center span.

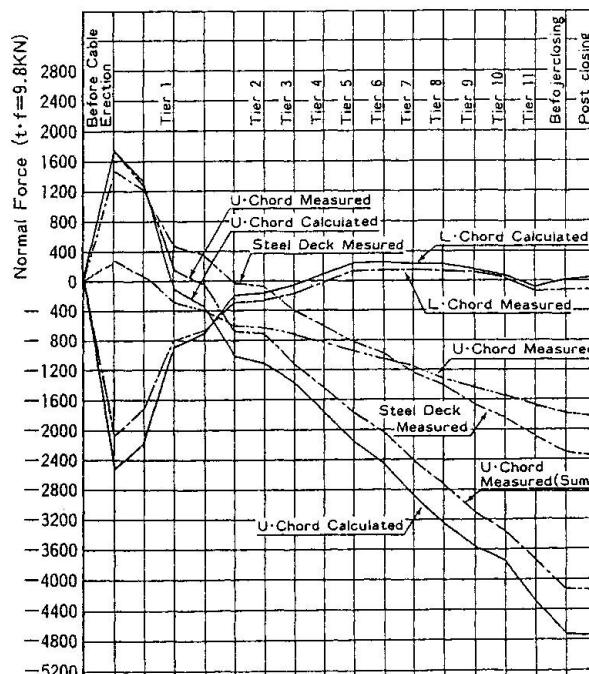
At each point of measurement a strain gauge was attached and the stresses at each erection stage were measured. The axial forces were calculated from these values and the planned values were compared. Fig-4 shows the condition of the axial force acting near the tower column on the 2P side. The axial force of the upper chord member of the composite steel deck plate is the resultant force of the axial force of the chord member alone and the axial force of the steel deck, but the difference in calculation between the planned value and the measured value is deemed to have resulted from the fact that the stress in the steel deck-plate includes the bending stress of the direct loading of erection machines, etc. However, since the values for the lower chord member match with the planned values, the erection can be judged to have been completed with a satisfactory accuracy.

Fig-4 Transition of Main Truss Stress
