Artikel: Construction of cable-stayed bridges in Honshu-Shikoku bridges project
Autor: Matsuzaki, M. / Ohnmachi, T. / Yasuda, M.
DOI: <https://doi.org/10.5169/seals-40347>

CONSTRUCTION OF CABLE-STAYED BRIDGE

Erection work and Quality control

Construction of Cable Stayed Bridges in Honshu-Shikoku Bridges Project

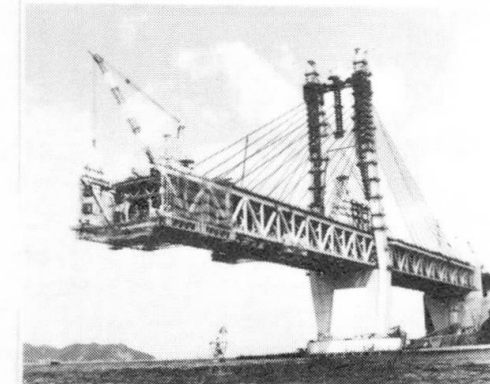
Erection of main truss

Regarding bolted joints, the pilot holes into which drift pins are driven during shop assembly are used in erection of main truss at the site to reproduce the figures in shop.

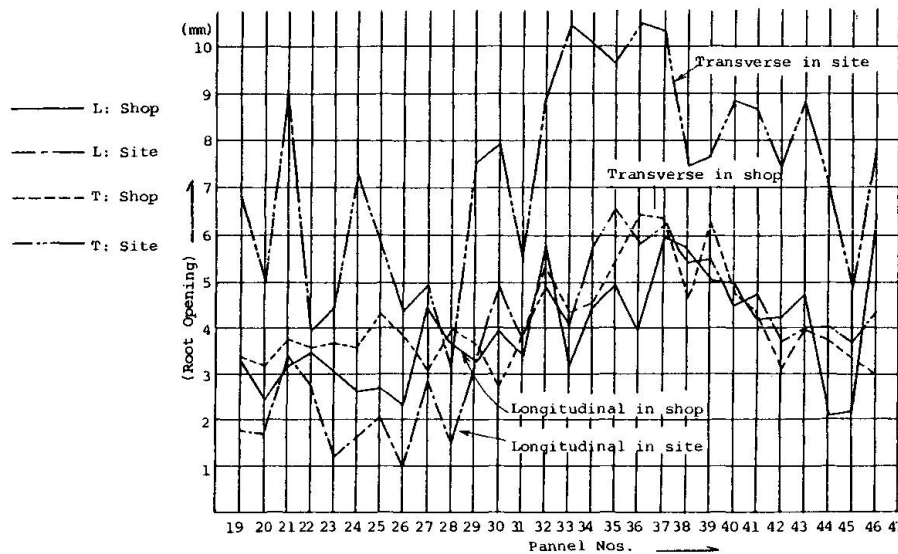
Fig-1 shows the root opening in the shop and on site.

Apparently the transverse root opening in the site bridge axis is larger than that in the shop. This is a result of the welding contraction, because the drift pins and the temporary bolts at the bolt joints between the main girder and the steel deckplate were removed, releasing the residual stress caused by welding. Therefore the main girder camber was not greatly affected by the contraction due to the welding.

The longitudinal root opening tends to be smaller at site than in the shop, although the difference is small.

Fig. 1 Root Opening Difference between Shop Assembly and Construction Site

Also the longitudinal root opening did not appear to have any effect on the width of the main girder because stress releasing was performed as in the case of the transverse opening, with the floor truss keeping the width of the main truss.

- (2) Quality of welds (Fig-1)

33 - 46 show larger root openings than 19 - 32. This is due to the fact that the standard values of the root opening differ depending on the method of welding (Submerged arc welding-CO₂ gas automatic arc welding).

The transverse root openings in the direction at right angles to the bridge axis were larger at the site, but the results of X-ray tests show that the quality of welding was satisfactory, presenting no problems.

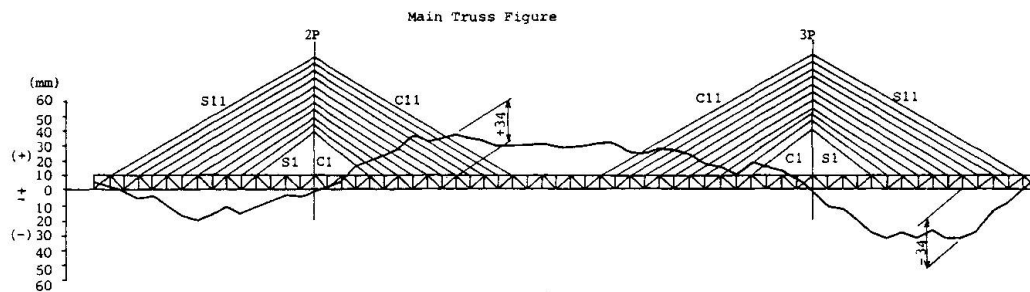
Fig-2 shows errors between the planned values and the measured values at the time of closure of the girder. In the figure, the planned values were calculated according to the loading at the time. The error at the center of the central span is + 34 mm and that on the side spans is - 34 mm, and the tolerance on the central span being 118 mm and 59 mm on the side spans, respectively. These prove that the accuracy is satisfactory.

Fig.-2 Vertical error

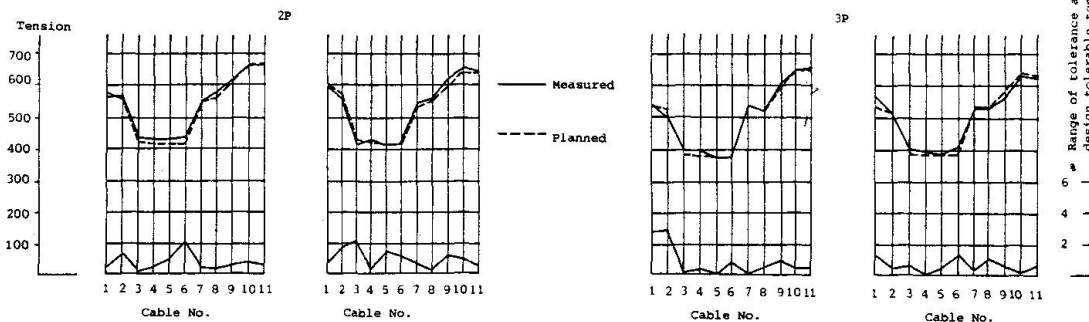
Fig. -3 Cable Tensions

Fig-3 shows cable tensions at each tier at the time of closure. The difference between the planned value and measured value according to the loading condition at the time was smaller than 5%, showing that the erection was performed with an extremely high accuracy.

However, as the allowed designed erection error was $\pm 5\%$ of the allowable design tension at the time of completion, it is judged that the range of errors at this stage was to be made $\pm 2.8\%$ of the allowable tension, taking into account the errors in the measurement. Therefore, shim plate adjustment was performed only on the cables at the 6th tier of the left side span, and at the 2nd tier and 1st tier on the right side of the center span.
