**Artikel:** Combatting road salt corrosion in concrete bridges - the way ahead  
**Autor:** Pritchard, Brian  
**DOI:** <https://doi.org/10.5169/seals-42737>

## Combatting Road Salt Corrosion in Concrete Bridges – the Way Ahead

The paper identifies de-icing salt generated corrosion as currently the most damaging threat to the integrity of our concrete bridge stock, requiring ever increasing expenditure on future maintenance. Examples are given of typical salt attack zones. A package of measures is proposed for the design, detailing and specification of future concrete bridges to improve their resistance to this insidious form of attack.

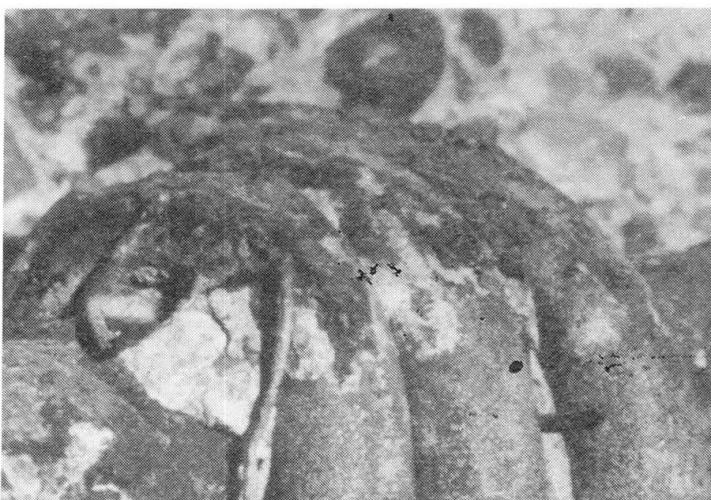
Fig. 1 Black Corrosion

Where the salt penetration is very random & there is not much free oxygen available at reinforcement or cable level, the lower ferric variety of corrosion develops. This is characterised by a local pitting of the attacked steel leading to a soft black corrosion deposit. With cover concrete of a reasonable strength, this deposit will not expand with sufficient force to break away the concrete. Typical local pitting black corrosion is shown in Figure 1. If more oxygen is present, the corrosion process is the more familiar variety with a general red surface rust. Inevitably the concrete cover is forced off by this harder & more expansive corrosion product, allowing more oxygen & moisture penetration along the bar, giving the more familiar progressive visible and red corrosion.

Thus, black corrosion is a potentially much more dangerous phenomenon as loss of reinforcement or prestressing cable is proceeding unseen under the surface. The accompanying reductions in structural integrity give no visible early warning such as cracking and spalling.
