Artikel: Combatting road salt corrosion in concrete bridges - the way ahead
Autor: Pritchard, Brian
DOI: <https://doi.org/10.5169/seals-42737>

Combating Road Salt Corrosion in Concrete Bridges – the Way Ahead

Brian PRITCHARD
Director
W.S. Atkins & Partners
Epsom, Surrey, UK

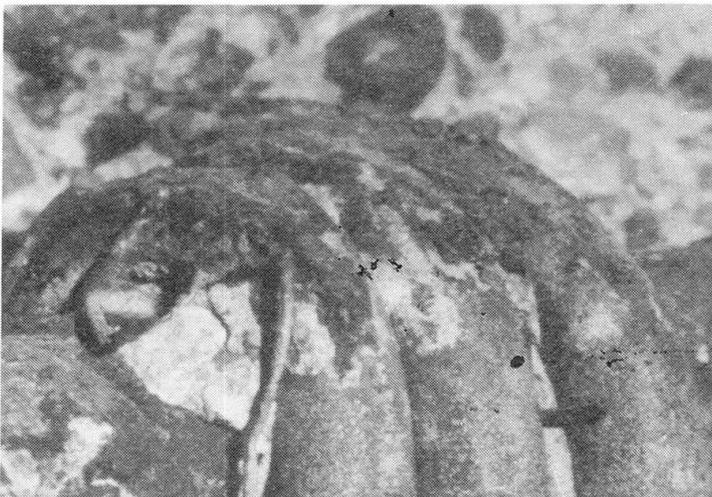
Fig. 1 Black Corrosion

Where the salt penetration is very random & there is not much free oxygen available at reinforcement or cable level, the lower ferric variety of corrosion develops. This is characterised by a local pitting of the attacked steel leading to a soft black corrosion deposit. With cover concrete of a reasonable strength, this deposit will not expand with sufficient force to break away the concrete. Typical local pitting black corrosion is shown in Figure 1. If more oxygen is present, the corrosion process is the more familiar variety with a general red surface rust. Inevitably the concrete cover is forced off by this harder & more expansive corrosion product, allowing more oxygen & moisture penetration along the bar, giving the more familiar progressive visible and red corrosion.

Thus, black corrosion is a potentially much more dangerous phenomenon as loss of reinforcement or prestressing cable is proceeding unseen under the surface. The accompanying reductions in structural integrity give no visible early warning such as cracking and spalling.

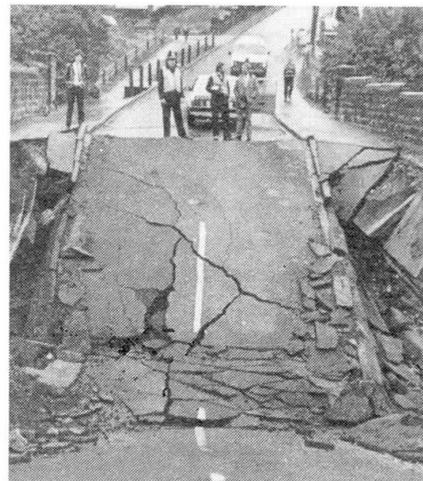
Fig. 2 Bridge Collapse

The demolition of a 25 year-old prestressed concrete flyover in Berlin because of road salt damage was well publicised in 1985. Events moved uncomfortably closer to the UK in 1986 with the demolition of one bridge, and the collapse of another, (Figure 2).

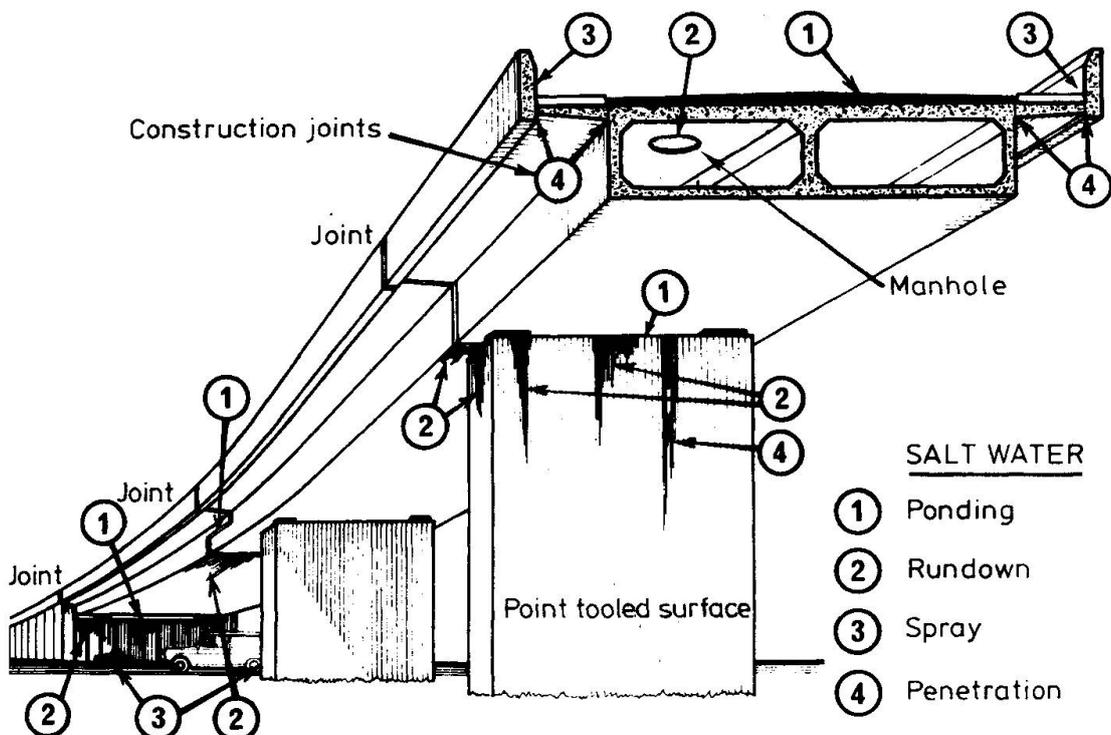
Fig. 3 Typical Salt-Vulnerable Zones

Figure 3 shows a typical concrete bridge unfortunate enough to be suffering all the winter de-icing salt attack zones which are commonly met with in bridge inspections. The vulnerable zones are indicated as subject to ponding, rundown, spray or direct penetration. The most troublesome areas are deck joints, parapets & piers. It should be emphasised that corrosion attack can be particularly rapid in local areas where the shelter of overlying structures prevents the beneficial cleansing actions of rain & salt-free spray.

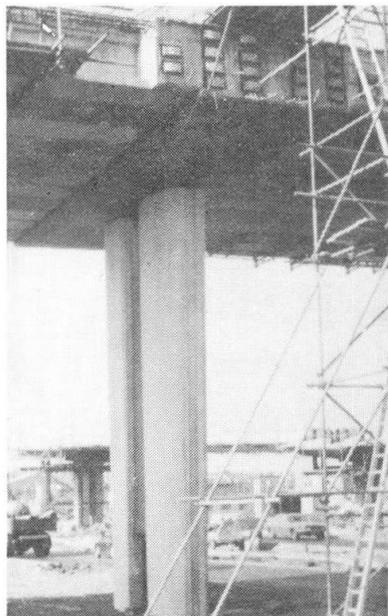
Fig. 4 Precast Beam Deck Continuity

Bridge deck expansion joints are particularly vulnerable to salt attack, not only affecting the surrounding concrete but also the underlying piers and abutments. It therefore appears logical that deck designs should set out to minimise the number of expansion joints. These occur at deck ends over the abutments, with intermediate joints if multi-span decks are designed as a series of simply supported spans or, worse, with cantilever & drop-in span half-joint arrangements. The end abutment joints may always be with us, except in the case of very short built-in single span decks. Intermediate joints are generally unnecessary if deck continuity is adopted for multi-span bridges & flyovers. Continuity possesses many other beneficial features, such as reductions in deck construction depths and pier bearings, widths & foundations, in addition to a better running quality. A major proposal is therefore that multi-span deck continuity should be mandatory, unless soil conditions dictate otherwise, and that cantilever and drop-in spans should never be permitted. Fortunately, deck continuity is now commonplace and is encouraged by several national bridge authorities. The technique of building precast beams into prestressed insitu crossheads has been used successfully to form continuous decks on several large flyovers, (Figure 4). It can readily be adapted to avoid drop-in arrangements, (Figure 5).

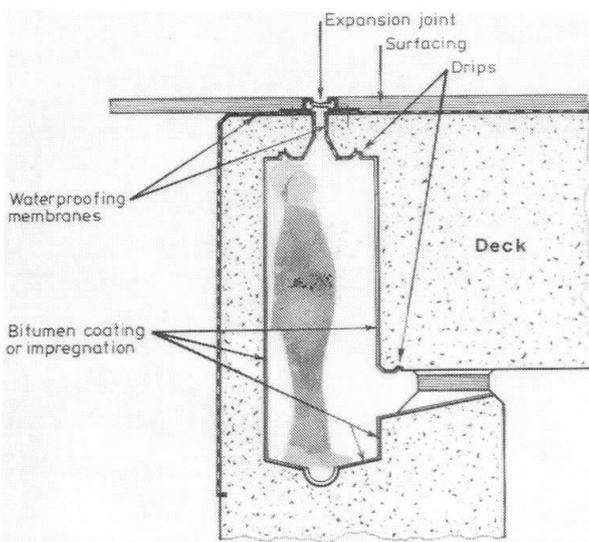
Fig. 6 Deck End Treatment

Figure 6 shows a proposed treatment to an end abutment expansion joint to avoid some of the common rundown & access problems. The ballast wall is set back and the abutment shelf dropped as necessary to provide sufficient access way at the back of the deck for future inspections & maintenance. Concrete corbels cantilever from the deck and the ballast wall to contain the expansion joint. The deck waterproofing is carried down the vertical/inclined edges of this joint and tucked into a drip formed under the corbel, providing rundown protection. The remaining soffit of the corbels and the deck vertical edge are treated with a thick bitumen paint or silane impregnation. This is particularly important in prestressed decks, where anchored cables lie just under the surface. Similar waterproofing treatment is provided on the ballast wall and abutment shelf, all applied from the access way. A drip is provided to the rear of the bearings to prevent any moisture migration across the deck soffit, which might occur due to failure of the drainage arrangements or excessive condensation within the access chamber. Adequate falls are provided to a substantial drain at the back of the abutment to prevent any rundown on the abutment face.

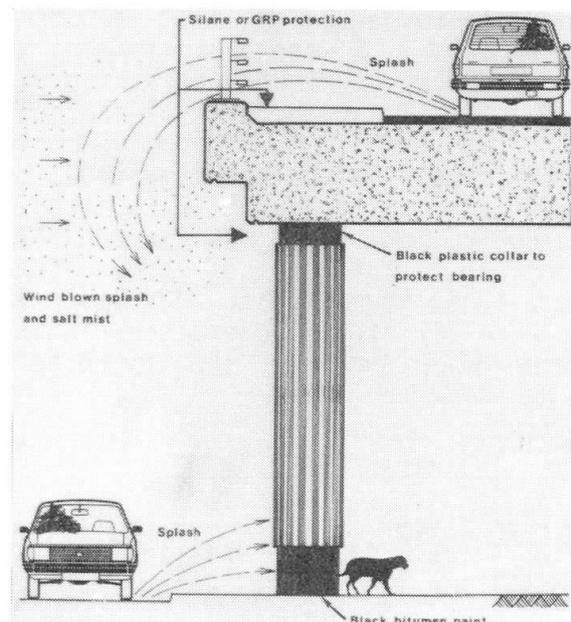
Fig. 7 Pier & Parapet Protection

It is not difficult to design adequate protection for bridge piers & parapets subject to salt splash corrosion. Splash tends to concentrate its attack just above the adjacent road surface and dogs often use columns as a tree-substitute, promoting further attack! Figure 7 shows typical treatments to a circular column pier and a parapet. The lower vulnerable zone of the pier is treated with a tough black bitumastic paint. To protect the bearings at the top from any salt laden mist, which may collect under the deck soffit, a matching black removable plastic collar is added. The overall effect can add aesthetic interest. The parapet can be treated with silane impregnation or grp sheeting.
