Artikel: Structural monitoring of a large space frame

Autor: West, R.E. / Osborn, A.E.N. / Rentschler, G.P.

Structural Monitoring of a Large Space Frame

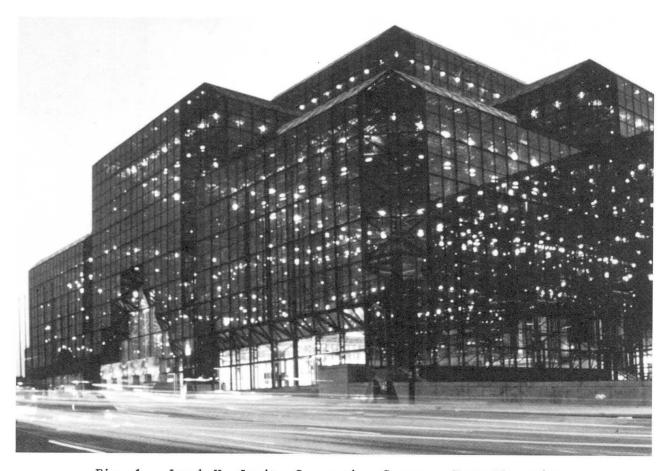
Fig. 1. Jacob K. Javits Convention Center - East Elevation

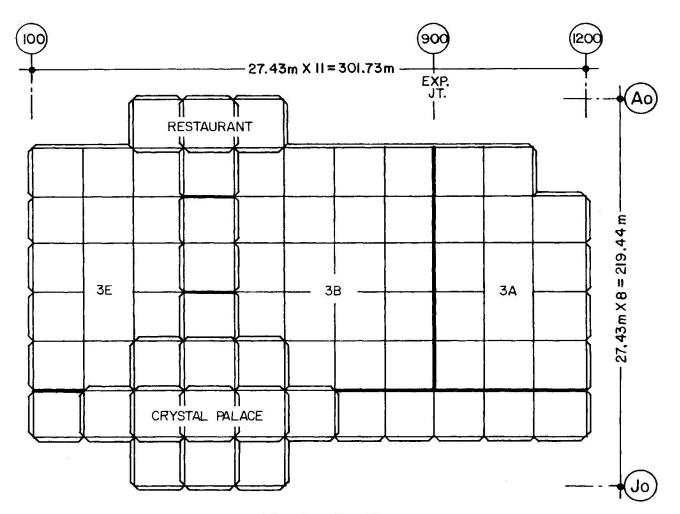
Fig. 2. Key Plan

-It is divided into several large regions (see Fig. 2) that are continuous in each direction over several spans of 27,43 m; the space frame, 1,52 m in depth, is supported by "diamond trusses" 3,05 m deep by 6,1 m wide at the column strips.

Because regions of the space frame are as large as 137 by 110 m (see Fig. 2), sliding bearings were designed to accommodate changes in dimension due to temperature variation and live loading. Since the section used for tension members is less than half that used for compression members, the tension elements of the space frame will elongate more under load than the compression elements will shorten.

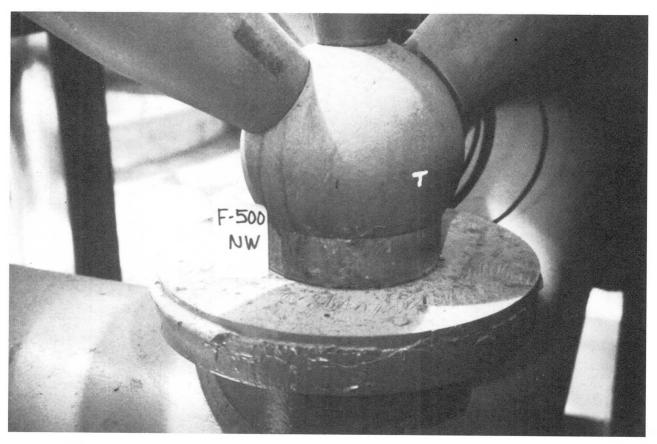
Fig. 3. One of Four Bearing Hubs at Top of "Champagne Column"

The horizontal portions of the space frame are supported by the diamond trusses along the column lines. Columns with four-legged towers support the trusses. Each leg terminates in a hub, which bears on the outstretched pipe frame 3 m square at the top of a column assembly (see Fig. 3). The 10 m high columns are

assembled from four pipes of 41 cm dia. filled with concrete and joined by cruciform plate weldments in the center. The shape is said to resemble a long-stemmed champagne glass (see Fig. 4). These assemblies are relatively flexible: the horizontal spring factor at the top is about 10 kN/mm. As the space frame is loaded, either by rising temperature or by gravity loads, the bearings push out from the center toward the edges of the structure. Although designed to slide, some friction occurs. If the friction is too great, loads could build up in the space frame members and in the columns beyond the loads considered in design. While bearings at corners are free to slide in all directions, others are confined to linear motion: this requires all four legs to slide in concert even though they are not rigidly connected to one another. All sliding bearings are unrestrained against uplift.
