Structural monitoring of a large space frame

Zeitschrift: **IABSE reports = Rapports AIPC = IVBH Berichte**

Band (Jahr): **56 (1987)**

Structural Monitoring of a Large Space Frame

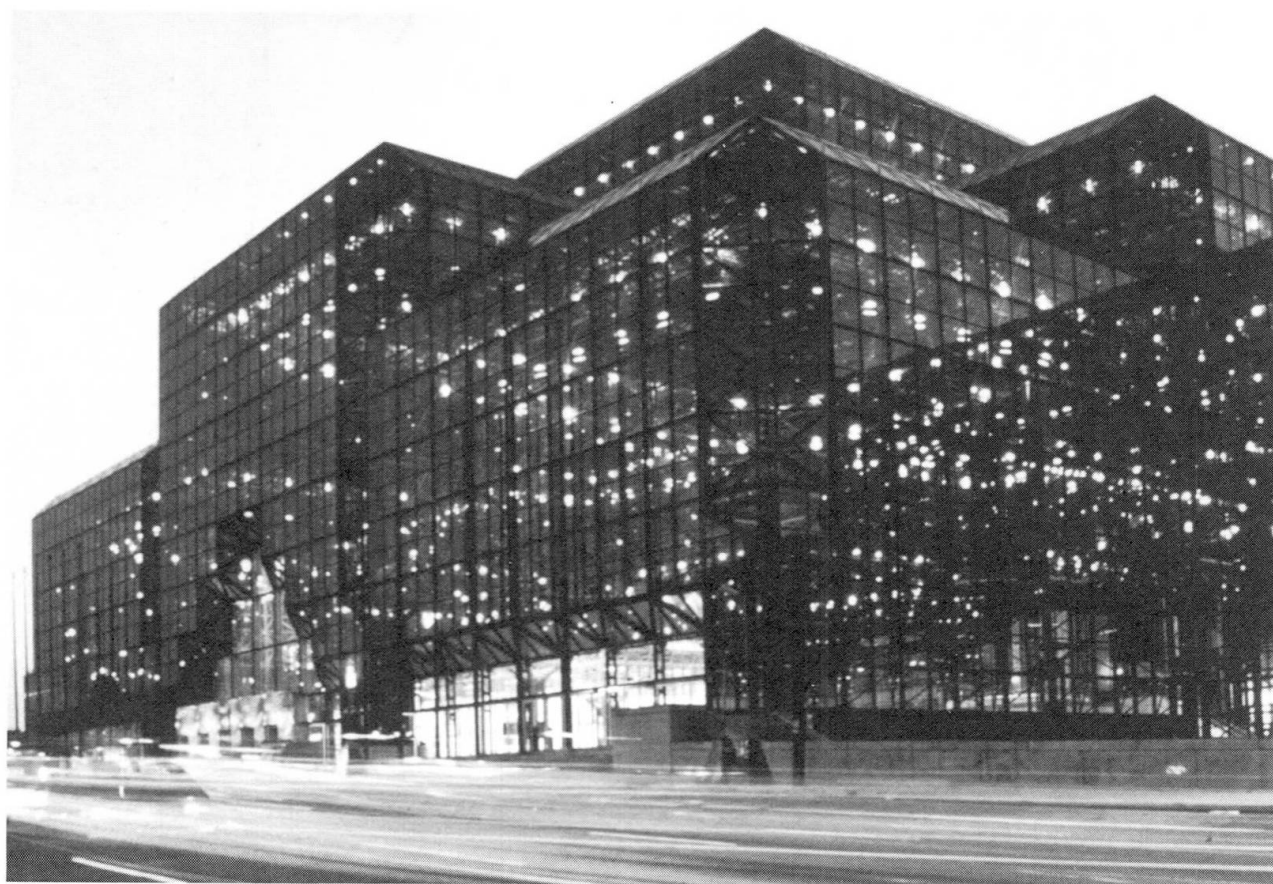
Fig. 1. Jacob K. Javits Convention Center - East Elevation

The Jacob K. Javits Convention Center in New York City, designed by I. M. Pei, was first occupied in April 1986. Distinguished by the interplay of large horizontal and vertical planes of black reflective glass, the great hall in this modern "Crystal Palace" vaults from elevation 6 to 23 m, then to 32, 41, and 56 m at the top (see Fig. 1). The space frame roof covers 53 400 m², and another 18 600 m² of vertical space frame support the glass walls.

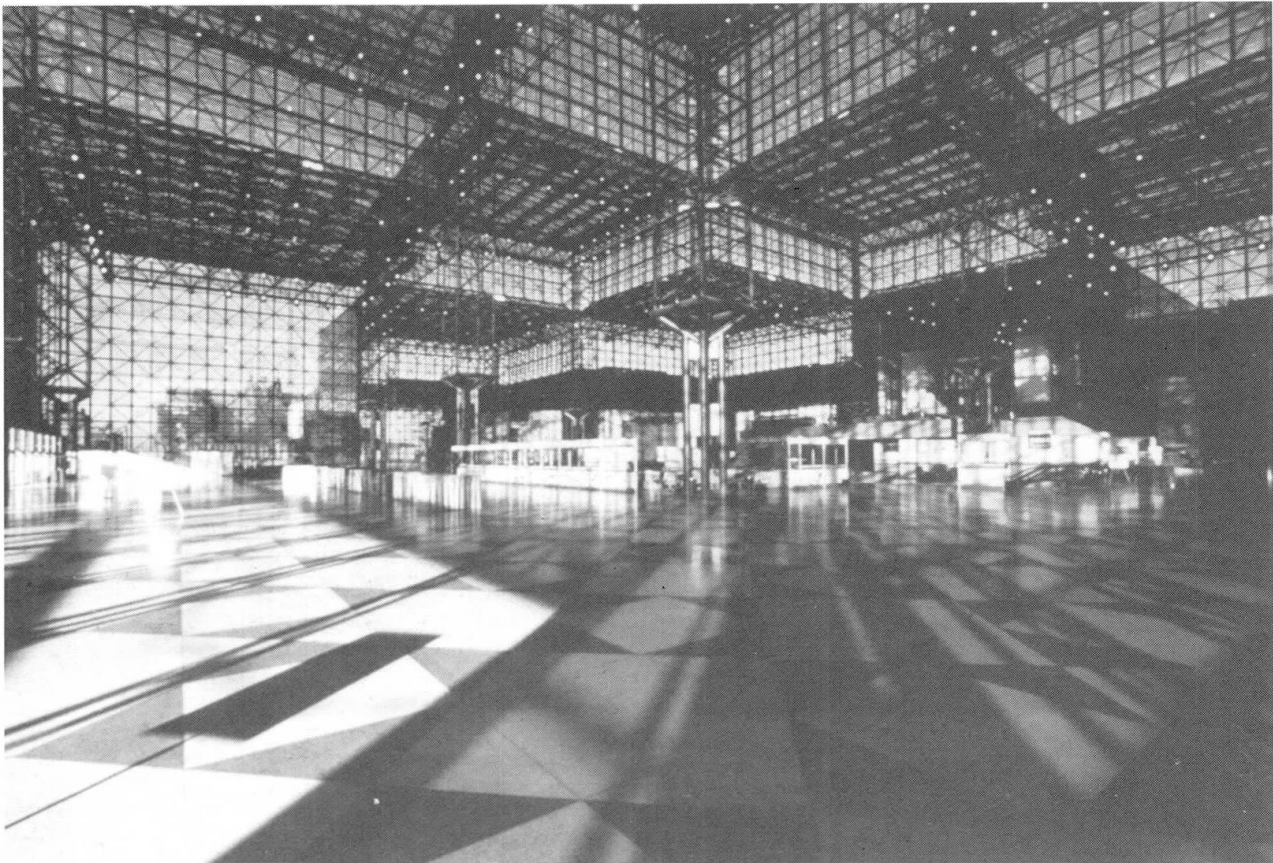
Fig. 4. Interior of "Crystal Palace"
(looking southwest)
