**Artikel:** Structural monitoring of a large space frame  
**Autor:** West, R.E. / Osborn, A.E.N. / Rentschler, G.P.  
**DOI:** <https://doi.org/10.5169/seals-43566>

## Structural Monitoring of a Large Space Frame

The Jacob K. Javits Convention Center in New York City, designed by I. M. Pei, was first occupied in April 1986. Distinguished by the interplay of large horizontal and vertical planes of black reflective glass, the great hall in this modern "Crystal Palace" vaults from elevation 6 to 23 m, then to 32, 41, and 56 m at the top (see Fig. 1). The space frame roof covers 53 400 m<sup>2</sup>, and another 18 600 m<sup>2</sup> of vertical space frame support the glass walls.

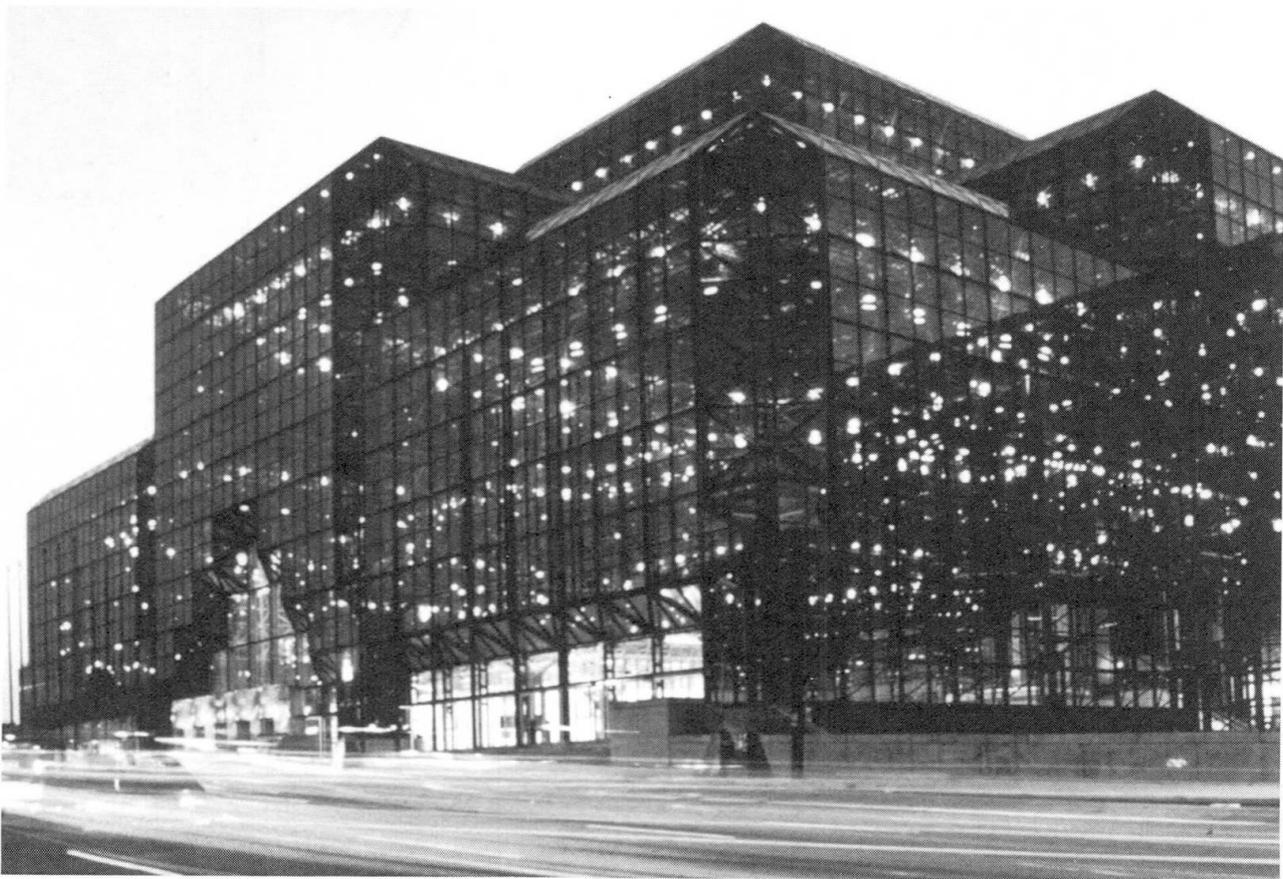
Fig. 1. Jacob K. Javits Convention Center - East Elevation

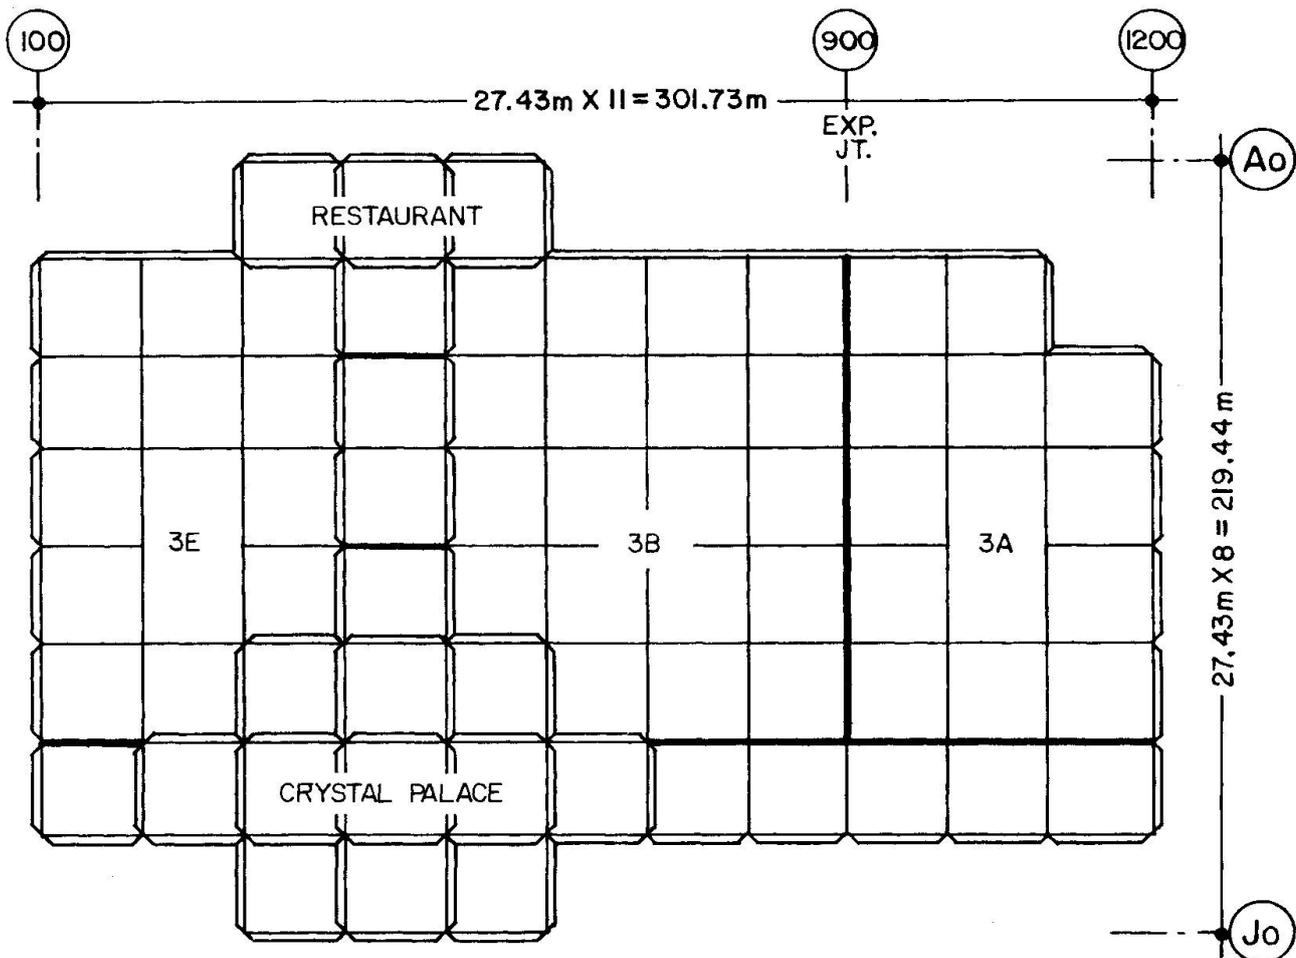
-It is divided into several large regions (see Fig. 2) that are continuous in each direction over several spans of 27,43 m; the space frame, 1,52 m in depth, is supported by "diamond trusses" 3,05 m deep by 6,1 m wide at the column strips.

Fig. 2. Key Plan

Because regions of the space frame are as large as 137 by 110 m (see Fig. 2), sliding bearings were designed to accommodate changes in dimension due to temperature variation and live loading. Since the section used for tension members is less than half that used for compression members, the tension elements of the space frame will elongate more under load than the compression elements will shorten.

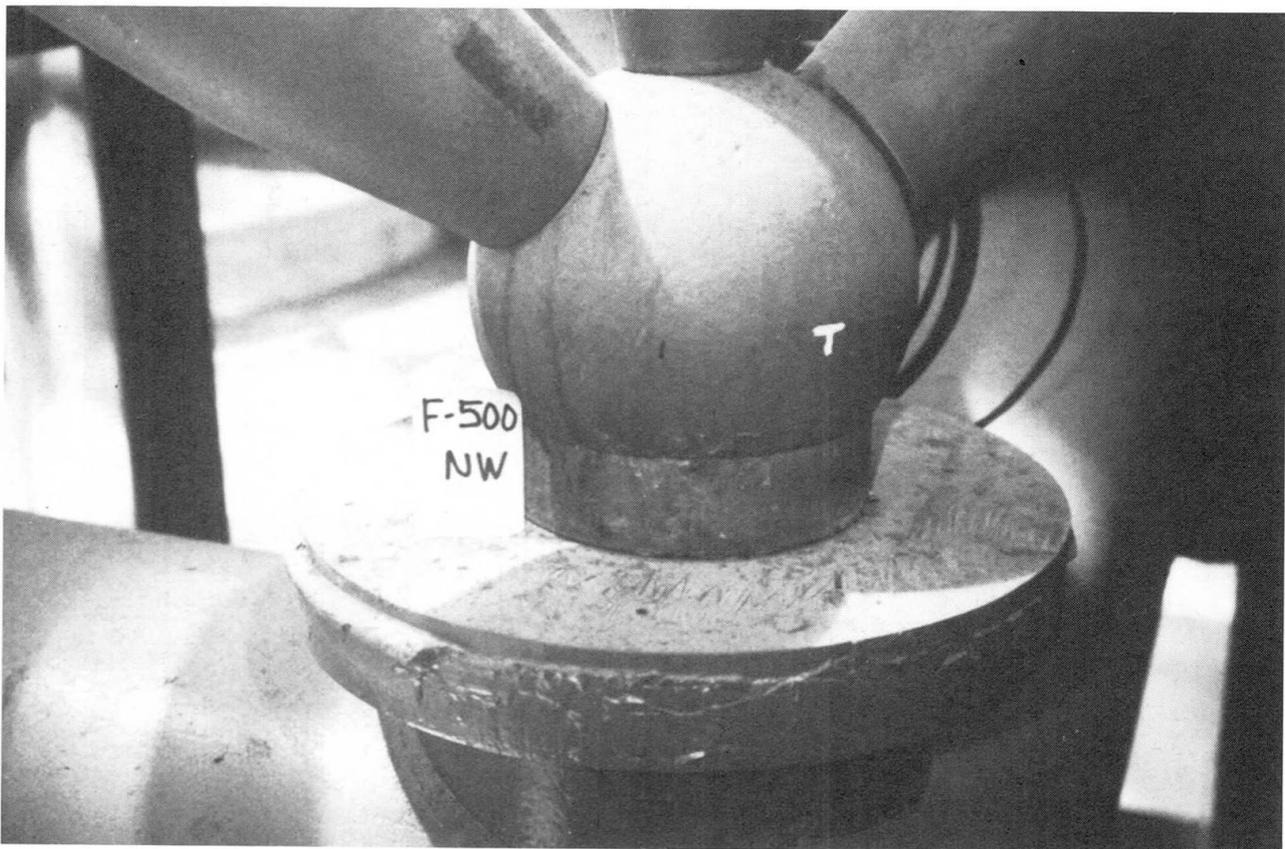
Fig. 3. One of Four Bearing Hubs at Top of "Champagne Column"

The horizontal portions of the space frame are supported by the diamond trusses along the column lines. Columns with four-legged towers support the trusses. Each leg terminates in a hub, which bears on the outstretched pipe frame 3 m square at the top of a column assembly (see Fig. 3). The 10 m high columns are

assembled from four pipes of 41 cm dia. filled with concrete and joined by cruciform plate weldments in the center. The shape is said to resemble a long-stemmed champagne glass (see Fig. 4). These assemblies are relatively flexible: the horizontal spring factor at the top is about 10 kN/mm. As the space frame is loaded, either by rising temperature or by gravity loads, the bearings push out from the center toward the edges of the structure. Although designed to slide, some friction occurs. If the friction is too great, loads could build up in the space frame members and in the columns beyond the loads considered in design. While bearings at corners are free to slide in all directions, others are confined to linear motion: this requires all four legs to slide in concert even though they are not rigidly connected to one another. All sliding bearings are unrestrained against uplift.

Periodic monitoring of bearing-hub movements on the chromed plates atop the "champagne columns" will be facilitated by scratch gages fabricated from stainless spring steel with a hardened stylus at the end to provide a trace on a soft brass tablet, 8 x 8 cm. An approximate record of movement since April 1986 has been provided by means of a coat of paint inadvertently applied over the chromed surface of the bearing plates and by observation of the disruption of recent dust layers.
