Zeitschrift: IABSE reports = Rapports AIPC = IVBH Berichte
Band: 56 (1987)
Rubrik: Session 3. Interpretative models and decision making

Interpretative Models and Decision Making

Dynamic Behaviour and Monitoring of Ancient Monuments

The Bridge Ulenbergstraße in Düsseldorf is the first road bridge construction where prestressing is entirely provided by resin bonded glass fibre (Polystal) tendons. In order to verify the structural integrity under service conditions a long term monitoring program has been established. In the paper, integrity monitoring techniques applicable to concrete bridges are briefly reviewed and the special monitoring program for Ulenbergstraße is presented. Finally, the results obtained until now are discussed.

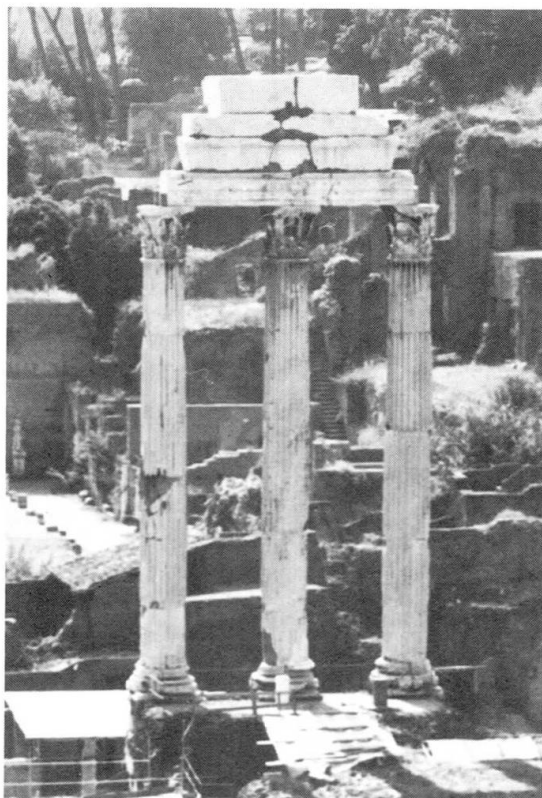
fig. 5 Tempio di Castore e Polluce: photo of the monument and of the Finite Elements model.

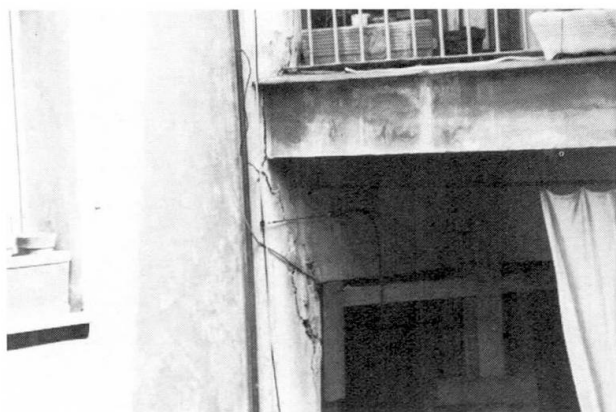
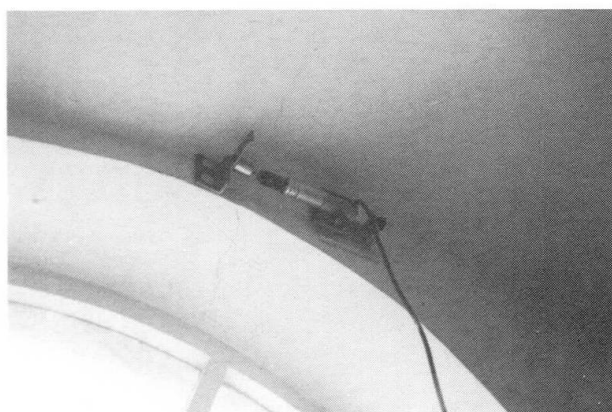
Fig. 8-11 Some of the most significant cracks on the masonry structures

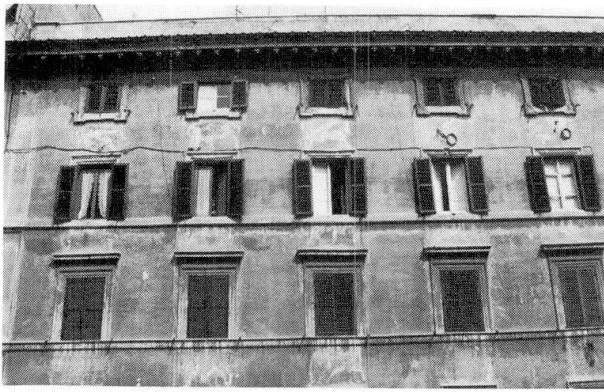
Fig. 12 Facade on Via Palestro with some of the installed instruments

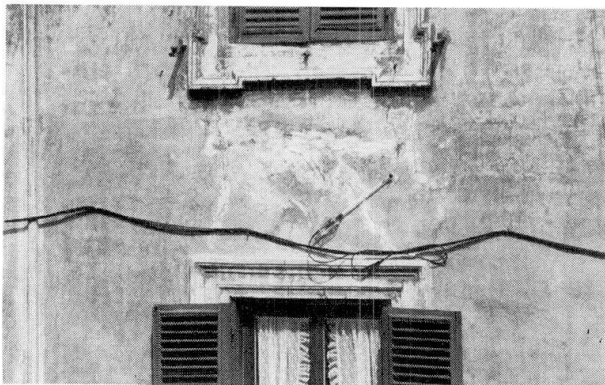
Fig. 14 The instrument n° 11
