Zeitschrift: IABSE reports = Rapports AIPC = IVBH Berichte
Band: 56 (1987)

Interpretative Models and Decision Making

Dynamic Behaviour and Monitoring of Ancient Monuments

Carlo BLASI

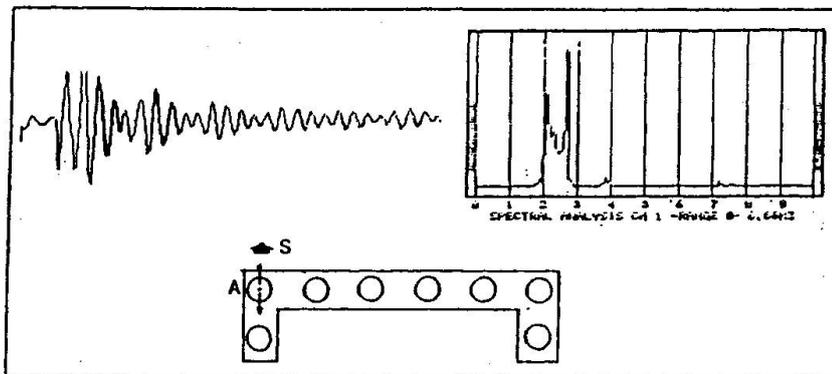
Experimental study		Numerical models	
		Hz	K	Hz
TEMPLE OF SATURN		1.50		1.87
		1.85		
		2.10

fig. 1 Tempio di Saturno: Displacements concerning 3 eigenmodes

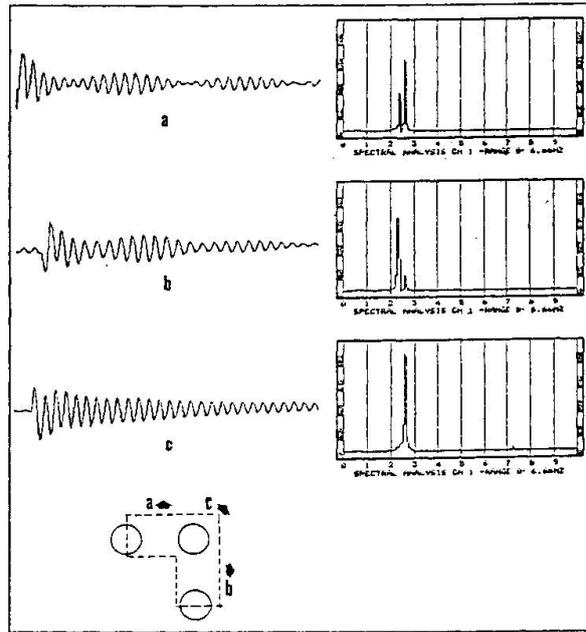
fig. 2 Tempio di Vespasiano: Displacements concerning 3 eigenmodes

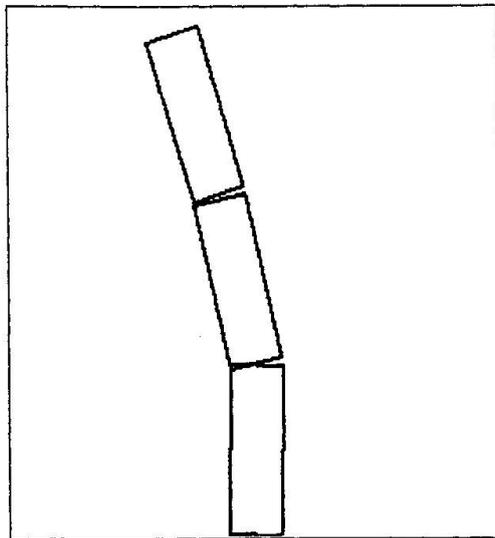
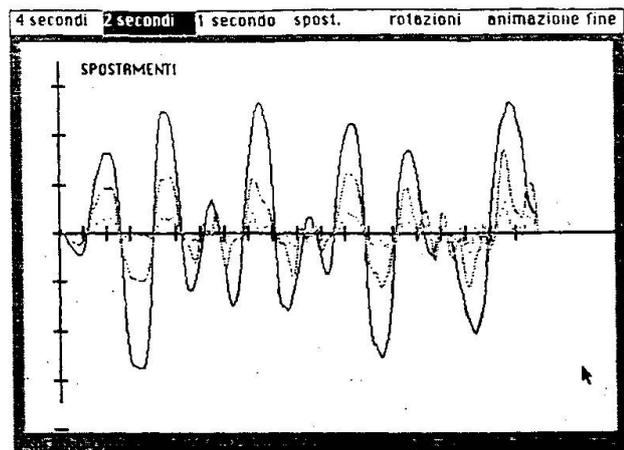
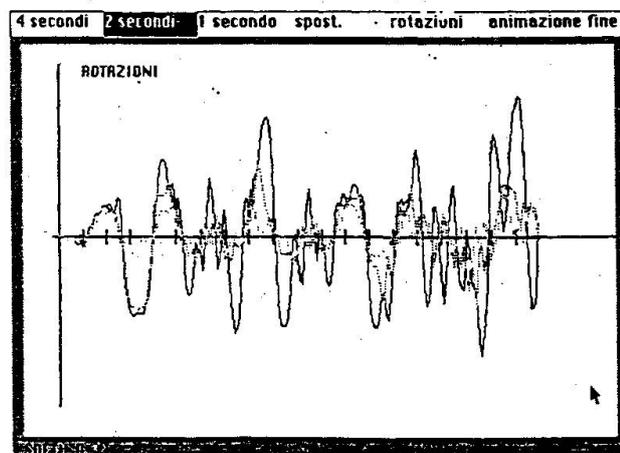
fig. 3 Colonna di Foca: Numerical non linear model and results (displacements and rotations)

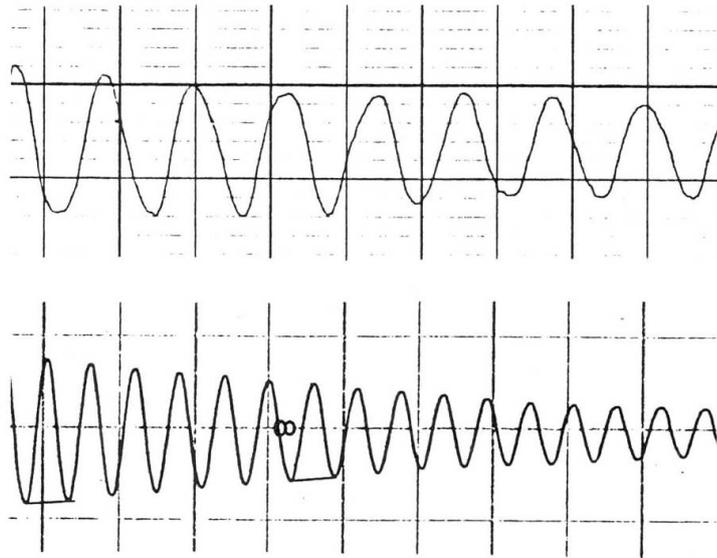
fig. 4 Colonna di Foca: Some examples of displacements effected before and after the consolidation

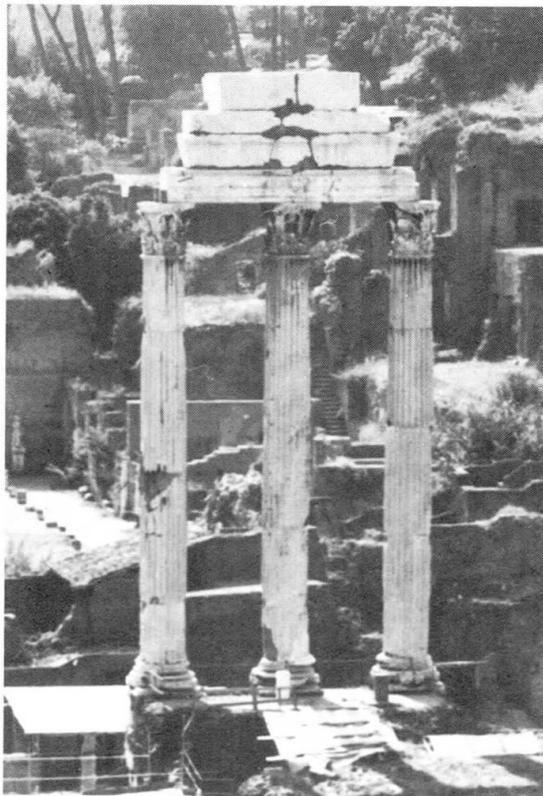
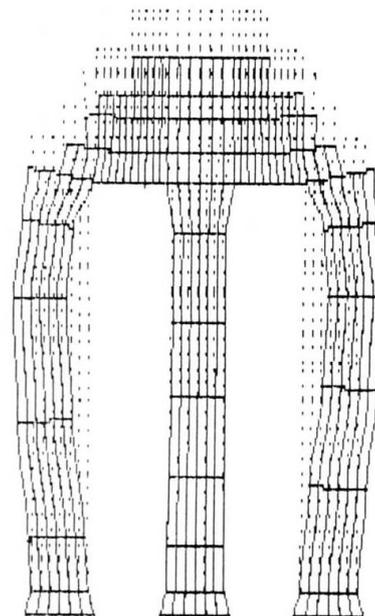
fig. 5 Tempio di Castore e Polluce: photo of the monument and of the Finite Elements model.

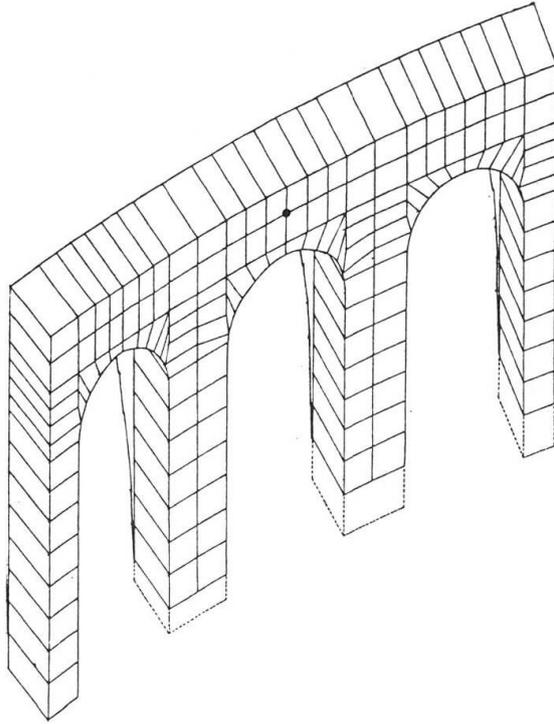
fig. 6 Colosseo: Finite Elements model of the research area.

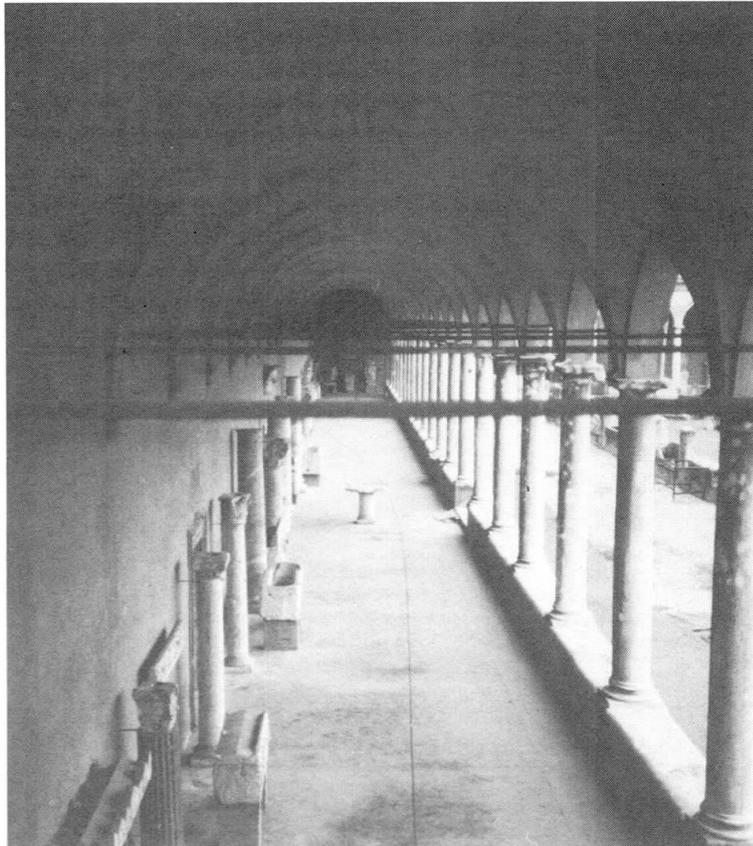
fig. 7 Photo of catenary system in Michelangelo cloister in the church of S. Maria degli Angeli in Rome.

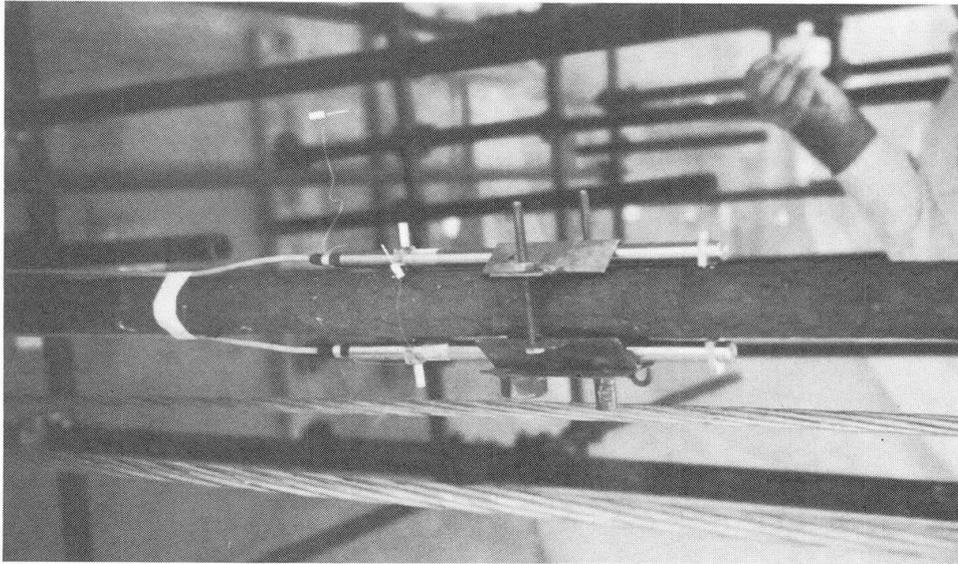
fig. 8 Photo of deformometers applied on a chain for dynamic tests.

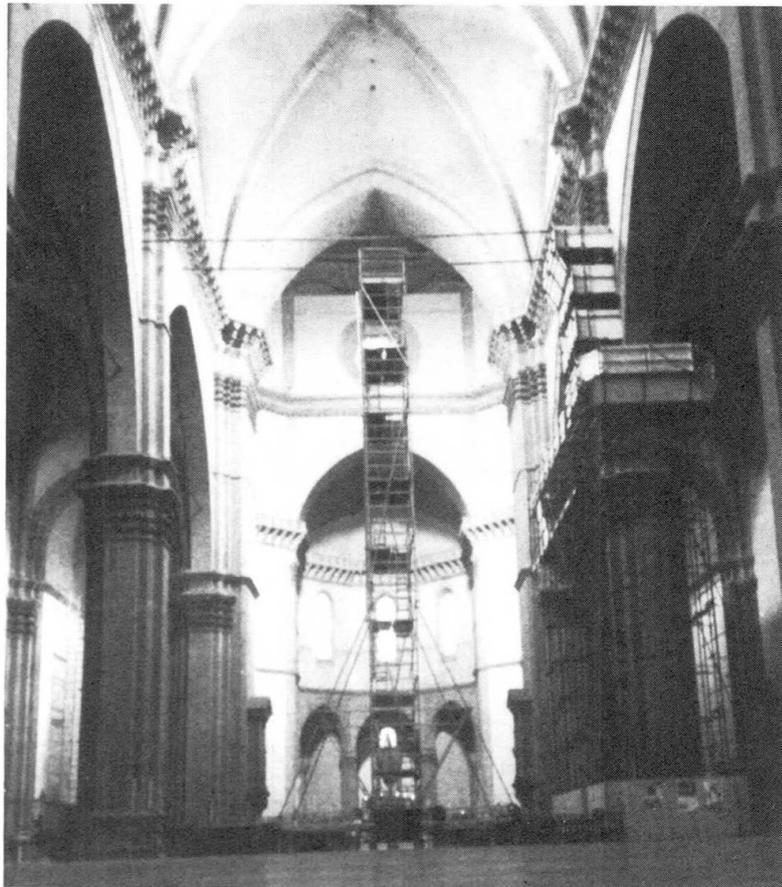
fig. 9 Photo of the church of S. Maria del Fiore in Florence during the test effected on transversal chain.

In collaboration with C.R.I.S.-E.N.E.L., under the protection of Commune of Florence and the Superintendent of Monuments, some dynamic tests have been conducted and other are in programm on some monuments in Florence. In particular Brunelleschi's dome and Arnolfo's Tower have been tested. The excitation was given by natural causes (wind) for the Brunelleschi's dome, whilst for Arnolfo's Tower besides the wind action, also a vibrodine at the top of the tower was employed for exciting the structure.

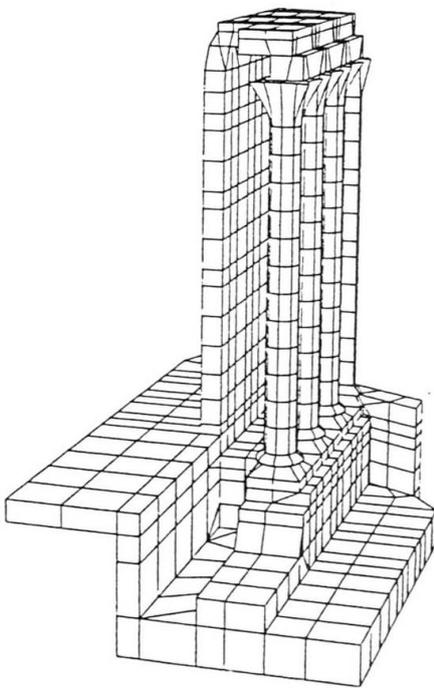
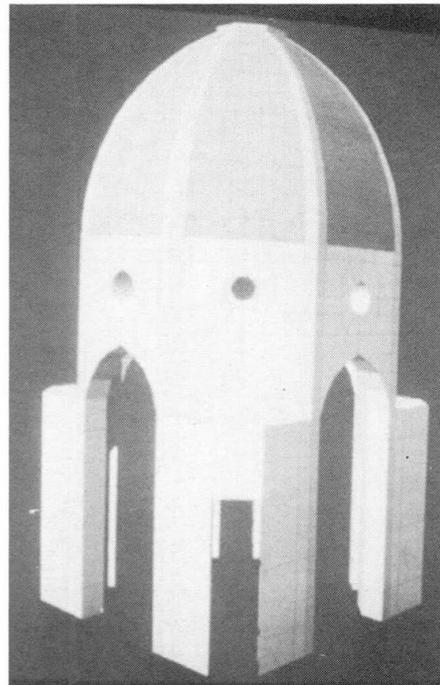
fig. 11 Tempio di Marte Ultore and Brunelleschi's Dome numerical models (CRIS-ENEL)

The speed of some points of the structure was recorded with a laser type technology. However more details on this tests and those on Temple of Marte Ultore in Rome will be presented in the works of Chiarugi, Castodi, Giuseppetti, Fanelli, Petrini presented at this Colloquium.

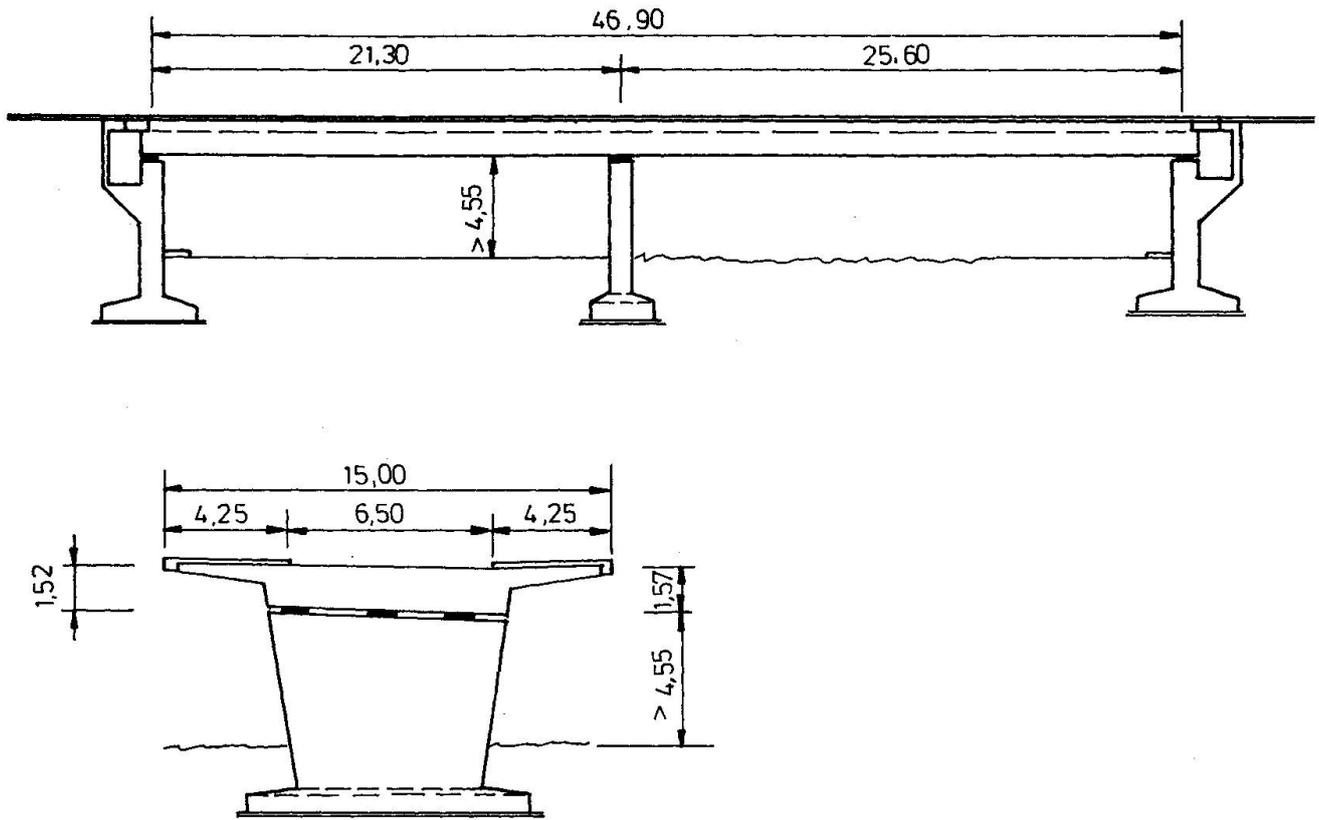
Fig. 1 Bridge Ulenbergstraße, Longitudinal and cross sections

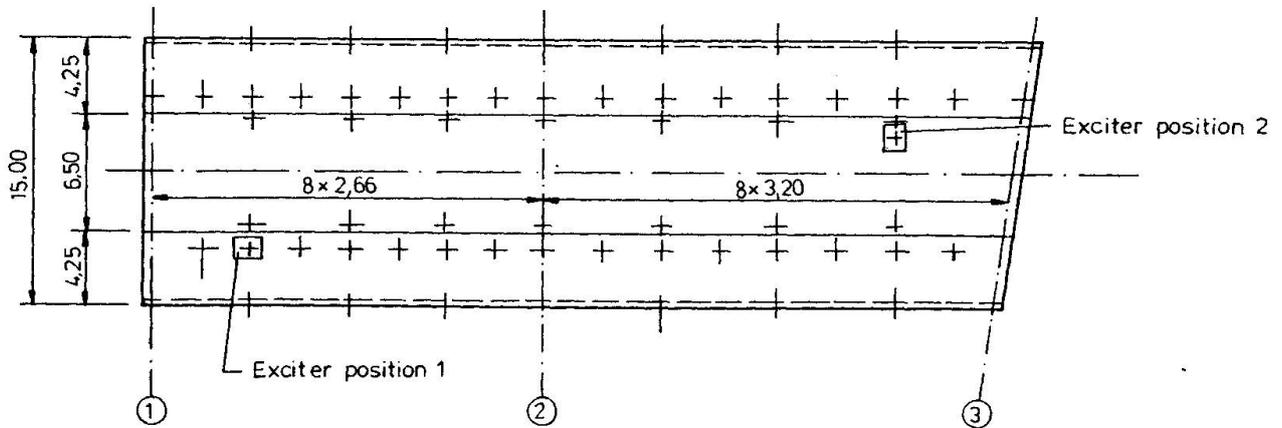
Fig. 2 Bridge Ulenbergstraße, Plan view
Exciter positions and measuring grid

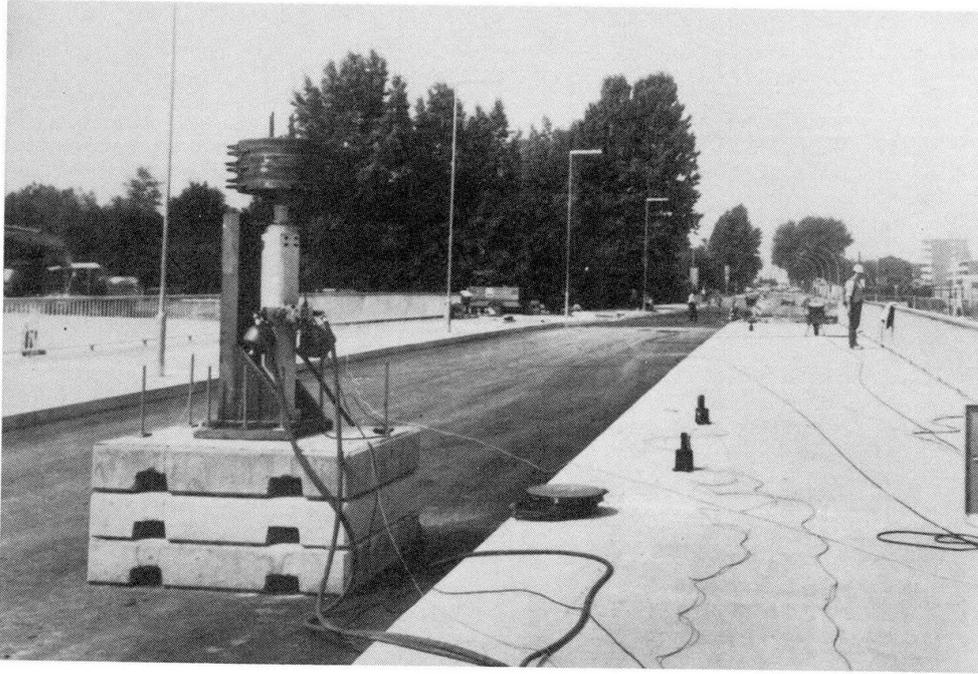
Fig. 3 Bridge Ulenbergstraße, hydraulic exciter (1st measurement)

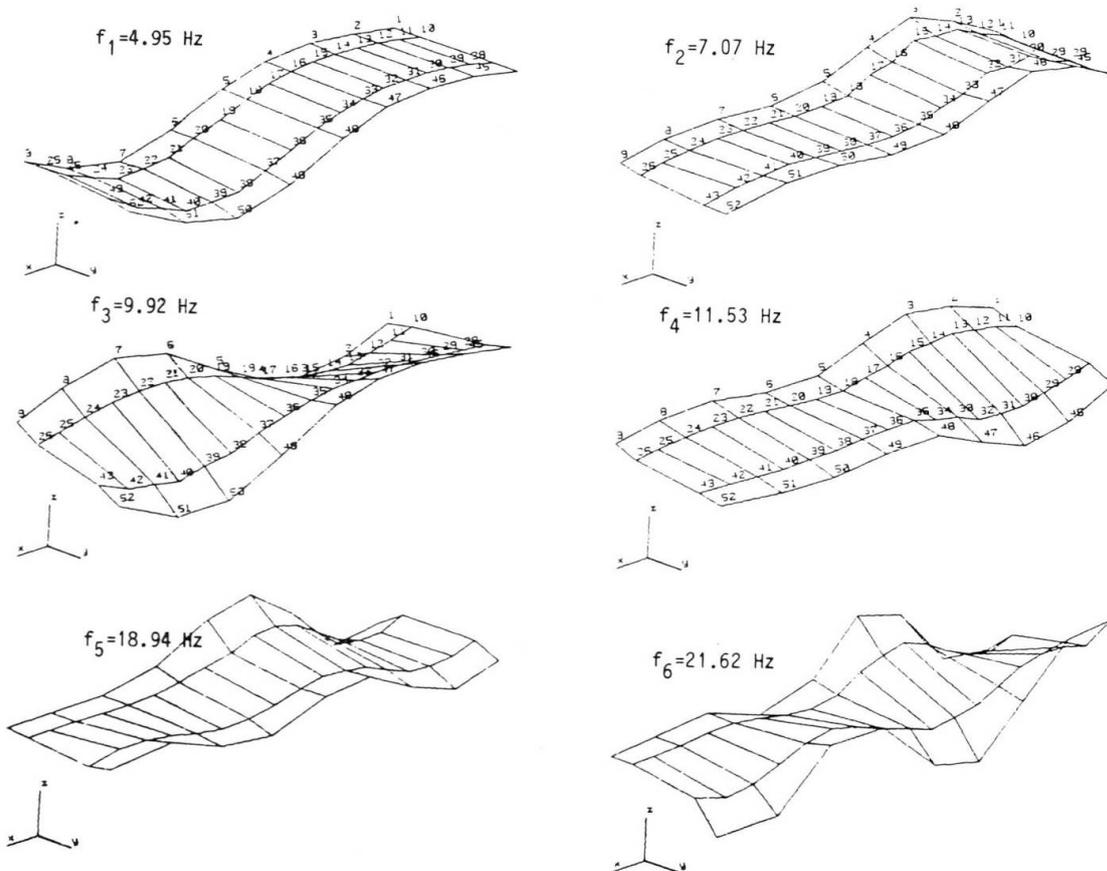
Fig. 4 Mode shapes extracted from the measured response

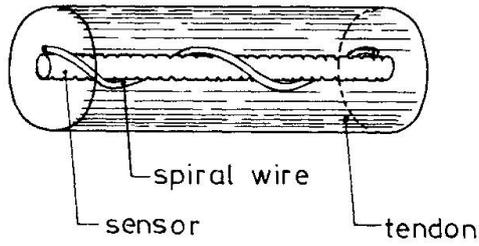
Fig. 5 Optical sensor (Felten & Guilleaume)

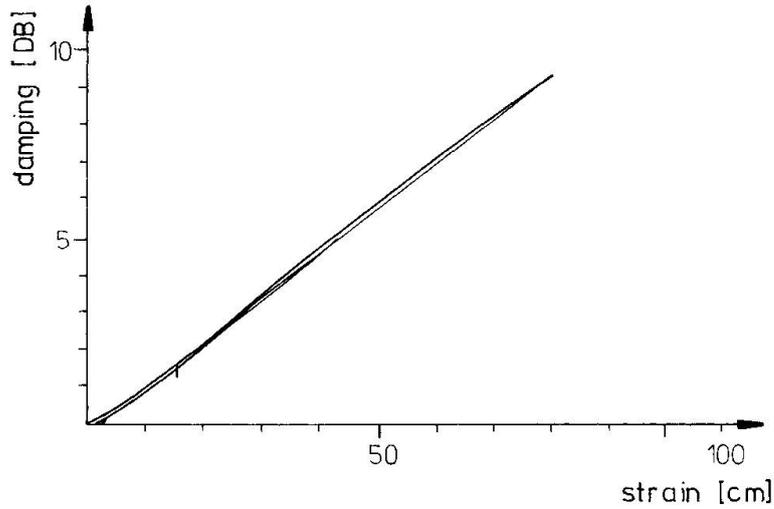
Fig. 6 Damping-strain relationship of the optical sensor

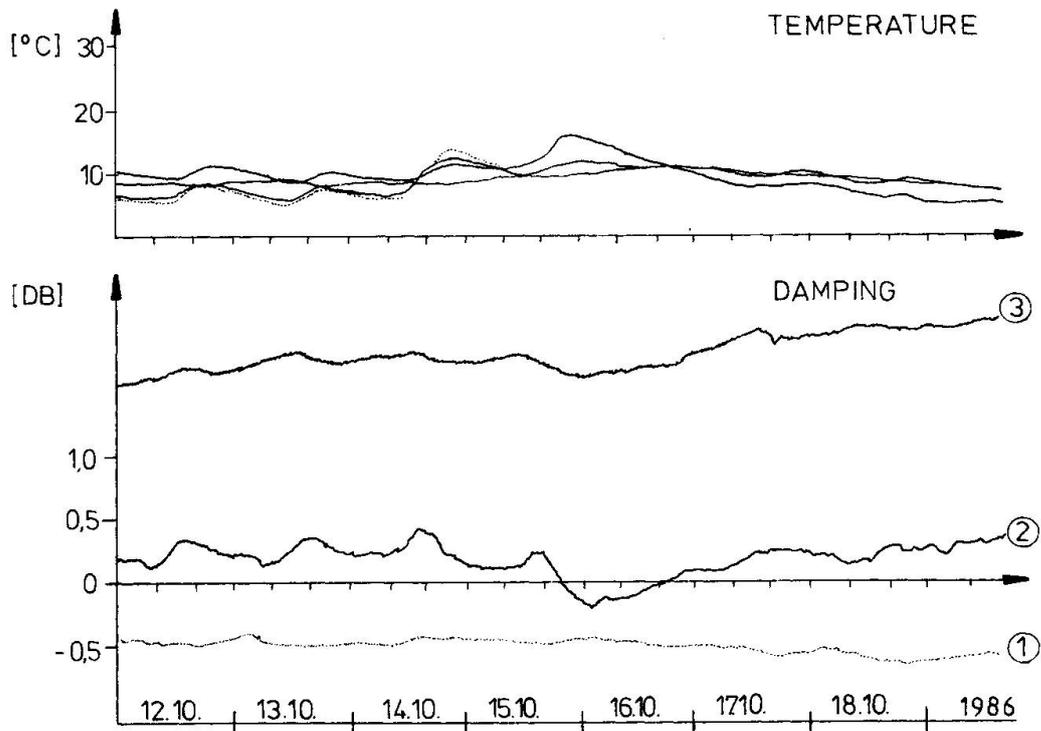
Fig. 7 Optical sensor monitoring on Bridge Ulenbergstraße

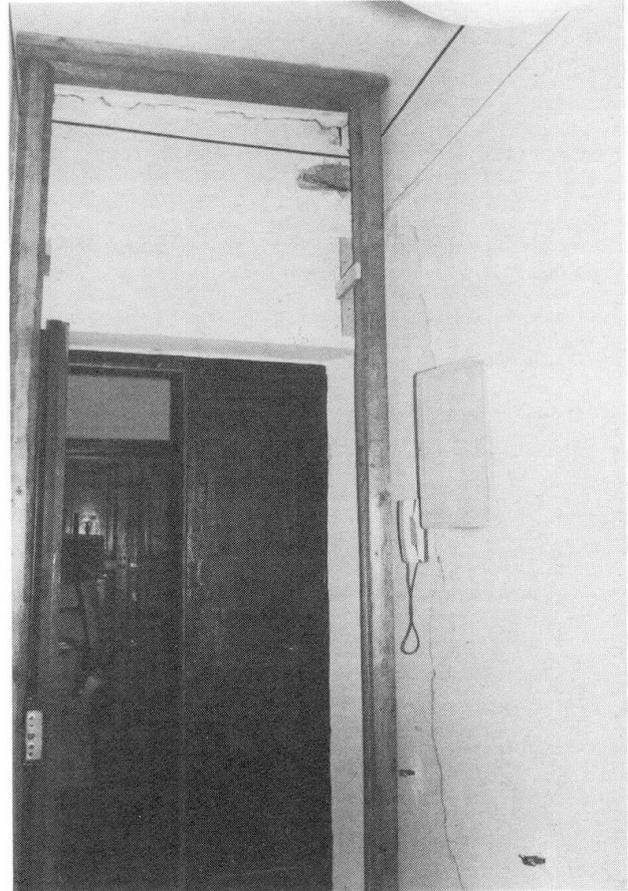
Fig. 8-11 Some of the most significant cracks on the masonry structures

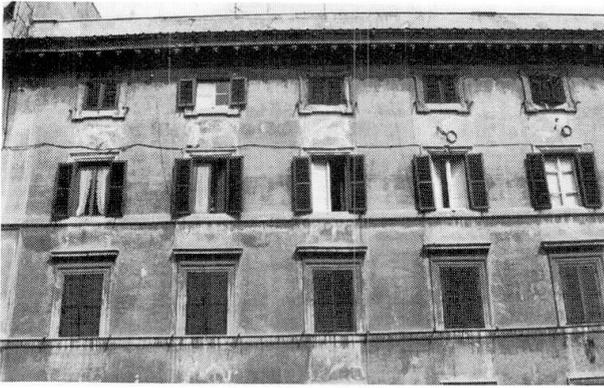
Fig. 12 Facade on Via Palestro with some of the installed instruments

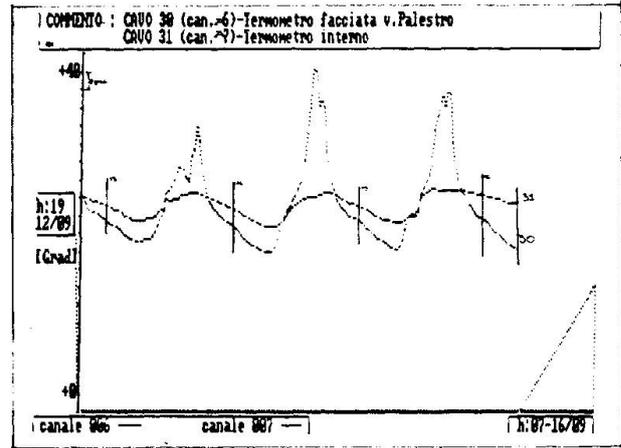
Figures 16 and 17 Two examples of the graphs produced

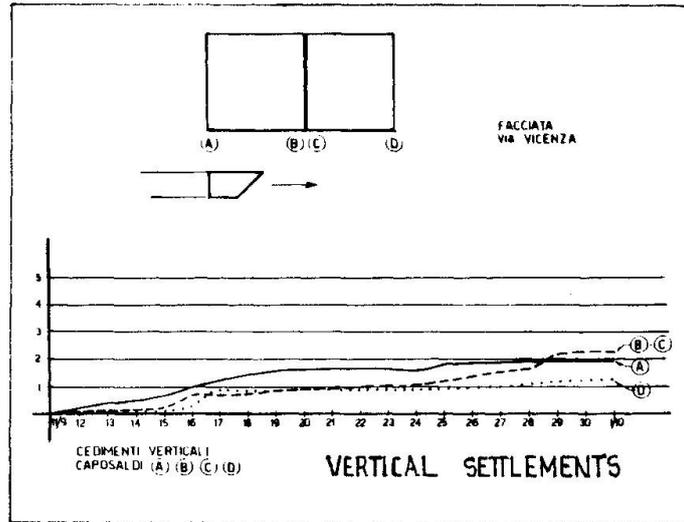
Fig. 27 Measured settlements on the base of the building on Via Vicenza

Figures 27 and 28 show the relationships between the changes over time in the subsidence measured at the data points on the Via Vicenza face and the behaviour of the joint between the two buildings on the same face. The following points deserve specific mention. First, the slightness of the subsidence and joint movements recorded up to 17th September (when the shield was entering below the building to the left of the joint) and, second, the

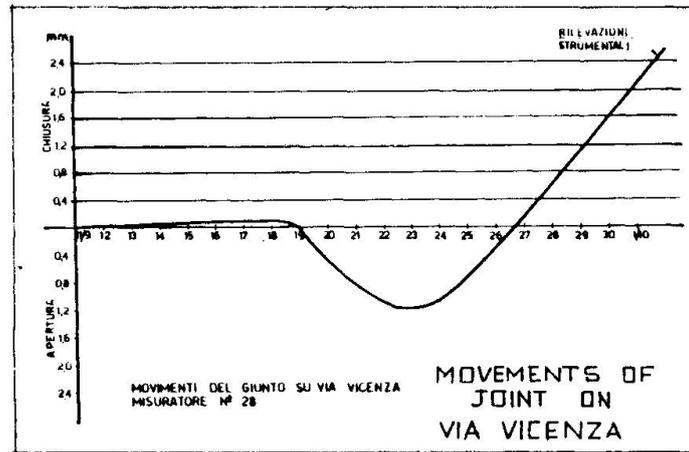
Fig. 28 Movements of the joint between the buildings on Via Vicenza

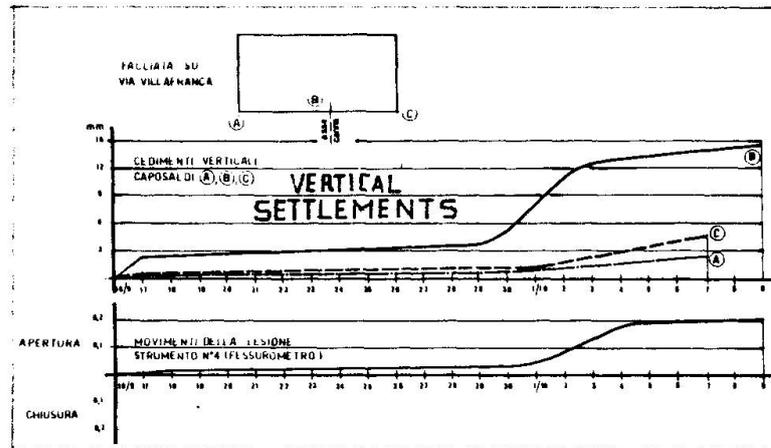
Fig. 29 Facade looking on Via Villafranca Comparison between measured settlements and movements of the joint

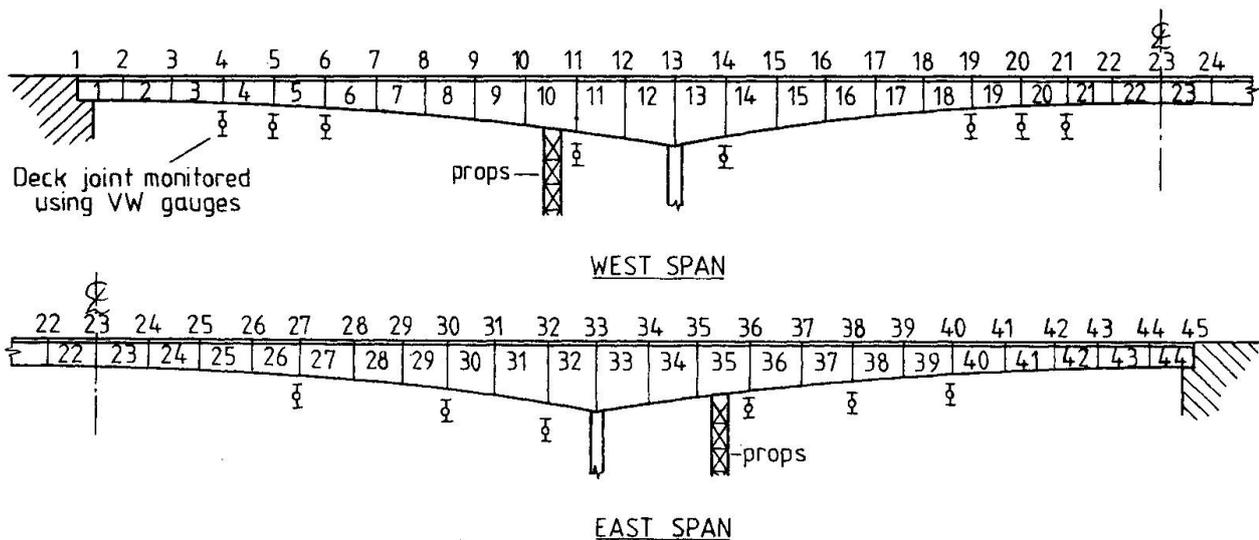
Fig. 1 Deck segment and joint numbering sequence

The segments and joints were numbered consecutively from the west end (Fig. 1). Each segment comprised four, 3m long, precast I-sections joined by in-situ top and bottom slabs to form a three cell box structure. The precast I-sections were temporarily held in place during erection by a diagonal Macalloy bar passing through the webs at the joints. The Macalloy bars remained in position in the permanent structure and were fully grouted. Longitudinal post-tensioning was then applied to the precast units so that two 19 wire/25mm diameter strands were anchored at each cantilever end, running through the previously assembled I-sections. The continuously reinforced slabs were cast and further post-tensioning was applied.

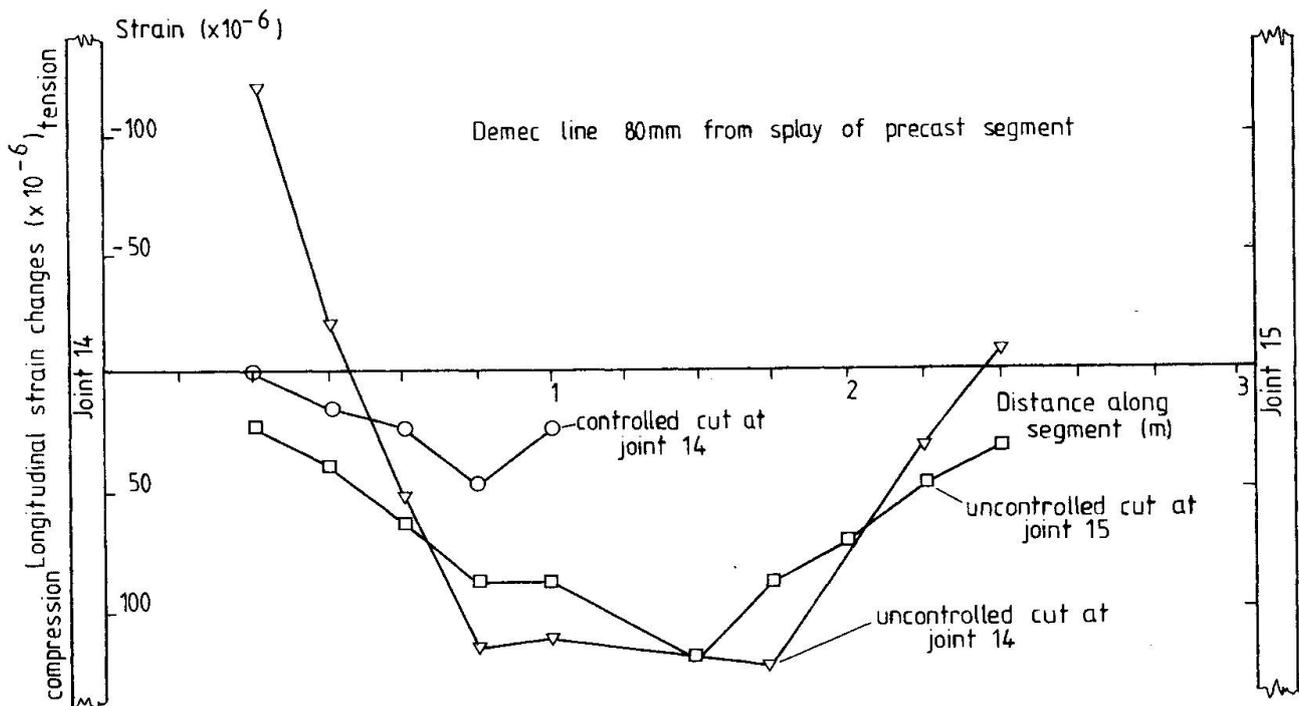
Fig.2 Typical debonding curve.

The curve for the controlled cut at point 1 relates to the cutting of 3 wires in the nearest 19 wire strand at joint 14. The curves for uncontrolled cutting at points 2 and 3 relate to the severing of all the tendons at joints 15 and 14 respectively. As the cutting at point 3 (joint 14) was carried out last, the corresponding curve shows a symmetrical distribution in the strain changes. Each half of the curve is of a form associated with the transfer of stress in the transmission zone of a pretensioned tendon. High strain gradients near the cut end of the tendon are a consequence of the transfer of force from the steel to the concrete by bond. The transmission length is of the order of a metre. In the

Generally the trials showed that fully grouted tendons would not debond more than a fraction of the length of a unit, ensuring that virtually all the residual prestress force would be present at the next in-situ joint. During progressive cutting of a tendon, the changes in strain on the adjacent concrete surface illustrated the debonding characteristics (Fig.2).

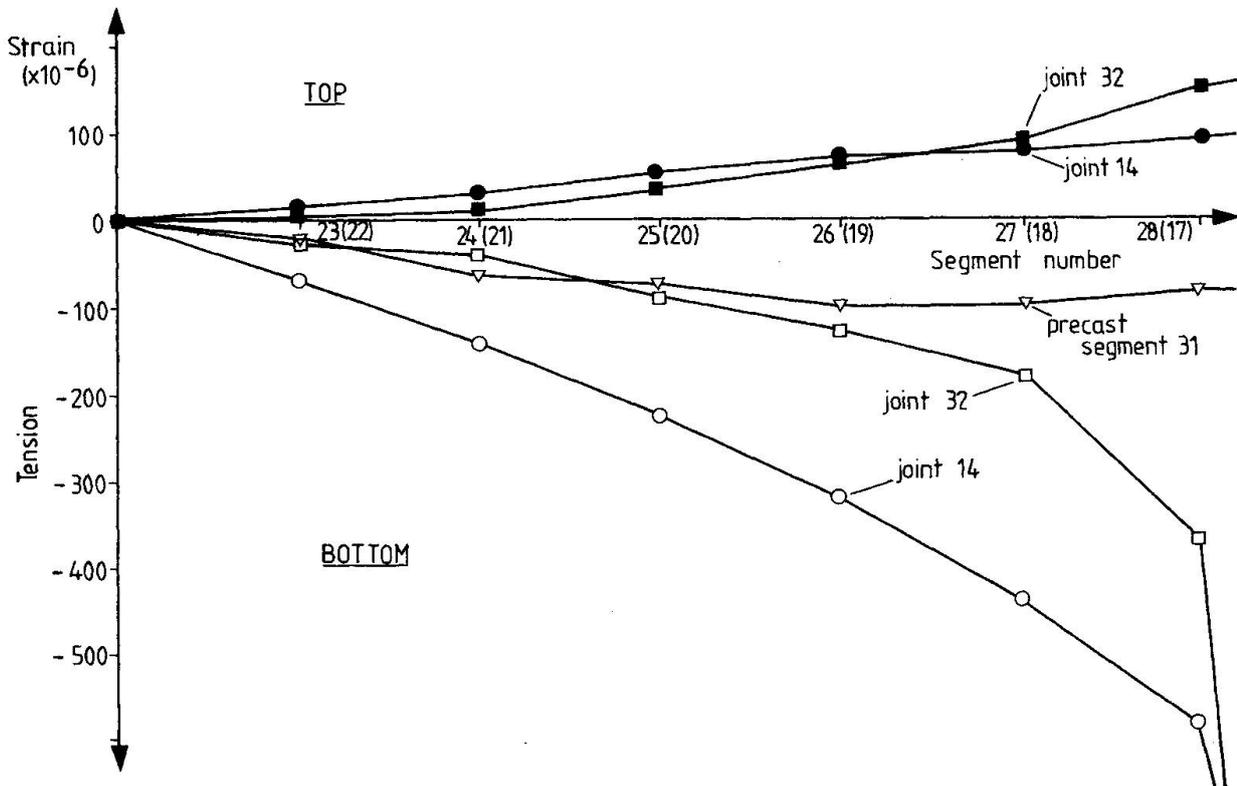
Fig. 3 Comparison of strain changes on south side.

Generally the strain changes due to the removal of the first box units were relatively small. The readings taken across the joints furthest from the piers were closely predicted by elastic theory. However, as demolition progressed the strain changes in the joints near the piers increased dramatically. This effect was particularly noticeable for joints 14 and 32 on the centre span. Although joint 32 did not initially suffer significant strain changes, after the first five midspan units had been removed the apparent tensile strains increased to become similar to the readings from joint 14 (Fig.3).

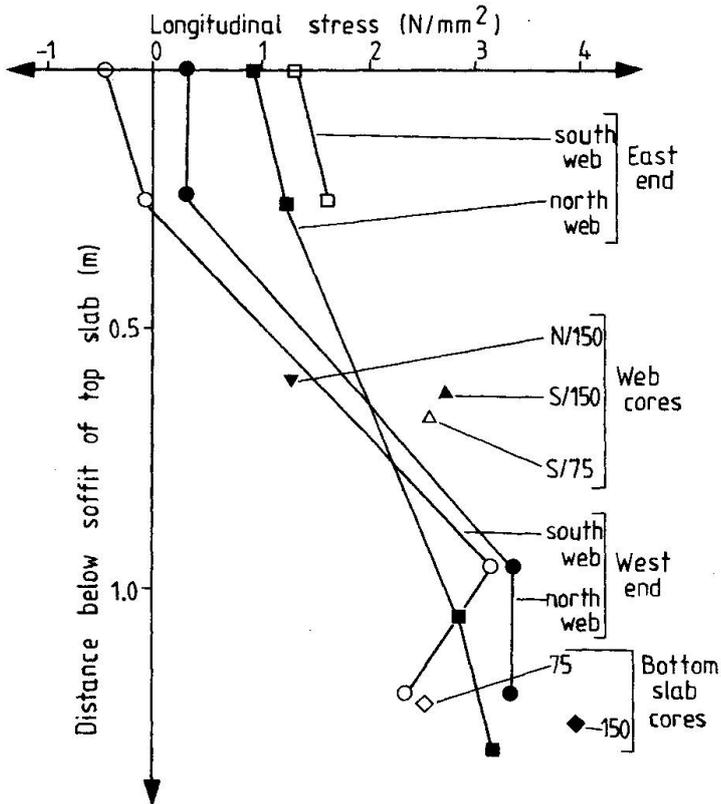
The stresses derived from the coring method were compared with those obtained from the complete removal of unit 25 (Fig.4). These longitudinal stresses were in reasonable agreement for both the north and south webs at each section although, as expected, there was a distinct difference between the two sections. Despite the fact that the conditions were not identical for the two trials, the results were in good agreement. This indicated that the coring method provided useful indirect evidence on the state of stress in the webs and flanges.

Fig. 4 Longitudinal stresses in unit 25

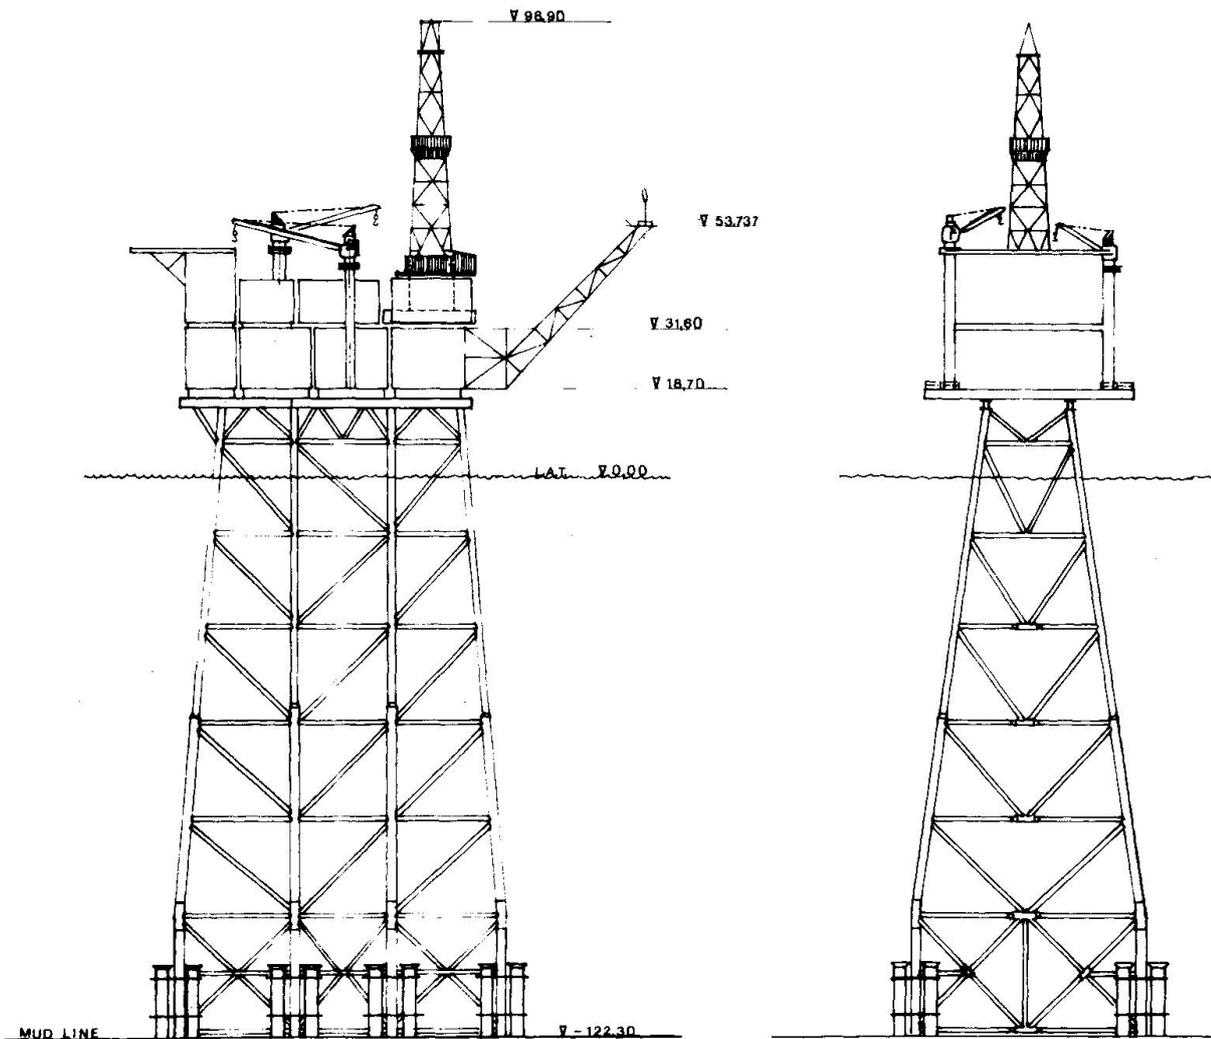
Figure 1 : North West and South West views of Vega A platform.

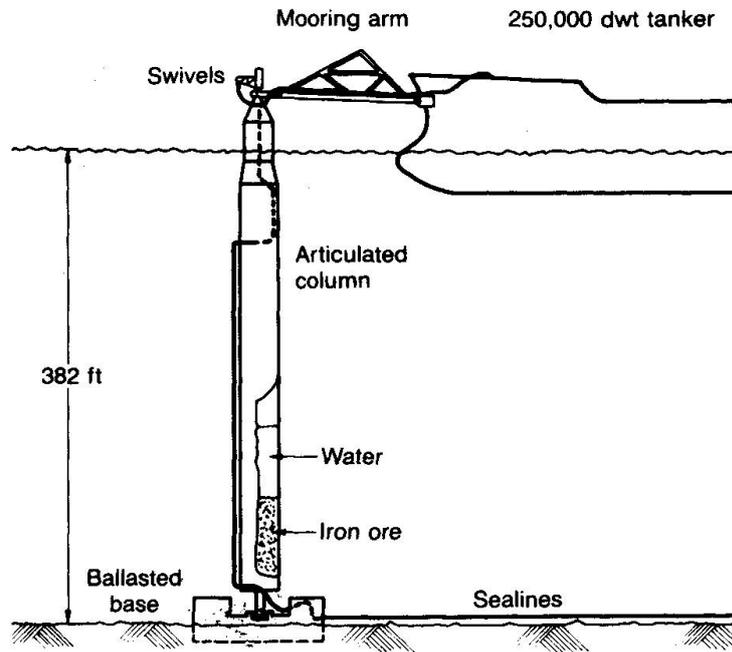
Figure 2 : Single point mooring for tanker at 2.3 km from platform.

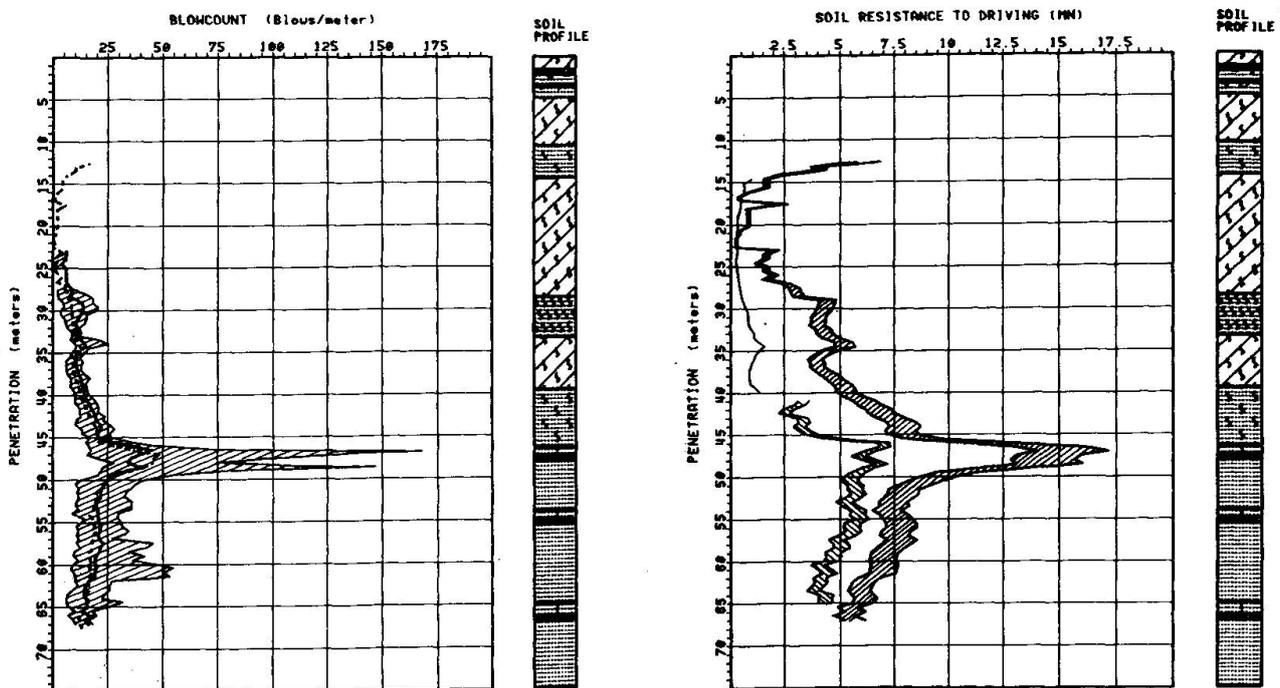
Figure 3 : Blawcount of foundation pile and soil resistance for pile and conductor during driving.

resistance acting on the piles was lower than expected due to remoulding and degradation effects, this also can be explained in terms of the excess energy available during driving.

For the piles figure 3 shows that the average blowcount never exceeded 50 blows per meter. This observed driving behaviour demonstrates that the frictional

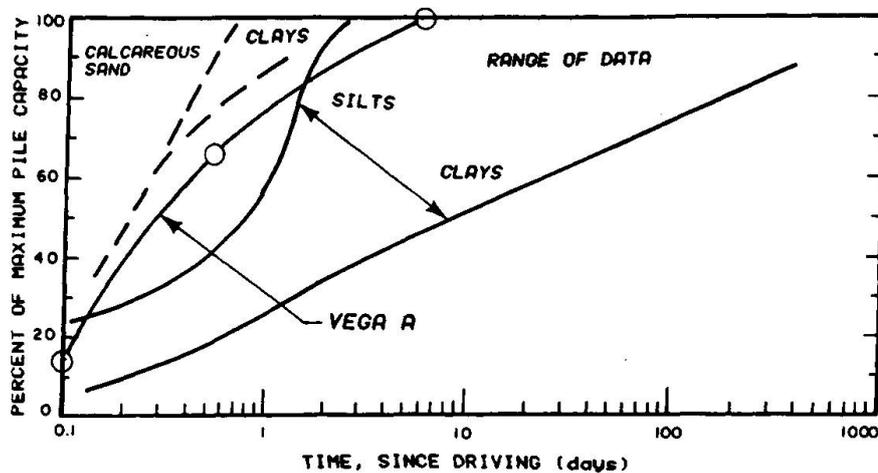
Figure 4 : Pile capacity for different soil conditions as a function of time after driving .

The adequacy of the foundation however was confirmed by redrive tests, performed at a depth of 65 meters, the first after a set-up period of 148 hours, the second after a set-up period of 14 hours. These tests indicated that the set-up or strength gain of the Vega A soil was considerable, as a plotted on figure 4. From a soil resistance to driving of about 13 MN the driving resistance increased to 30 MN after 14 hours set-up, and about 45 MN after six days.

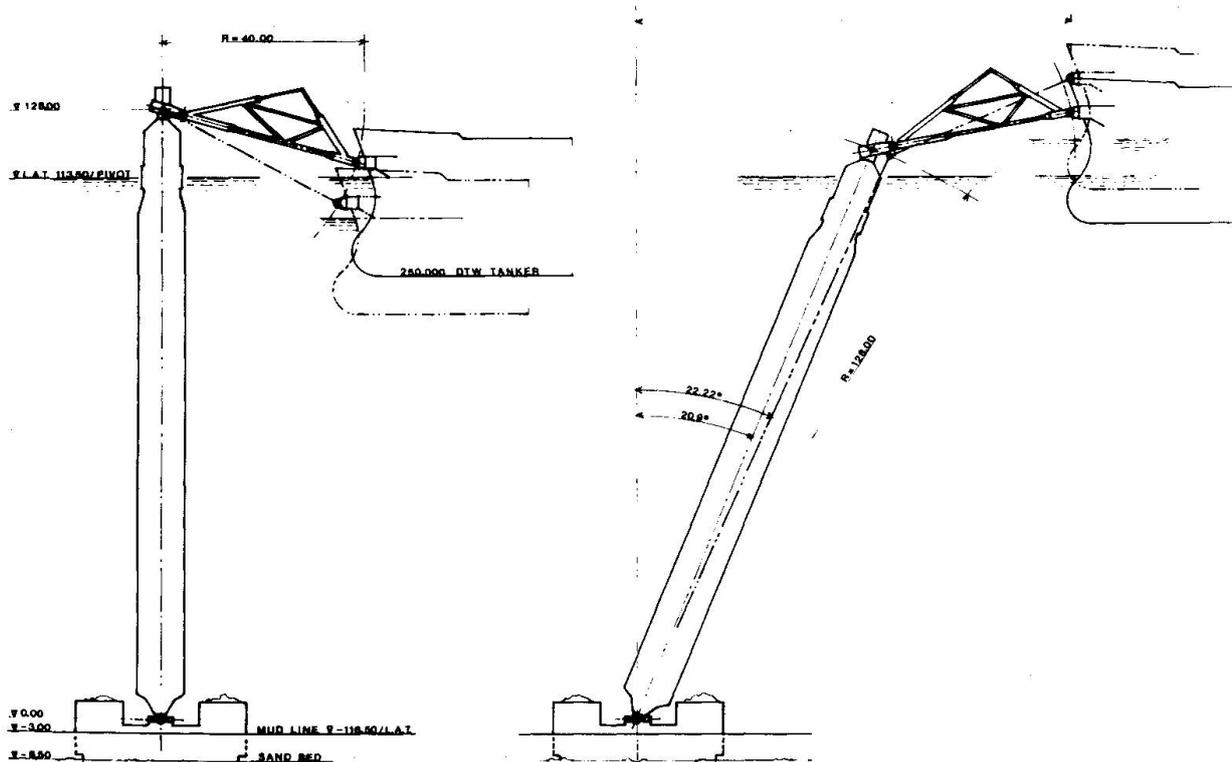
Figure 5 : Single point mooring movements of column, yoke and tanker

- the three angles between base/column, column/yoke and yoke/tanker by pitch-roll sensor;
- the load between the columns and tanker through the yoke by stress sensor.

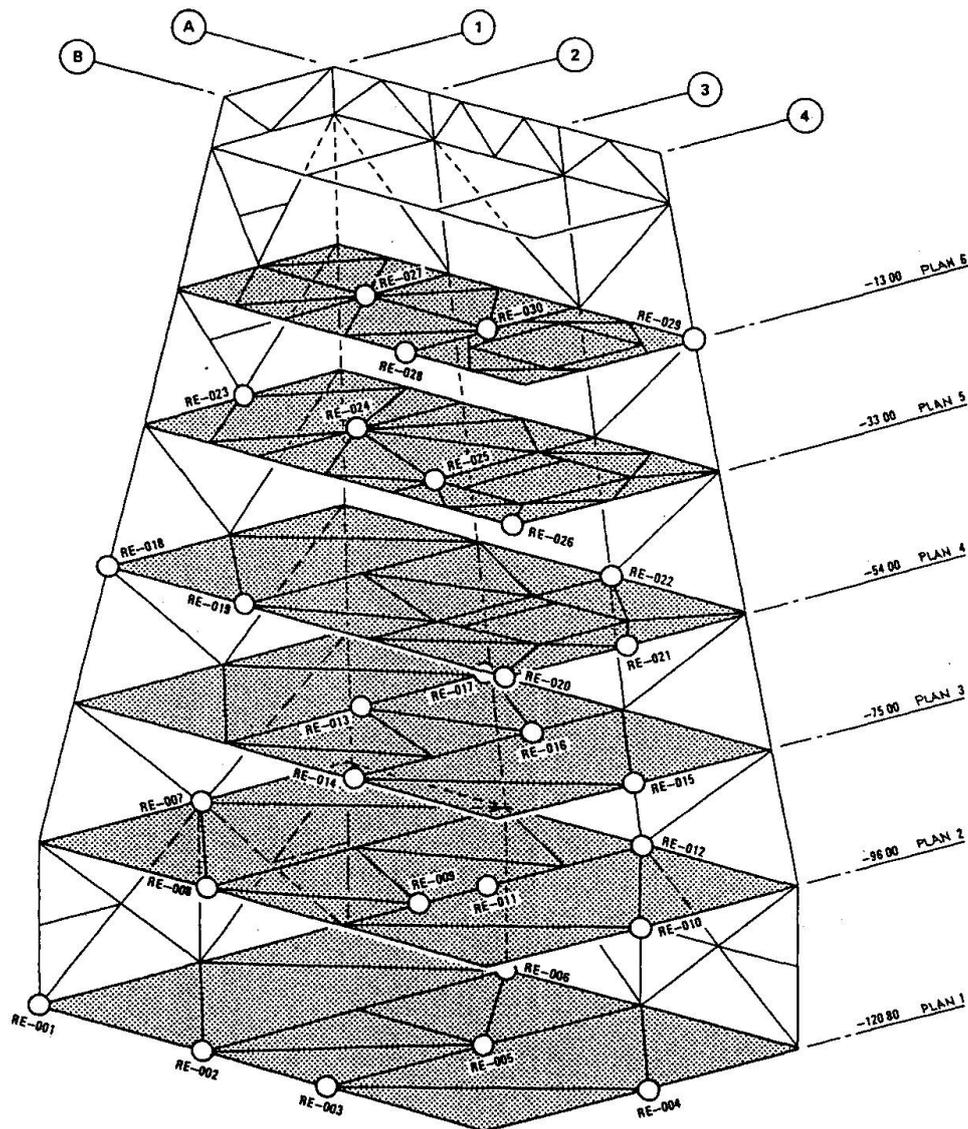
Figure 6 : Position of reference cells for cathodic protection monitoring system.

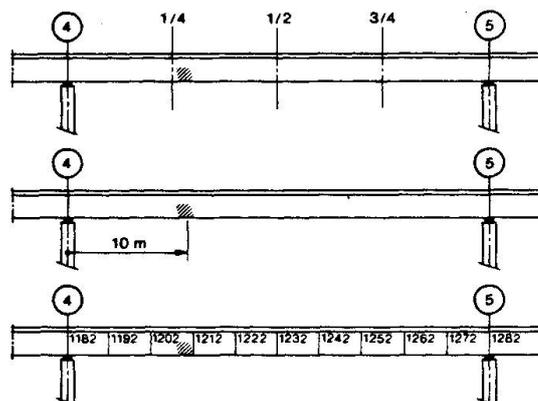
Fig. 1 Locating of observations

A good deal of these observations should be noted in drawings (fig. 1). Cracks, water infiltration, traces of corrosion, bursting of concrete etc. have to be carried back conscientiously in the drawings in order to get a general survey of the disorders. For that purpose, the drawing of each span should be divided in equal parts, creating a regular wide-mesh net (maillage) which has also to be reported on the bridge itself. In fact, it proves difficult to situate an observation only by means of a distance, for instance 10 m from pier 4 as shown in Fig. 1. These drawings have to be utilized during all the life time of the bridge, so that with time a lot of indications will have to be plotted, with many specifications as crack length, crack width, date of appearance, evolution observed from the last inspection etc.
