Zeitschrift: IABSE reports = Rapports AIPC = IVBH Berichte
Band: 56 (1987)

Interpretative Models and Decision Making

Dynamic Behaviour and Monitoring of Ancient Monuments

Carlo BLASI

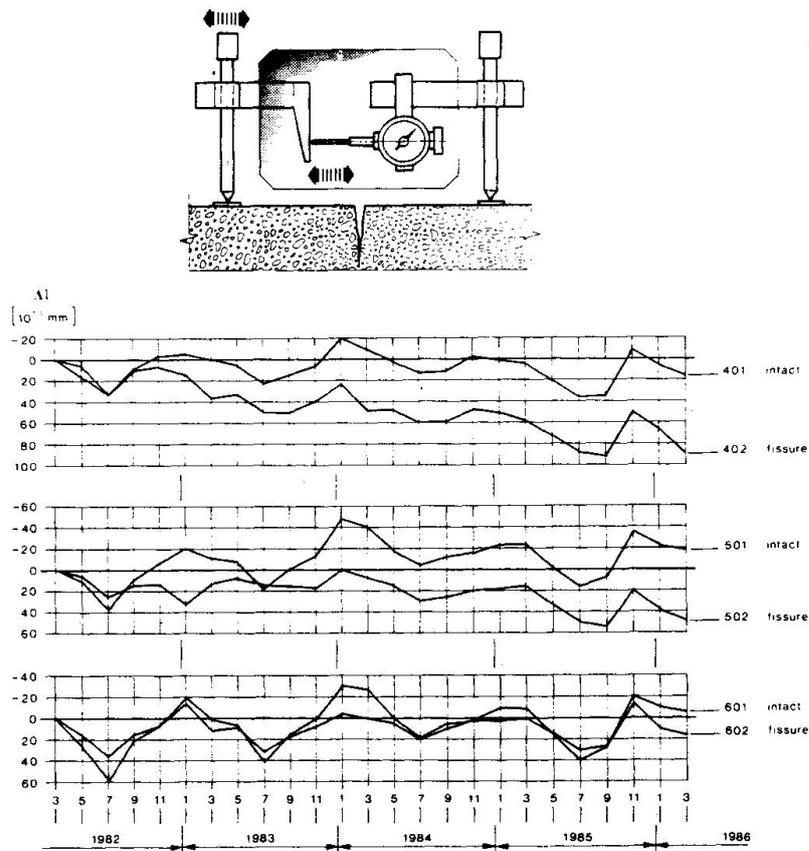
Fig. 3 Evolution of crack-openings

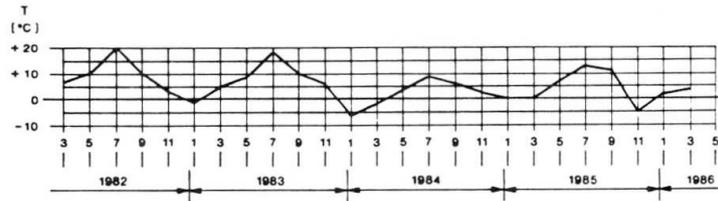
Fig. 4 Evolution of temperature in concrete

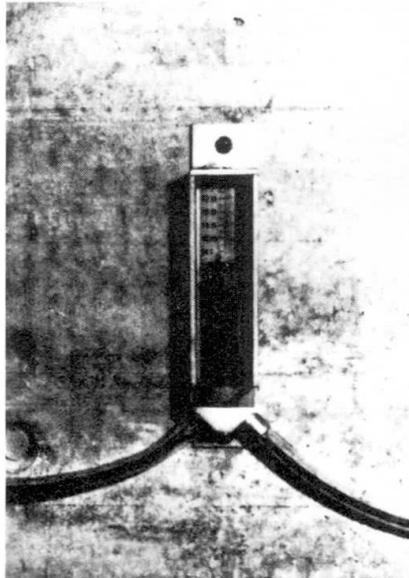
Fig. 5 Vessel for hydraulic levelling

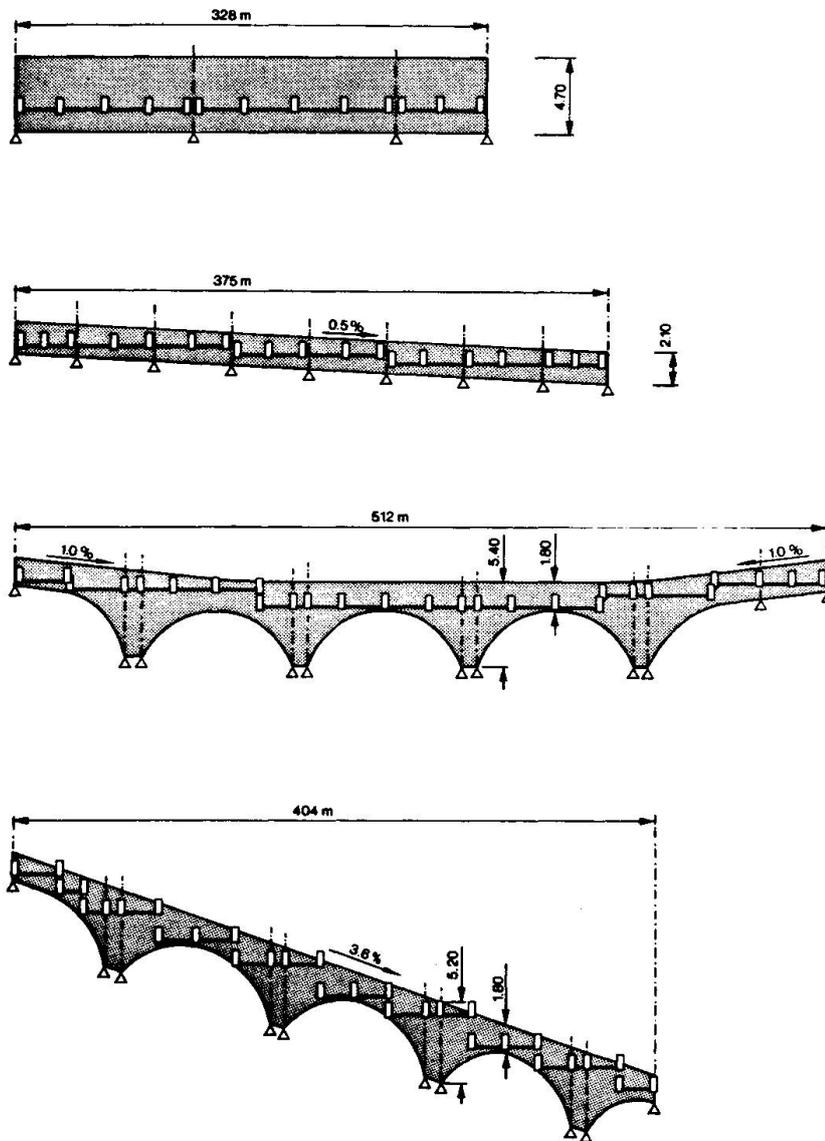
Fig. 6 Examples of installed communicating vessels

A reference point has to be chosen, an abutment for instance. As a minimum, communicating vessels are placed on the supports and at mid-span, but also quarterly along the significant spans. In order to notably reduce the thermal effects, the measurements should be carried out in similar conditions, that is late autumn or winter. They therefore rarely coincide with the periodic inspections, at least at the beginning. They should be carried out every year for the first five, then every other year for the following four years and then every five years during the remaining life span. Thus the evolution tendency can be better estimated.

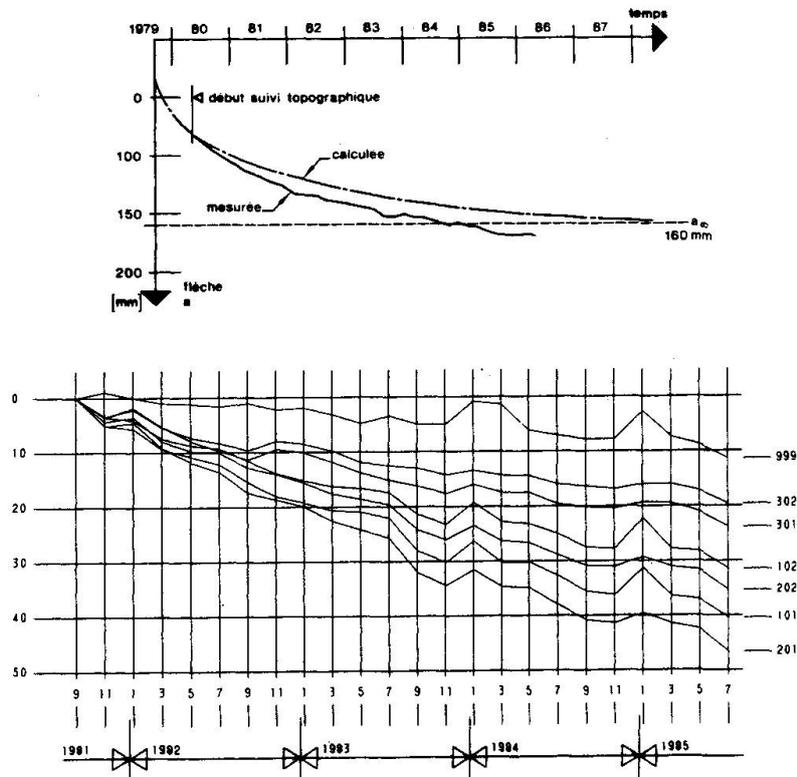
Fig. 8 Two examples of long term deflections greater than predicted

If the long term deformations are bigger than the predicted ones (Fig. 8), the reasons have to be investigated very thoroughly. One has to be aware of the fact that there is a real lack of knowledge concerning the prediction of long term deflections.

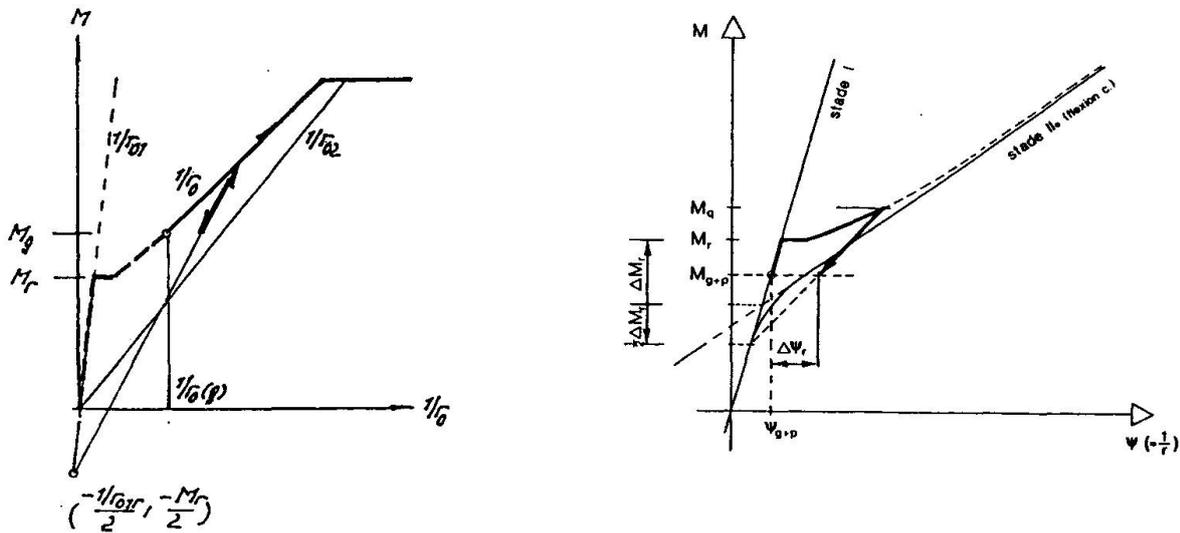
Fig. 9 Moment-curvature relationship for instantaneous reloading/unloading
 a) simple bending
 b) bending with normal force
