SESSION 3

Interpretative Models and Decision Making

Dynamic Behaviour and Monitoring of Ancient Monuments

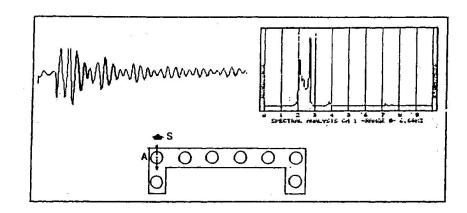
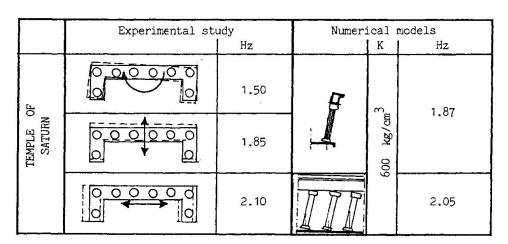
fig. 1 Tempio di Saturno: Displacements concerning 3 eigenmodes

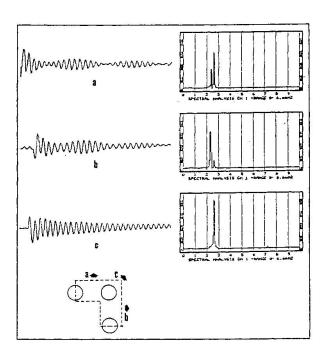
fig. 2 Tempio di Vespasiano: Displacements concerning 3 eigenmodes

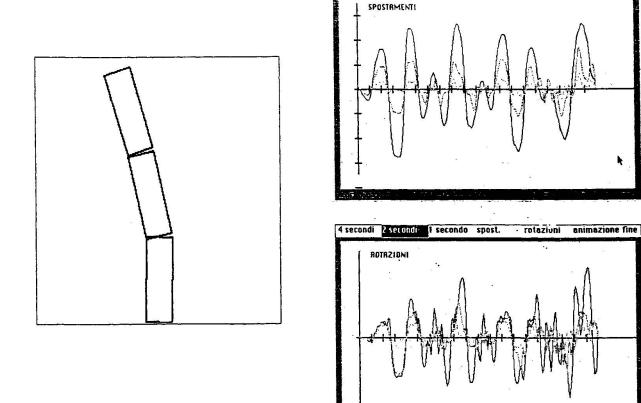
fig. 3 Colonna di Foca: Numerical non linear model and results (displacements and rotations)

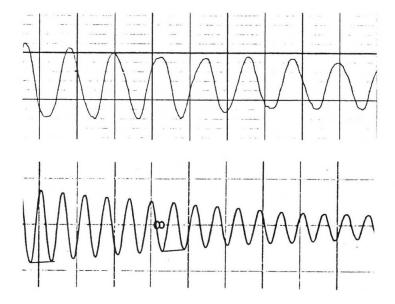
fig. 4 Colonna di Foca: Some examples of displacements effected before and after the consolidation

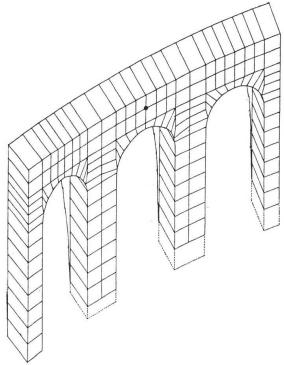
fig. 6 Colosseo: Finite Elements model of the research area.

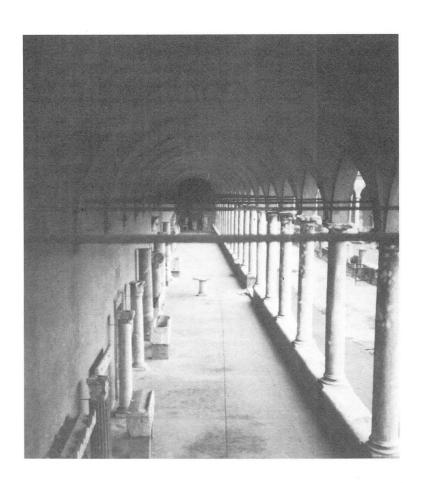
fig. 7 Photo of catenary system in Michelangelo cloister in the church of S. Maria degli Angeli in Rome.

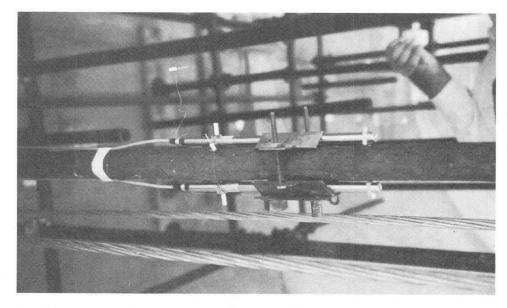
fig. 8 Photo of deformometers applied on a chain for dynamic tests.

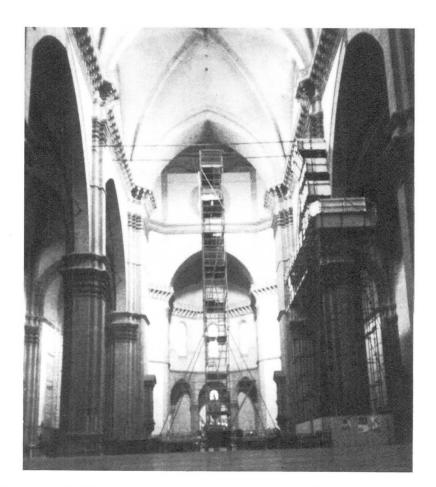
fig. 9 Photo of the church of S. Maria del Fiore in Florence during the test effected on transversal chain.

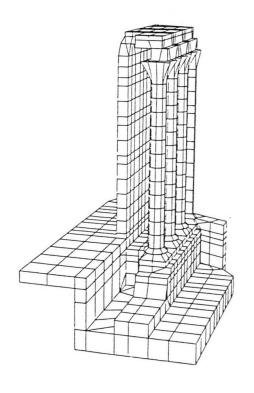
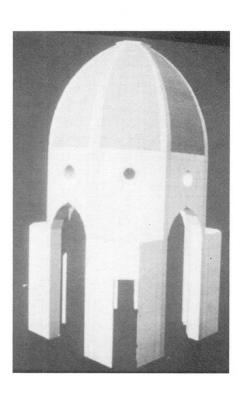
fig. 11 Tempio di Marte Ultore and Brunelleschi's Dome numerical models (CRIS-ENEL)

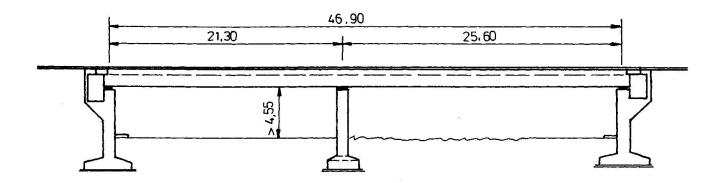
Fig. 1 Bridge Ulenbergstraße, Longitudinal and cross sections

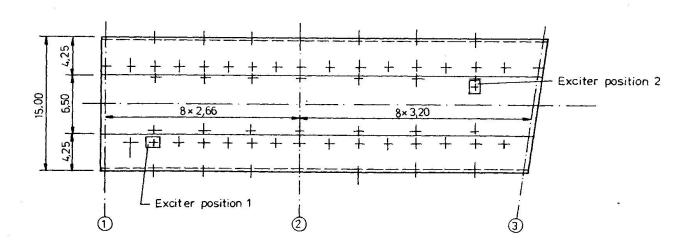
Fig. 2 Bridge Ulenbergstraße, Plan view Exciter positions and measuring grid

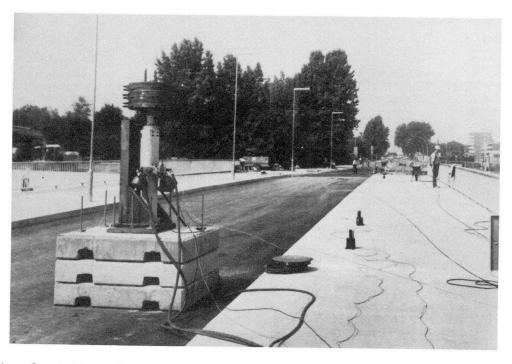
Fig. 3 Bridge Ulenbergstraße, hydraulic exciter (1st measurement)

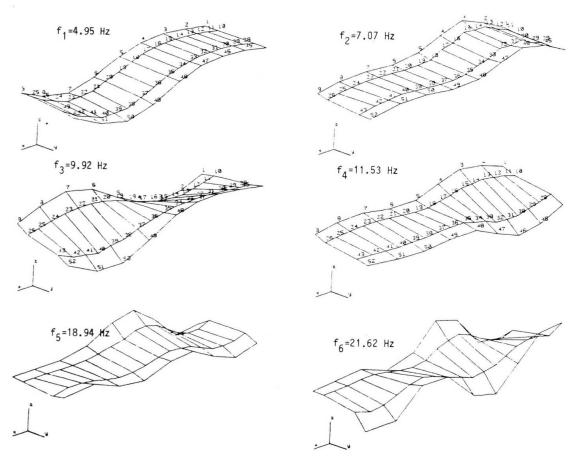
$\underline{\text{Fig. 4}}$ Mode shapes extr $oldsymbol{lpha}$ cted from the measured response

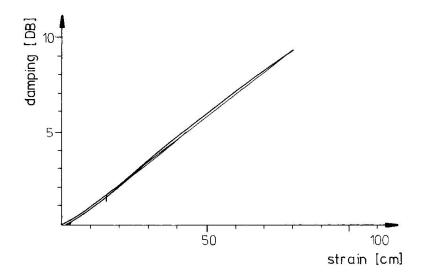
Fig. 6 Damping-strain relationship of the optical sensor

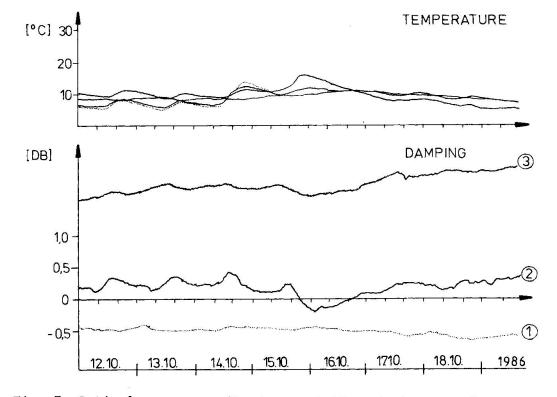
Fig. 7 Optical sensor monitoring on Bridge Ulenbergstraße

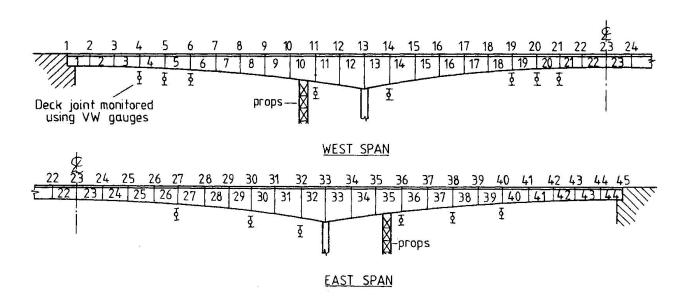
Fig. 1 Deck segment and joint numbering sequence

The segments and joints were numbered consecutively from the west end (Fig. 1). Each segment comprised four, 3m long, precast I-sections joined by in-situ top and bottom slabs to form a three cell box structure. The precast I-sections were temporarily held in place during erection by a diagonal Macalloy bar passing through the webs at the joints. The Macalloy bars remained in position in the permanent structure and were fully grouted. Longitudinal post-tensioning was then applied to the precast units so that two 19 wire/25mm diameter strands were anchored at each cantilever end, running through the previously assembled I-sections. The continuously reinforced slabs were cast and further post-tensioning was applied.

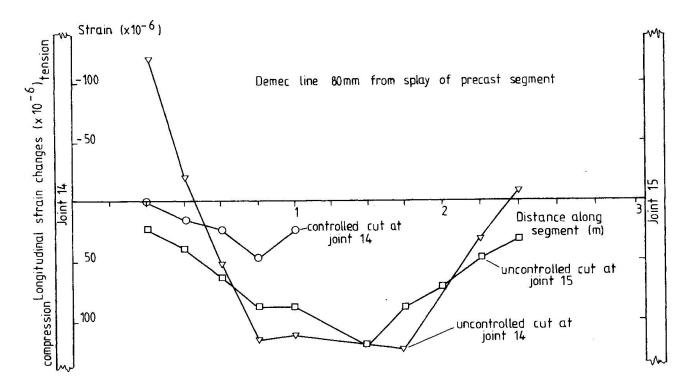
Fig.2 Typical debonding curve.

The curve for the controlled cut at point 1 relates to the cutting of 3 wires in the nearest 19 wire strand at joint 14. The curves for uncontrolled cutting at points 2 and 3 relate to the severing of all the tendons at joints 15 and 14 respectively. As the cutting at point 3 (joint 14) was carried out last, the corresponding curve shows a symmetrical distribution in the strain changes. Each half of the curve is of a form associated with the transfer of stress in the transmission zone of a pretensioned tendon. High strain gradients near the cut end of the tendon are a consequence of the transfer of force from the steel to the concrete by bond. The transmission length is of the order of a metre. In the

Generally the trials showed that fully grouted tendons would not debond more than a fraction of the length of a unit, ensuring that virtually all the residual prestress force would be present at the next in-situ joint. During progressive cutting of a tendon, the changes in strain on the adjacent concrete surface illustrated the debonding characteristics (Fig. 2).

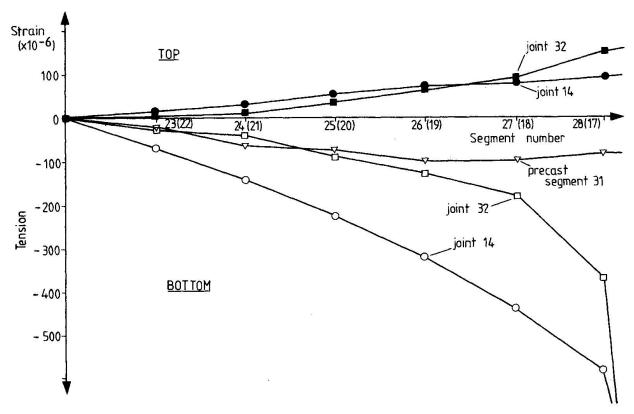
Fig. 3 Comparison of strain changes on south side.

Generally the strain changes due to the removal of the first box units were relatively small. The readings taken across the joints furthest from the piers were closely predicted by elastic theory. However, as demolition progressed the strain changes in the joints near the piers increased dramatically. This effect was particularly noticeable for joints 14 and 32 on the centre span. Although joint 32 did not initially suffer significant strain changes, after the first five midspan units had been removed the apparent tensile strains increased to become similar to the readings from joint 14 (Fig. 3).

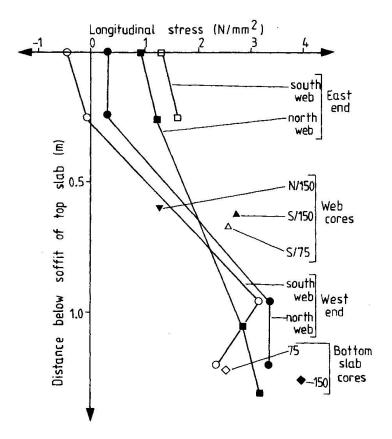
The stresses derived the method coring were compared with those obtained from the complete removal of unit 25 (Fig. 4). stresses longitudinal were in reasonable agreement for both the north and south at each although, as expected, there was a distinct difference between the two sections. Despite the fact that the conditions were not identical for the two the results were in trials, agreement. This acod indicated that the coring method provided useful indirect evidence on the state of stress in the webs and flanges.

Fig. 4 Longitudinal stresses in unit 25

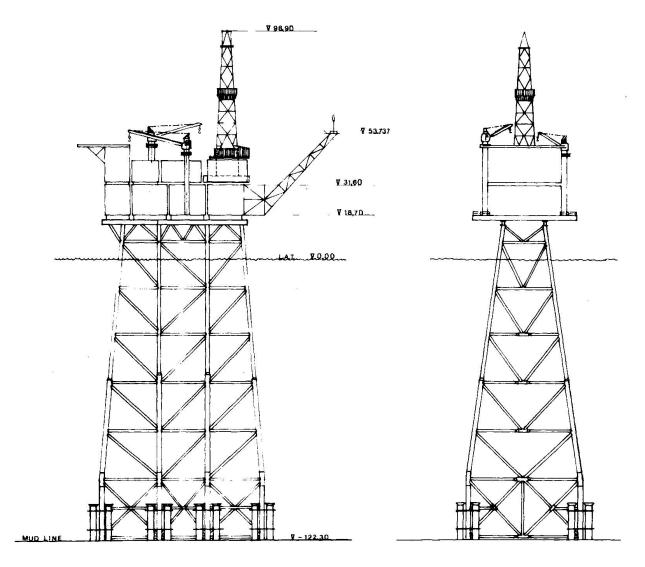
Figure 1 : North West and South West views of Vega A platform.

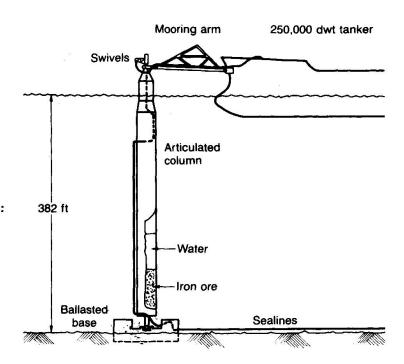
Figure 2: Single point mooring for tanker at 2.3 km from platform.

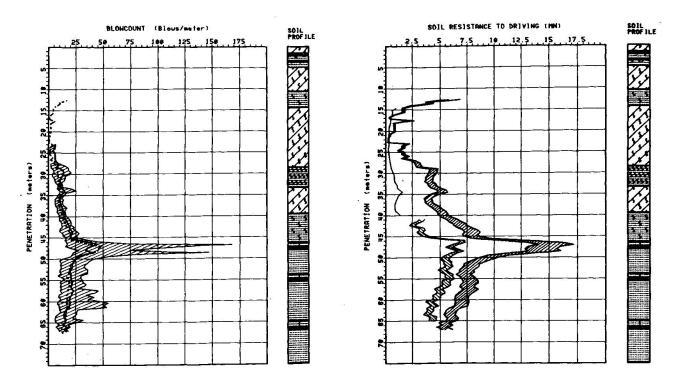
For the piles figure 3 shows that the average blowcount never exceeded 50 blows per meter. This observed driving behaviour demonstrates that the frictional

Figure 3: Blawcount of foundation pile and soil resistance for pile and conductor during driving.

resistence acting on the piles was lower than expected due to remoulding and degradation effects, this also can be explained in terms of the excess energy available during driving.

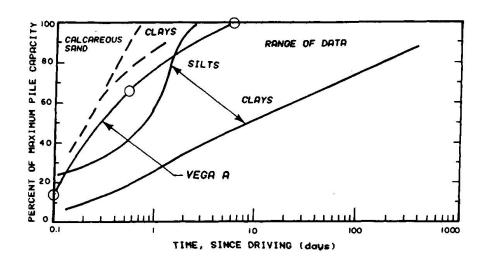
Figure 4: Pile capacity for different soil conditions as a founction of time after driving.

The adequacy of the foundation however was confirmed by redrive tests, performed at a depth of 65 meters, the first after a set-up period of 148 hours, the second after a set-up period of 14 hours. These tests indicated that the set-up or strength gain of the Vega A soil was considerable, as a plotted on figure 4. From a soil resistence to driving of about 13 MN the driving resistence increased to 30 MN after 14 hours set-up, and about 45 MN after six days.

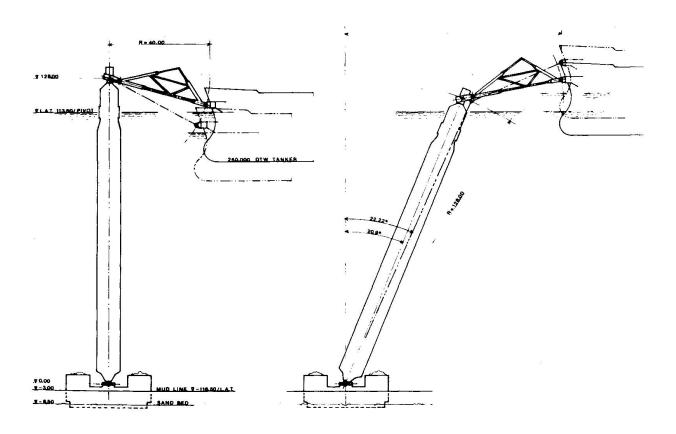
Figure 5 : Single point mooring movements of column, yoke and tanker

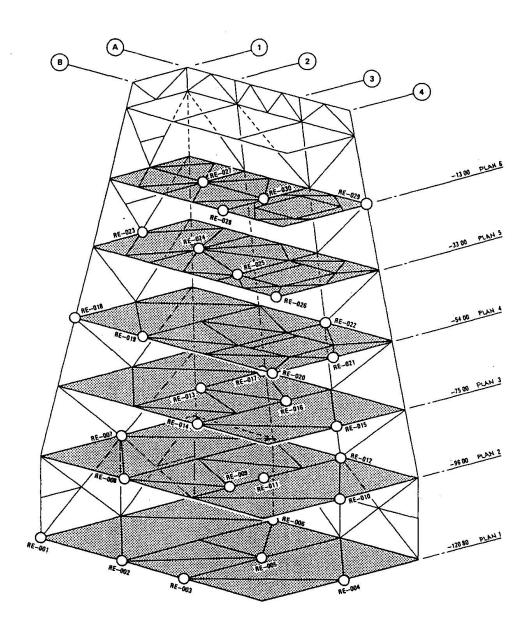
Figure 6 : Position of reference cells for cathodic protection monitoring system.

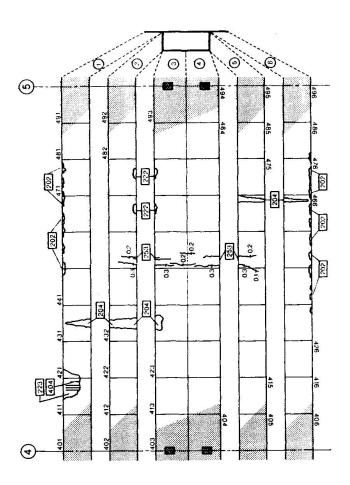
Fig. 2 Observations on the external surfaces plotted in a drawing provided with a numbered net

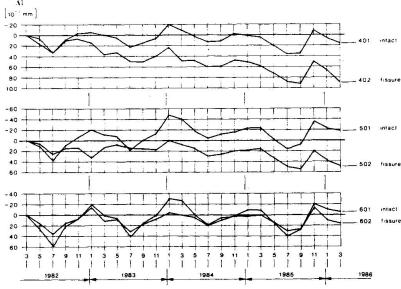
Fig. 3 Evolution of crack-openings

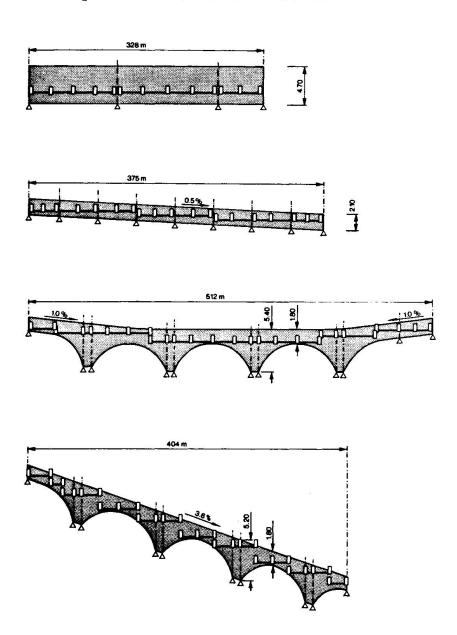
Fig. 6 Examples of installed communicating vessels

A reference point has to be choosen, an abutment for instance. As a minimum, communicating vessels are placed on the supports and at mid-span, but also quarterly along the significant spans. In order to notably reduce the thermal effects, the measurements should be carried out in similar conditions, that is late autumn or winter. They therefore rarely coincide with the periodic inspections, at least at the beginning. They should be carried out every year for the first five, then every other year for the following four years and then every five years during the remaining life span. Thus the evolution tendancy can be better estimated.

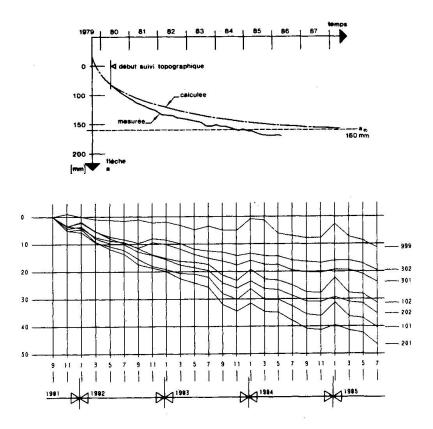
Fig. 8 Two examples of long term deflections greater than predicted

If the long term deformations are bigger than the predicted ones (Fig. 8), the reasons have to be investigated very thoroughly. One has to be aware of the fact that there is a real lack of knowledge concerning the prediction of long term deflections.

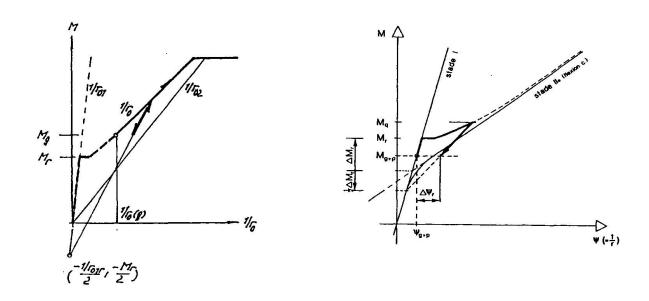
Fig. 9 Moment-curvature relationship for instantaneous reloading/unloading

- a) simple bending
- b) bending with normal force
